OR-FACE ALERT

Follow manufacturer's instructions

Construction Fatal Stories

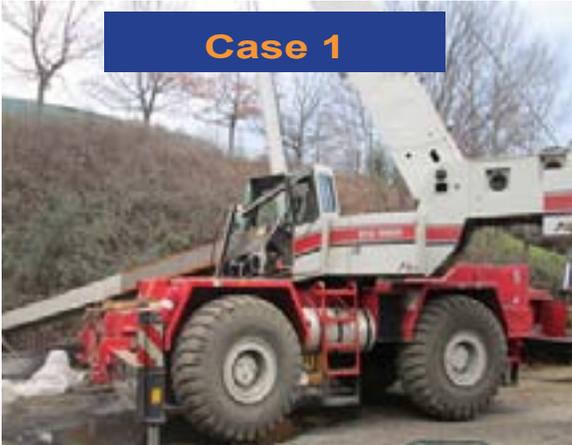
Case 1

Case 1: A 40-year old crane operator was killed when a 35-foot (5600 lb) H-beam fell crushing the crane cab and striking him in the head. During a pile driving operation, the H-beam pile had been placed in a drilled 25-foot hole. While using a vibratory hammer to force the pile further into the hole, the pile shifted. After several failed attempts to correctly position the pile it was extracted using the hydraulic clamp of the vibratory hammer and moved 12 feet from the hole. It was held in a vertical position with the bottom of the pile resting on the ground. The clamp holding the top of the pile unexpectedly released. The pile was not rigged to the clamp housing or attached to the whipline. The 5600 lb pile fell, struck and crushed the crane cab, and killed the operator.

The crew was not aware of the manufacturer instructions warning of clamp failure if the hydraulic clamp cylinder was not bled of entrained air. Pile lifting instructions in the manual required a shackle and short line attached to the hole in the pile clamp housing with the shackle fastened into the lifting hole in the pile.

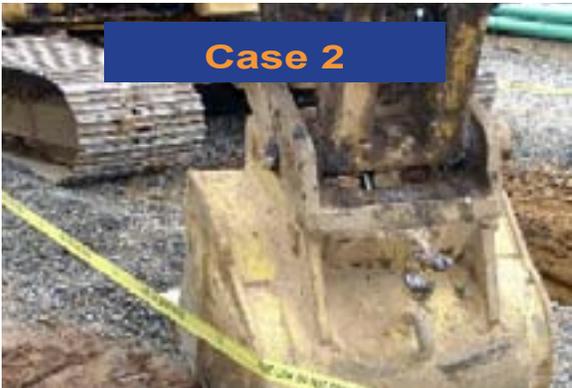
Case 2

Case 2: A 40-year-old pipelayer was struck in the head by the flying rigging of a towline that failed at an excavation site, and died 2 days later. During installation of a sewer pipeline, a hydraulic excavator, commonly called a track-hoe, pulled a 14,000 lb. steel trench shield forward inside a 14.5 ft trench, using a wire rope and hook system. The pipelayer was standing inside the shield while it was being moved. A hook attached to the track-hoe failed, causing the taut rigging to snap loose, fly into the trench shield, and hit the pipelayer on the back of his hard hat. The pipelayer was air evacuated to a hospital, where he later died.

The manufacturer safety instructions warned that coupler and components should not be modified. The closed lifting eye had been removed and replaced with a latched hook.

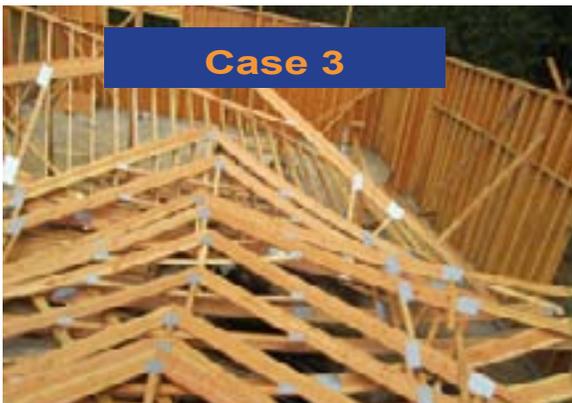
Case 3

Case 3: A 33-year old carpenter foreman was killed when the roof truss system he and his crew were installing collapsed. The critical elements of standard practice provided in the BCSI-B1 Summary Sheet Guide to Handling, Installing, Restraining and Bracing of Trusses prior to and during truss installation were not followed. After the thirteenth truss was toenailed into its place, the victim disconnected the truss from the rigging. The truck operator and crew member on the trailer saw the truss system collapsing and yelled to warn the crew. The foreman sustained a fatal head injury when he was struck on the head by a falling truss.

The Structural Building Components Association, BCSI-B1 Summary Sheet-Guide to Handling, Installing, Restraining and Bracing of Trusses, delivered by the truck driver, contained specifications for adequate bracing during truss installation.
