# Fatality Investigation Report

OR 2006-26-1

## Machine operator dies after head crushed in machine

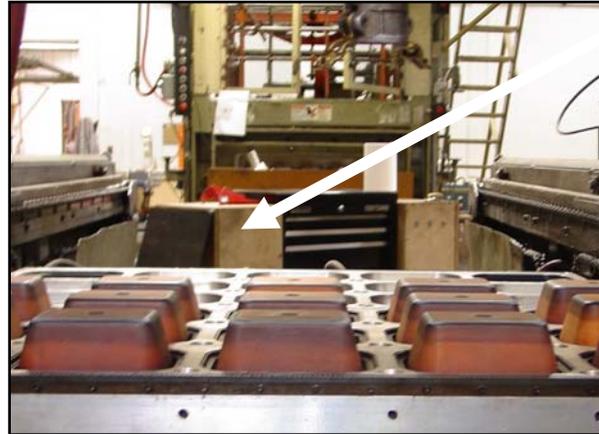
This interior view of the plastic thermoforming machine shows the oven cavity (arrow) where the machine operator was working to adjust the alignment of the molds and bottom platen (in foreground).

The swing-shift crew started to align the mold and adjust the height of the top platen, so when it opened, the newly-formed product would clear the mold. The machine operator rolled the oven out to a position where he could get into the oven cavity area, then began to make adjustments inside the cavity. The coworker was about 4 feet away, on the opposite side of the oven, making adjustments to the machine's top platen stop.

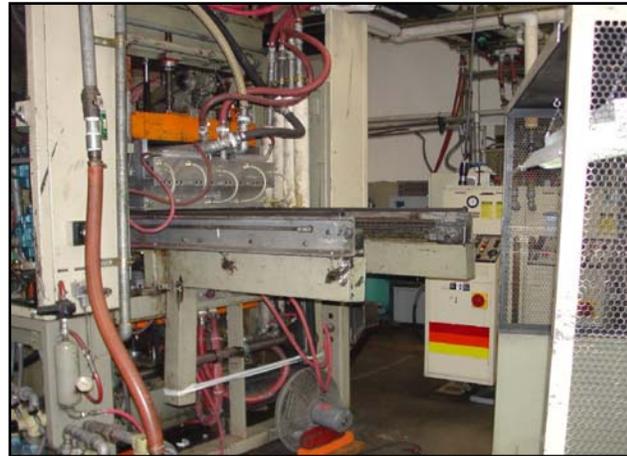
After adjusting the platen stop, the set-up worker yelled “clear” – the signal he regularly used to warn that he was going to activate the pneumatic toggle switch. Although electrical energy had been shut down, the switch remained energized by an independent air supply. The coworker looked through the oven area, and did not see the machine operator (or by a second account, did see the machine operator making final adjustments outside the oven). Other running machinery in the plant made a noisy environment, which made verbal communication between the two workers difficult.

This front view of the plastic thermoformer machine shows where the set-up worker was making adjustments to the top platen, while the machine operator was working in the rear of the machine to adjust the oven. The pneumatic hose on the left of the machine remained energized during the adjustments.

Individual lockout devices to shut down all energy sources, including pneumatic sources, must be applied prior to conducting maintenance or adjustment in the operating areas of a machine. In this incident, even though the machine was electrically de-energized at the time of the incident, pneumatic energy used to operate the platens and oven motor could not be locked out. No control mechanism was available. The manufacturer's instructions specified that the air infeed line should be shut down before making adjustments, but the procedure was not included in the firm's written lockout procedures. In addition, a block to place between the platens and prevent them from closing while working inside the oven area was available but not used.

### **Recommendation #1. Perform all appropriate lockout/tag out procedures to control hazardous energy before conducting maintenance inside machinery.**

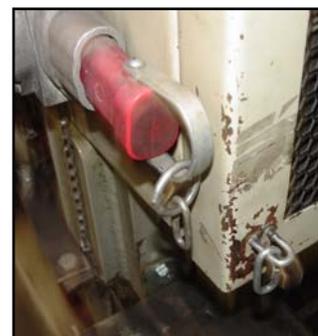
Do not bypass safety interlock circuits or other safety devices. In this incident, the thermoform machine was equipped with four safety interlock devices on the access doors of each side of the machine. These devices prevent machine operation when the access doors or gates are opened. In this incident, all interlock devices were disconnected or bypassed.

One of the disconnected safety interlocks on the thermoform machine would have prevented start-up if a gate was open.

### **Recommendation #2. Before starting a machine, make sure all safety mechanisms are in place, such as interlock devices and machine guards.**

Hazard inspections should ensure all safety devices are in place and lockout/tag out procedures are being followed by machine operators and set-up workers. In the case here, periodic inspections of energy-control procedures could have identified and corrected the bypass of the machine's safety interlock system. Hazard inspections are best performed regularly. Corrective actions should be completed by a scheduled date.
