Fatality Investigation Report

OR 2003-22-1

Shipyard welder ignites hydraulic fluid and is fatally burned

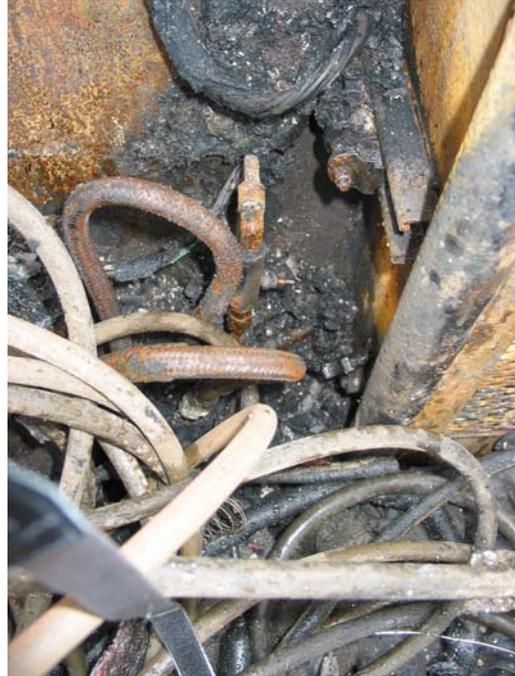
Figure 1: Hydraulic lines in high lift work location.

Figure 1 on the first page shows the remnants of a hydraulic line connection inside the worker's platform. The hoses are gone and only the braided steel reinforcement remains. It is believed that an initial break caused the hydraulic fluid to "spray" out under line pressures (up to 1800 p.s.i.) and become the fuel that kept supplying and re-igniting the victims' clothes.

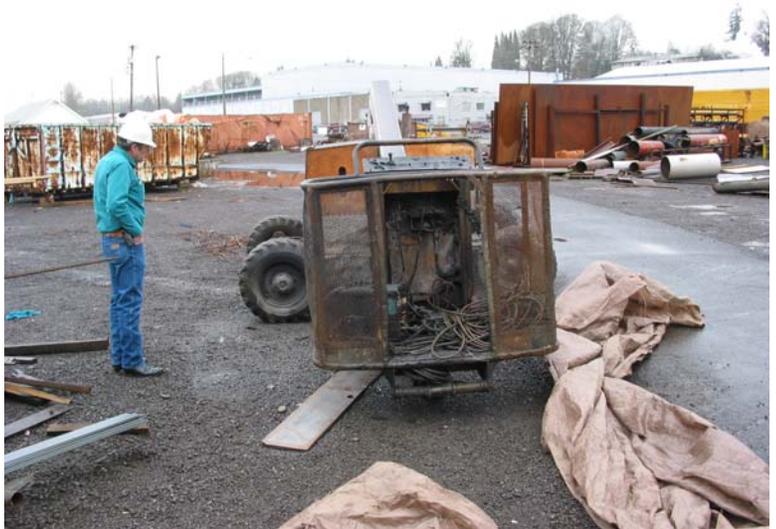
Figure 2: High lift used in the incident.

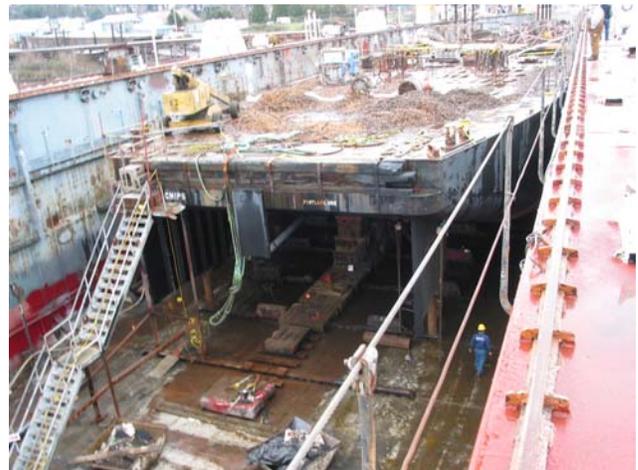
Figure 3: Barge in dry dock.

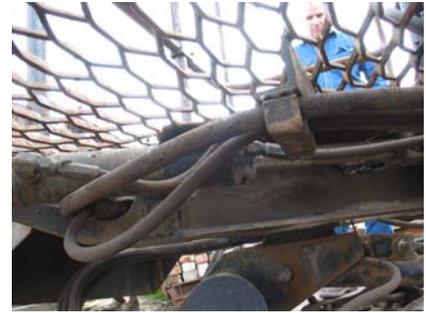
Figure 4: Exposed hydraulic lines under grating of work platform.

Hydraulic lines should be routed so that they are protected from hazards created by the work process and from physical damage. Hydraulic lines on the high lift were routed up through the floor of the cage into the worker area. The floor to the cage was an open grating (see Fig. 4). The proximity of the work area to the hydraulic lines demonstrates the concern to physically protect the lines. Open gratings cannot prevent hot slag from coming into contact with the hoses. Co-workers indicated that fire blanket material had been used in the past to act as a protective physical barrier between the hydraulic lines and the work being performed from inside the cage. Employees reported that they had routinely applied fire blanket materials over exposed hydraulic lines to protect them from the physical hazards present in the work environment, in the past.

Exposed hydraulic lines need to be protected from physical wear and tear of every day use by a means that is appropriate, based on the employer's assessment of risk. Fire blankets help to protect the lines from physical damage and may serve to deflect hydraulic oil spray in the event of a similar catastrophe. The victim had used fire blankets in the past, but not on the day of the incident. It is not known why fire blankets weren't used on the day of the incident. Management was apparently unaware of the use of fire blankets, or their need, to protect the equipment from welding operations.

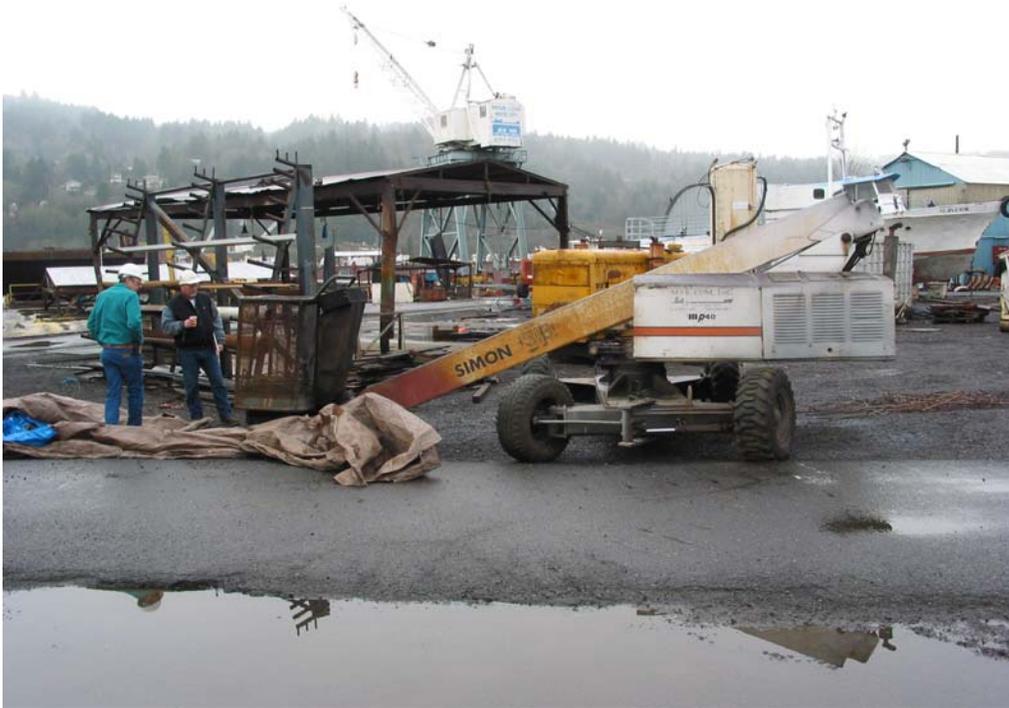
Figure 5: Photo of the manlift involved in this incident.
