Fatality Investigation Report

OR 2003-21-1

Worker killed in wood-dust fire sparked by faulty fuse

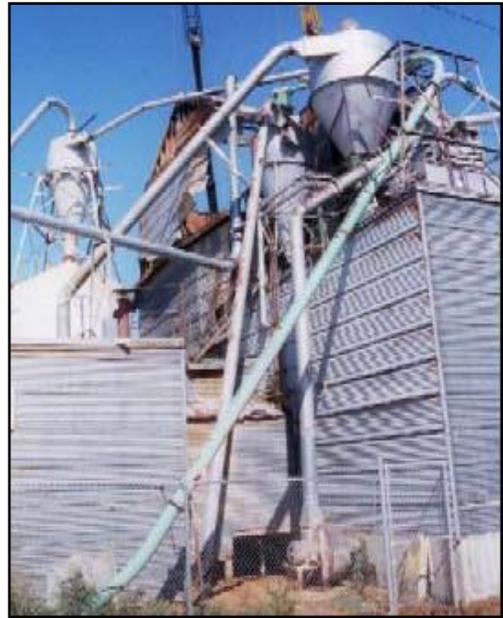
The top of the factory roof was destroyed in the wood-dust explosion.

The concussion from the initial blast caused wood dust on other surfaces in the area to become airborne, creating a rapid succession of at least three explosions that combined into one very loud, superheated explosion. The required isolation of the fuse-panel room was compromised by a large hole in the wall (1 ft x 3 ft), created during an earlier installation of an I-beam to support the main flour bin. The hole had allowed wood dust to collect on surfaces in the fuse-panel room. When the explosion occurred, the hole also allowed the blast to reach directly where the worker was standing. The upper portion of his body was severely burned, and he inhaled toxic, superheated air.

This incident emphasizes the danger of dust as a combustible material with explosive potential. Electrical safety codes explicitly address the hazards of combustible wood flour and other organic dust. In addition to following codes to isolate electrical equipment from dust accumulation, employers should also conduct regular inspections and remove dust with a vacuum.

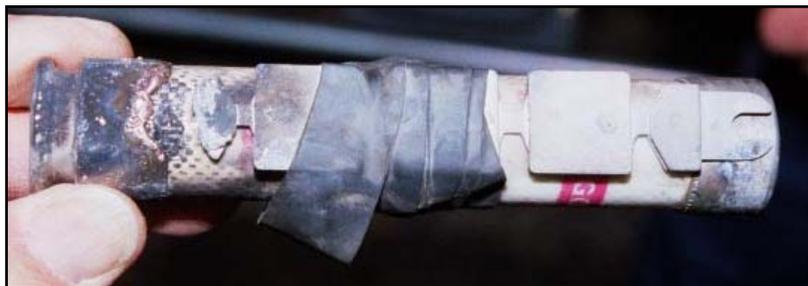
On the day prior to the incident, the production worker was shown a fuse that had been repaired by a coworker during the previous shift. Apparently, the appropriate replacement fuse was not available (or there was trouble getting it to work properly), and the coworker had taped a renewable fuse link to the outside of the melted, nonrenewable fuse cartridge. The production worker removed the rigged fuse to inspect it, and then reinserted it into the fuse holder.

A melted fuse was repaired by taping a renewable fuse link on the outside.

At 7 a.m. on the following day, the production worker started up the plant operation. Working alone, he began switching on the equipment in a standard start-up sequence. Switches were located in a large storage area adjacent to the fuse-panel room. The rigged fuse was connected to a three-phase 440-volt/30 amp electrical motor for a fan that collected dust emissions from the milling process. The motor was later inspected and found to be fully operational. The rigged fuse had evidently made good contact with the fuse holder earlier, but when removed and reinserted it remained loose enough to allow the renewable fuse link to “chatter” against the ends of the housing, due to vibrations from running equipment in the factory. When the worker hit the switch for the fan, an electric arc was generated across the poor connection between the makeshift fuse and the fuse holder. The wood dust that had accumulated inside the fuse panel ignited and exploded.

The poor contact between the makeshift fuse and the fuse holder was a primary risk in this incident. Fuse holders are designed to ensure tight electrical contact with the fuse end to prevent arcing. The makeshift fuse used in this incident defeated this design. In a renewable fuse, the fuse link is enclosed, and any sparks that might occur are contained. One-time-use fuses must be replaced with a new fuse once expended. A supply of appropriate fuses and circuit-breaker replacements should be maintained for each circuit in a facility.

Recommendation #1. Protection devices for electrical current, such as fuses, should not be altered or bypassed.
