Fatality Investigation Report

OR 2013-05-1

Vineyard worker killed in fall from trailer

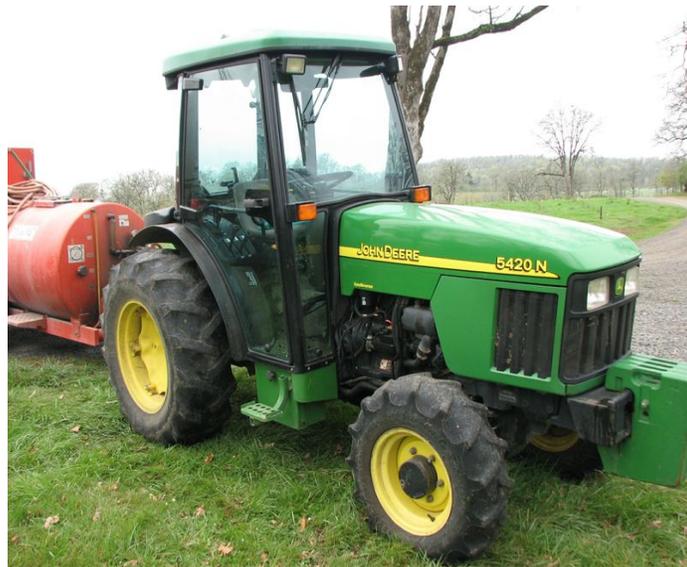
Figure 1. Tractor and trailer mounted 400 gallon chemical tank.

Three workers had been applying pesticide in the vineyard. The pesticide was contained in a trailer mounted chemical tank hitched to a tractor that pulled the tank through the vineyard (see Figure 1). Workers applied the pesticide by using hoses connected to the chemical tank and walked alongside the trailer while spraying the base of the grape vines. To allow the workers to ride the trailer to and from the field, the employer constructed a wooden platform toward the rear of the trailer (see Figures 2 and 3) and attached a nylon rope to the tank for use as a handhold by workers while on the platform. The crew finished their application and was returning to the equipment shop.

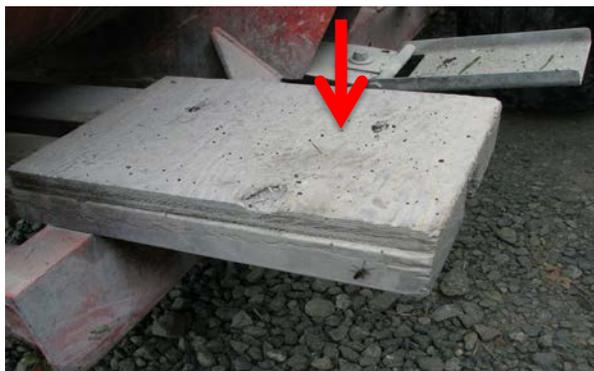
Figure 2. Close-up of wooden platform constructed by employer.

The employer had previously modified the trailer by adding wooden platforms, one on each side of the trailer (see Figures 2 and 3). The intended use of these platforms was for workers to stand on and ride the trailer to and from the field as it was towed by a tractor. These platforms were constructed with 2-inch by 4-inch lumber approximately 48 inches long, placed beneath the fan housing on the back of the trailer and on top of the frame holding the tank. Attached to the top of the 2X4's were pieces of 12-inch by 8 ½-inch plywood. The top of the improvised platforms were approximately 17 inches from the ground. The employer stated that a nylon line approximately ¼-inch was added around the top of the framework to the fan to be used by workers as a handle while they were standing on the platform. Employee interviews indicated that standing on these make-shift platforms had been done many times without incident.

The day of the incident was clear without precipitation. The surface condition of the wooden platform was not affected by weather conditions, however, it is possible that the boots worn by the employees may have been wet from the spray process, or the platform may have been slippery due to chemical overspray during the day.

- The employer added the platforms to provide worker transportation to and from the field. The modification may have created additional hazards or altered safe operating parameters. Although not known, the wooden surface of the platform may have been slippery and contributed to the incident. Other consideration when modifying machines or equipment is whether the design capacity would be exceeded and structural stability and strength compromised. As required by OAR 437-004-3460(1), "The manufacturer or a professional engineer must direct modifications and additions that affect capacity and safe operation of industrial vehicles...."

- Oregon Administrative Rule 437-004-3410(3)(a)(c) specifically states, "persons are never to ride on fenders, axles, hitches, tongues, buckets, forks, drawbars or any other area not intended to carry passengers." The platforms were created for passengers; however, the trailer was not designed to carry passengers.

Recommendation #1: Employers should consult the manufacturer or a professional engineer before modifying, installing or retrofitting components of equipment.

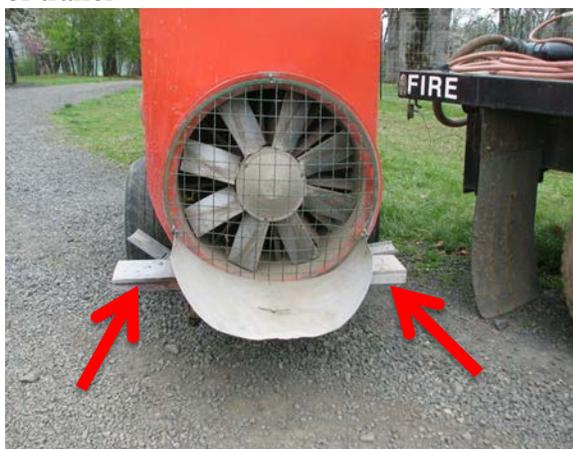
Figure 3. Wooden platforms from rear view of trailer

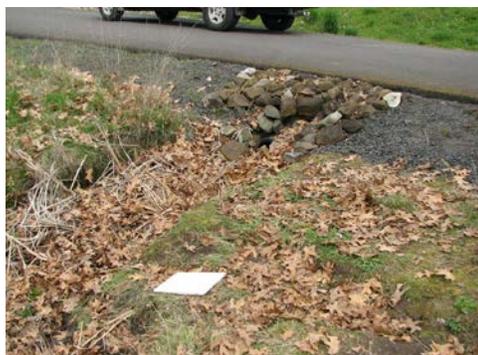
The worker wore a baseball cap that fell off his head while he was standing on the platform. Just prior to the incident the trailer was in tow along a paved roadway (see Figure 4). According to the police report, the foreman stopped the tractor for the worker to retrieve his cap and did not start movement until the worker returned to the platform. Another interview indicated that the worker was attempting to step onto the platform while the trailer was moving when he lost his balance and fell. The worker on the opposing platform did not see the fall but claimed to have heard the worker's head hit the pavement and then saw his body roll into the ditch. He immediately alerted the foreman who stopped the tractor and called the vineyard manager. According to this coworker, the fall happened a few seconds after the trailer started moving.

Figure 4. Landscape culvert and sloped surface on edge of roadway traveled.
