# Fatality Investigation Report

OR 2003-29-1

## Operator killed when bulldozer slides off logging road

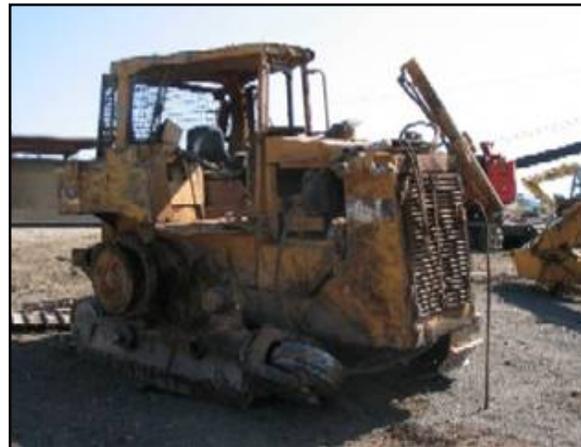
On September 6, 2003, a 75-year-old logger, working as a bulldozer operator, was killed when the D6H Caterpillar crawler tractor he was operating tumbled off a steep skid road into a ravine. The operator was climbing a 20-25 degree slope while reopening an old skid road. The bulldozer slid off of the road against a tree while on a hard rock face covered by a 4-inch surface of scabble rock. The operator apparently regained control, and may have been trying to get the bulldozer back up on the road when it slipped off the 60-70 degree sidehill and tumbled about 150 ft to a logging road, where the operator was ejected. The bulldozer bounced another 450 ft into a ravine. The event was not witnessed. Fatal injuries probably occurred when the victim was thrown around in the cab, before being ejected.

The D6H Caterpillar following the incident shows noticeable damage – missing the front blade, rear grapple, and tracks – but the operator's cage is relatively intact.

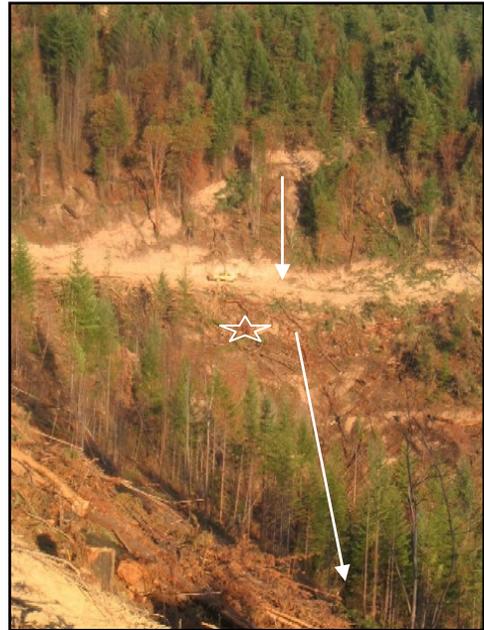
Arrows indicate the path of the Caterpillar as it tumbled off the skid road into the ravine. The star shows where the operator was thrown from the cab.

About 150 ft up the road, a hard layer of sedimentary rock was exposed. The bulldozer's metal tracks lost traction on the slick rock surface, and the 27-ton machine slid off the road, but was stopped by an old madrone tree. The bulldozer was facing uphill at this point. The operator had probably dropped the blade in an attempt to stop the slide off the road, causing the machine to face uphill when it came to rest against the tree. The operator regained control and apparently decided to turn downhill to get off the side of the mountain.

The exact maneuver at this point is not clear, but in the effort to regain the road, the bulldozer slipped off the steep 60-70 degree sidehill and tumbled several times before hitting the main logging road 150 ft below. The impact tore off the blade and the operator was ejected. The bulldozer continued to tumble to the bottom of the ravine another 450 ft farther, leaving a trail of metal debris.

When faced with a situation where the bulldozer starts to slide, it is best to drop the blade in an attempt to stop the downward progression. Usually dropping the blade is enough to stop sideways motion, though in some circumstances the blade may slide on the hard surface as well. On steep terrain, wherever possible, a bulldozer should face downhill while working to increase the effectiveness of the blade to control a slide.
