# Fatality Investigation Report

OR 2005-08-1

## Mechanic killed while inspecting masonry stacker machine

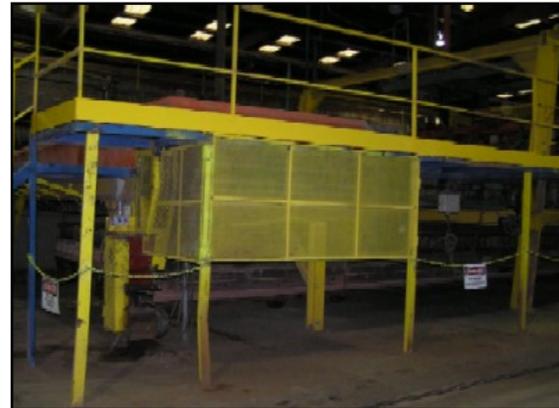
View of stacker shows barricaded undercarriage where incident occurred.

The area where the traveling bar moves under this setting machine was secured only by a chain, and the mesh gate barring access to the alignment area was not secured. A permanently affixed barricade constructed from metal framework and mesh to fully enclose the traveling bar and alignment areas would prevent easy access to this hazardous area. Any access gates for maintenance repairs must be secured when machines are operating.

**Recommendation #1. Employers should ensure that all machine moving parts and pinch point areas are fully enclosed or fully barricaded from access, and that machine guards are properly installed.**

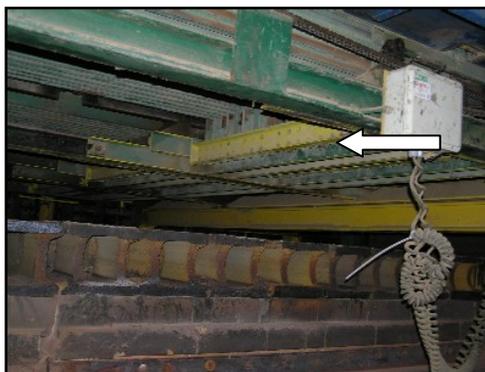
A traveling bar under the stacker moves an alignment chain. Arrow shows bar and direction of travel.

The operator ran the stacker for 1 hour, and then placed it on idle for about 5 minutes while he added more unfired product by hand to the existing stack. The operator returned to the control panel at about 8:05 a.m., took the machine off idle, and started up the process, causing the traveling bar to move toward the crossbeam. The plant manager walked past the machine shortly afterward and found the unresponsive maintenance mechanic lying on his back with his head crushed. The traveling bar evidently crushed his head against the horizontal crossbeam. There were no witnesses to the incident. When local law enforcement and medical crews arrived shortly thereafter, the victim was declared dead at the scene.

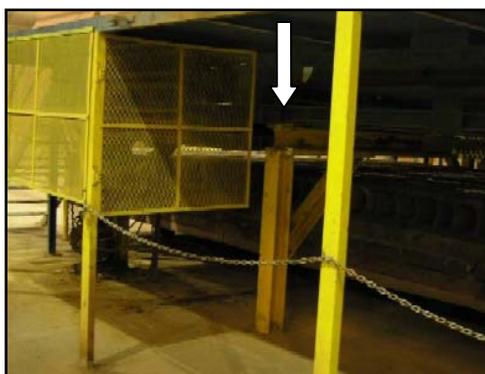
Arrow shows the horizontal crossbeam under the stacker, inside the barricaded area.
