Fatality Investigation Report

OR 2013-08-1

Contract sanitation worker killed cleaning meat blending equipment.

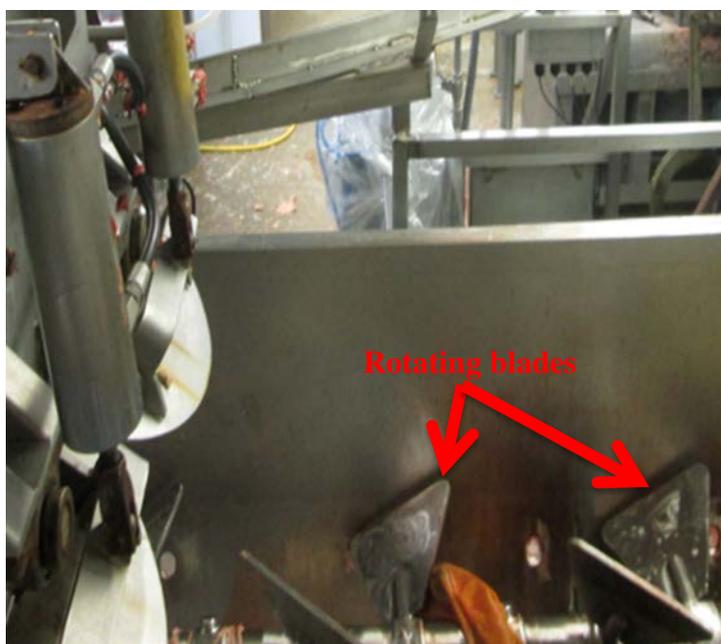
On April 2013, a 41-year old sanitation worker was killed when he fell into an industrial meat blender (see Figure 1). The worker was a member of a contract cleaning crew for a meat processing facility. On the day of the incident he reported to work and began routine cleaning and sanitation. Cleaning procedures began with a hot water wash of the rotating blades and mechanical parts to remove residual meat product. The hoses used in rinsing were long, and it was a common practice for workers to wrap the excess hose around their bodies (torso and/or legs). The

Figure 1. Open top of meat blender where the incident occurred.

clean consisted of two horizontal shafts between 6 and 7 feet long and approximately 24 to 30 inches wide. Each shaft had blades/paddles that rotated in opposite directions (see Figure 1). The blender was used to adjust the fat content by mixing product (~3000 pounds) together until the desired content was achieved. It was the only blender in the room. The room was separated by walls from the rest of the processing area. The worker was working alone cleaning his assigned equipment. Other employees were in the building but none had a direct sight line to the worker.

Recommendation #1: Host employers should remove or reduce worker exposures to moving machine parts by identifying and installing guards or interlock features.

- The top of the blender was open exposing blades/paddles rotating while the worker was on the platform cleaning from above. It is not known whether a guard such as that pictured in figure 5 was onsite and could have been installed. If not available, the equipment manufacturer could have been contacted for a similar retrofit. An online review of meat processing equipment showed advances in interlocked safety guards for grinding/blending equipment. The OR-OSHA report mentioned that moving feed augers and conveyor chain/sprocket were also exposed and running. Similarly, guards/screens could have been installed to prevent contact with these moving parts.

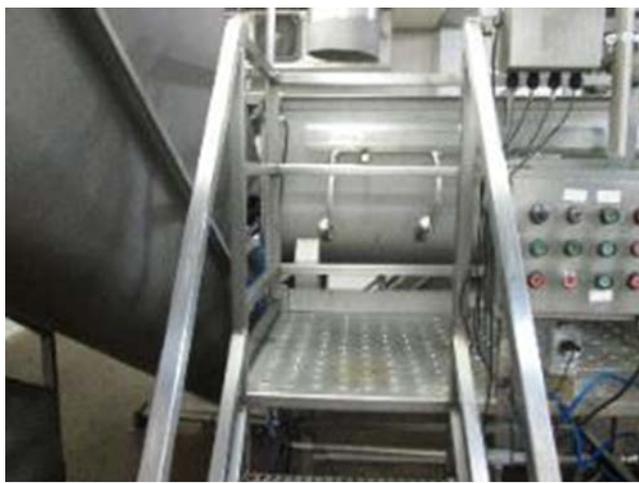
Figure 2. Platform to access the top of the blender vat.

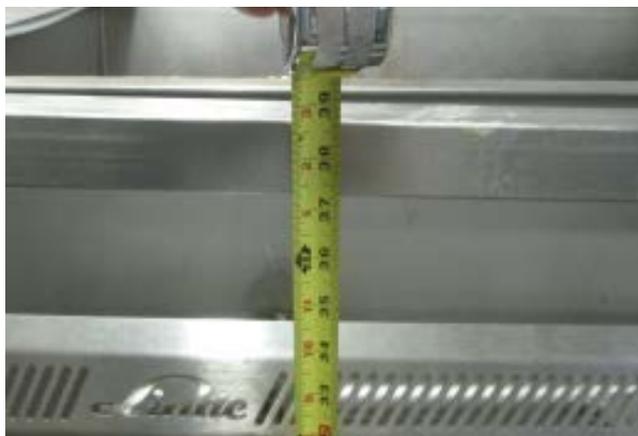
The meat processing company (host employer) workers were responsible for some cleaning-related preparation prior to the arrival of the cleaning crew and had slid the blender top cover to the side to provide access to the interior of the blender vat. While standing on a raised platform, workers would wash the interior of the vat with hot water. The platform (see Figure 2) was approximately 38 inches above the floor. The top guard rail of the platform was measured at 38 11/16th inches above the platform surface, see Figure 3.

Figure 3. Top rail height on platform. It's not known how the victim entered the vat, but evidence suggests that he fell over the railing.

- The use and length of hoses during cleaning exposed contract workers to the risk for entanglement, tripping, or ergonomics.
 - Cleaning the blender may have required the worker to reach over the railing, increasing the risk of falling into the vat. Additional safety precautions could have been identified to prevent falls into the vat, e.g. metal grate (see Figure 5), higher railing, power jet wand (wand would minimize need to reach into vat). The working/walking surfaces were slippery from production residue. The cleaning procedure may have been revised to start with washing the walking surfaces to prevent slips and falls. In addition, requiring slip-resistant footwear/boots for employees should be considered for this work environment.

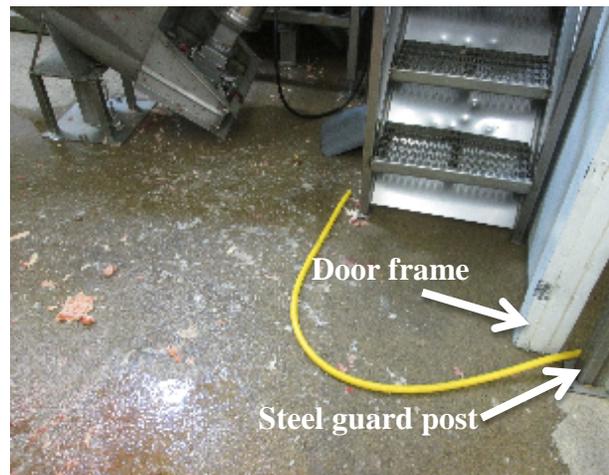
There was a galvanized pipe coupler that connected the hoses found inside the blender vat, which may have caused the unusual sound that brought the incident to the supervisor's attention. It appeared that the hose had been pulled into the room from the location of the spigot between an overhead door frame and a steel guard post, see Figure 4.

Although not known, it is believed that while the worker was on the platform, washing down the blender, the hose splice may have caught on the overhead door frame. When he pulled to free the hose, its sudden release allowed the slack in the hose to fall into the blender. During cleaning, the flowing hot water into cold blender vat would have created steam, preventing the worker from seeing the slack fall into the blender. It is likely that he was pulled into the blender when the hose that appeared to have been wrapped around his leg

Figure 4. Hose looped between door frame and steel guard post.

- In a routine hazard review, the unguarded moving parts and unsafe practice with hoses might have been identified, prompting facility redesign or procedure modification to prevent injuries.
 - Using prevention through design practices (see Renshaw) may have mitigated the risks of hose entanglement and falling into the blender vat. Spigots near equipment where washing was required would have reduced the length of hose and eliminated the need to pull hose through the overhead door frame thus reducing entanglement, tripping, and ergonomic hazards. Another method for mitigating these hazards would

be self-coiling, retracting hoses or overhead connections that would have reduced the slack in the hose.

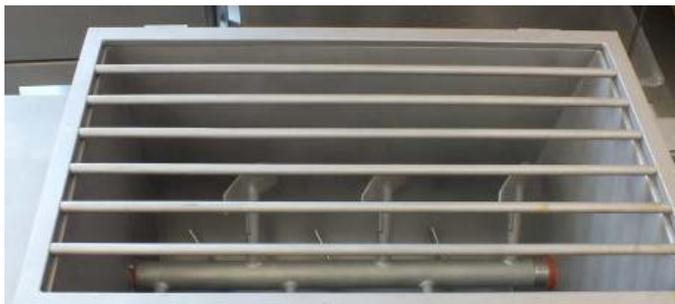
Figure 5. Example of guard for blender/grinder to prevent access to moving parts but allow cleaning.
