# Fatality Investigation Report

OR 2005-28-1

## Bulldozer movement kills operator standing on track

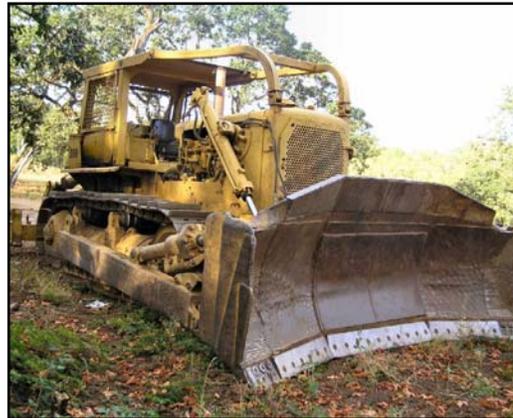
The Caterpillar D8H bulldozer in this incident unexpectedly rolled backward from a parked position.

In the weeks preceding the incident, the operator had been clearing brush off the hillsides and woodlands, and smoothing ground around the vineyard with the bulldozer. The incident occurred on a Saturday morning at about 6:23 a.m. The operator had just begun his early morning shift, and was heading up a wooded hillside with the bulldozer when he encountered a coworker who needed to get to an ATV parked at the top of the hill. The operator gave the coworker a ride up the 10% grade hillside, and stopped in a relatively level area with a 2%-3% grade to let him get off. Noticing the coworker left a jacket in the cab, the operator lowered the bulldozer's blade to the ground, put the engine into idle, and climbed out to stand on the track to hand the jacket to the coworker. He did not set the parking brake. The tractor suddenly moved backward, and the operator lost his balance and fell feet first between the track and deck. The bulldozer continued to roll 8-10 ft backward, and the operator was pulled beneath the tractor and crushed.

**Recommendation #1. Before exiting a bulldozer, the operator must secure hazardous energy by following all manufacturer recommended steps in parking, including setting the parking brake.**

The operator's manual for Caterpillar D8 Tractors advises the following steps to park.

1. Stop on level ground.
2. Reduce engine speed.
3. Move transmission control lever to neutral and engage safety lock.
4. Apply brake pedals and engage brake lock.
5. Lower all raised equipment to the ground. Apply a slight downward pressure.

The final advice to “apply a slight downward pressure” to the dropped blade or other raised equipment is a step added in the operator's manual for the newest model of the Caterpillar D8 Tractor. Lowering the blade to the ground effectively stabilizes the machine from movement, more so by pushing the blade down into a penetrable surface rather than simply floating to a resting point.

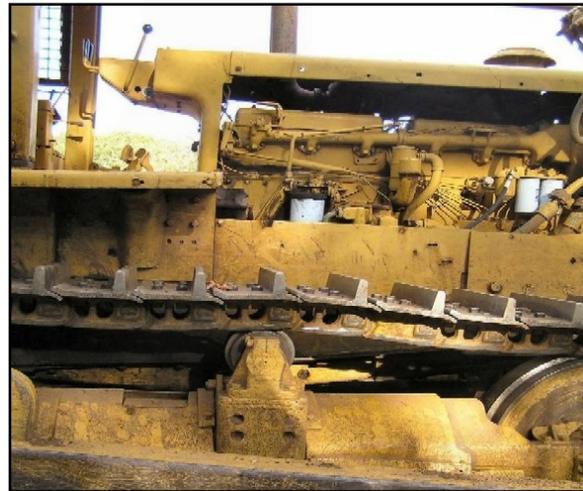
On many bulldozer models, the operator must stand on the track to access the cab.

**Recommendation #3. No passengers should be permitted to ride on mobile machinery, unless a properly equipped seat is provided.**

OSHA regulations prohibit riders on mobile machinery, unless a safe place to ride is provided (29 CFR 1926.602(c)(1)(vii)). Extra riders without a seat and seatbelt are especially vulnerable to being thrown off and crushed. The bulldozer in this case was not properly equipped for a passenger, and the employer prohibited operators from giving rides to coworkers. Refresher training on mobile machinery should include information on hazards to extra riders.
