Fatality Investigation Report

OR 2013-27-1

Collapsed roof trusses kill carpenter foreman

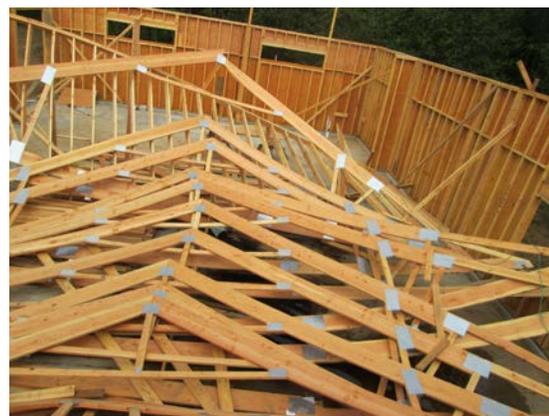
Figure 1. Collapsed trusses where the incident occurred.

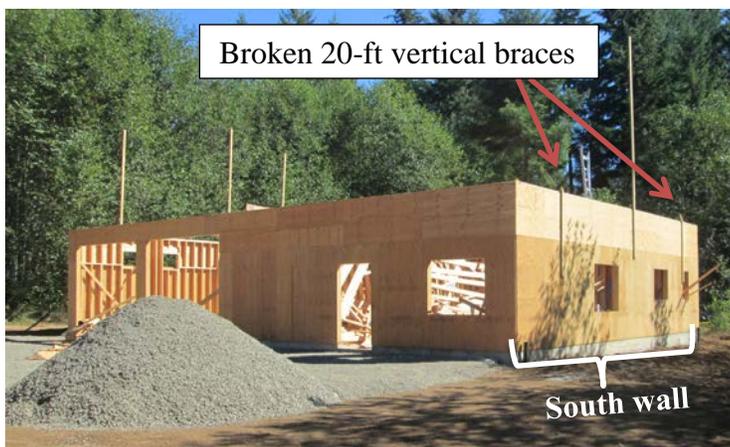
Figure 2. The shop/garage building with collapsed trusses within the structure. Note the 2X4's nailed to the outside of the south wall and that ground bracing was not erected. Middle vertical brace remained unbroken.

On the morning of the incident, two workers arrived at the job site for the first time. The crew completed the framing of the interior wall that would separate the garage from the shop. At the south end of the structure the crew nailed three 20-foot long 2X4's to the outside of the south wall (see Figure 2). Contrary to the Structural Building Components Association, BCSI-B1

Summary Sheet (see Figure 4 and Reference #7) additional diagonal external or internal ground bracing was not installed along the south wall, the gable end. One worker explained in his recorded interview that the practice he observed on the job was consistent with his experience on similar jobs.

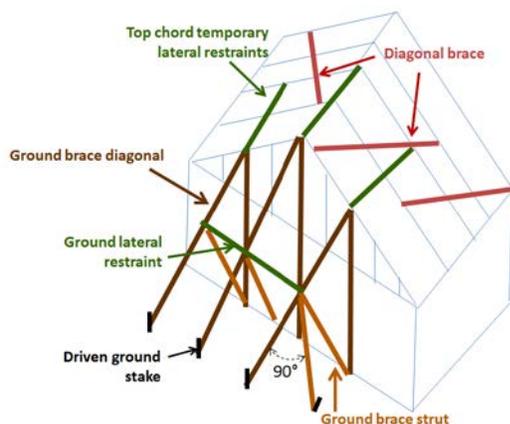
Figure 4. Recommended bracing schematic 1. Adapted from diagrams in BCSI-B1 Summary Sheet-Guide to Handling, installing, Restraining and Bracing of Trusses (see Reference #7 for complete information).

was, “brief all members of the erection/installation crew as to the installation plan and the intended lateral restraint and diagonal bracing requirements.” A specific notice (see page 19) warns that, “the use of ground brace verticals alone, attached to the end wall, is not considered good construction practice and is not permitted.”

Recommendation # 1: Employers and supervisors should assess the workplace hazards and plan each stage of construction to comply with manufacturer’s recommendations or standard best practice. In this case, the critical elements of standard practice provided in the BCSI-B1 Summary Sheet for adequate bracing prior to and during truss installation were not followed.

- The truss manufacturer document, Structural Building BCSI-B1 Summary Sheet (see Reference #7 and Figure 4 below for recommended bracing) provided upon delivery, warned of potential collapse if improperly handled, erected, installed, restrained or braced. Evidence from pictures taken immediately after the incident and from recorded interviews and discussion with the OSHA inspector confirmed that adequate bracing was not installed and a bracing plan was not discussed with the crew. Three vertical 2X4’s nailed to the outside of the south wall were used to brace the first gable truss but without ground bracing, struts or restraint (see Figure 5 to view bracing installed on day of incident). The guide specifically states that step 1 for setting trusses is to, “install ground bracing.” Additionally, it recommended diagonal bracing at each end and for each set of four trusses. The BCSI booklet 2013 edition (see Reference #6) provides best practices and includes a checklist for the erection/installation process and safety reminders. Among the BCSI recommendations

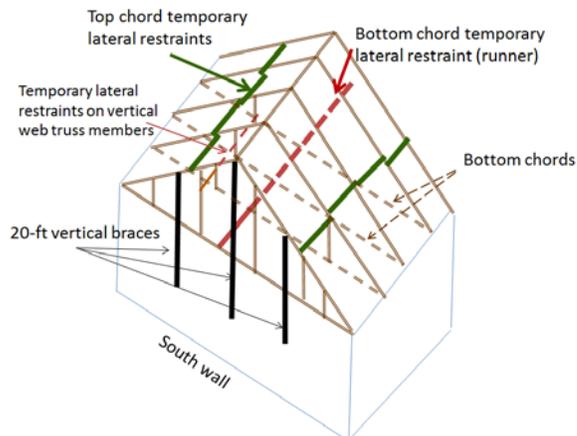
According to the OSHA report and recorded interviews, the crane operator and the worker assisting him, called out to the foreman several times that bracing was inadequate. In response, additional temporary lateral restraint boards were added between the first six east side vertical truss web members and across the first nine west side vertical web truss members but not ground braces or diagonal braces. The process continued until after the 13th truss was set in place. The foreman disconnected the truss from the rigging. As the rigging cleared the truss by approximately one foot, the crane operator and the worker on the trailer saw the trusses falling and tried to warn the crew.

Figure 5. Implemented bracing schematic 2. This schematic represents the braces and restraints believed to have been installed by the crew on the day of the incident.

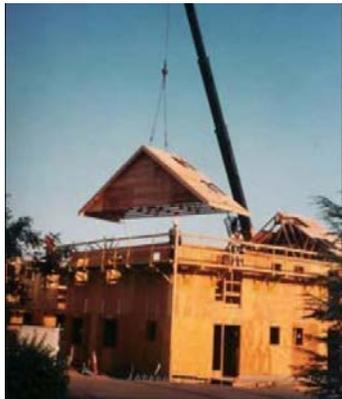
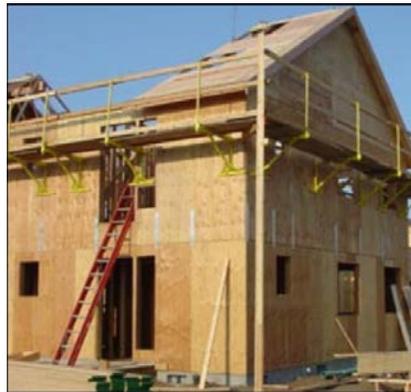
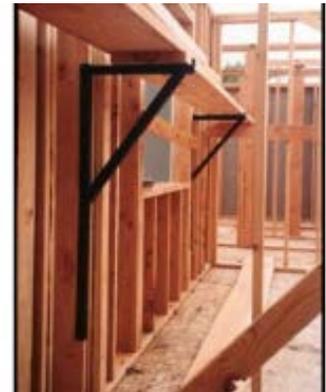
Figure 6. Three construction methods to minimize fall hazards when erecting trusses.

Example 1. Erecting and sheeting a series of trusses on the ground and then lifting the unit into place with a crane.

Example 2. Exterior scaffolding on structure.

Example 3. Interior scaffolding.

- Wood trusses are not designed to support a fall-arrest system and should not be used to tie-off personal fall protection devices. The height of the walls was 12 feet, thus workers were above the height required by OR-OSHA for fall protection (see Reference #5). To minimize fall hazards, installing internal and/or external scaffolds are options that could have been considered. Figure 2, a photograph of the structure, does not show evidence of scaffolding or other fall protection methods. In recorded interviews employees expressed that they were not trained on fall hazards.
