Fatality Investigation Report

OR 2003-10-01

Home construction worker falls down elevator shaft

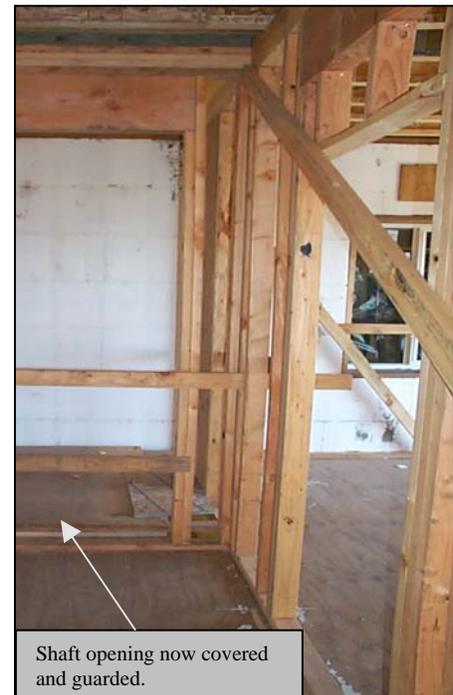
On May 16, 2003, a 41-year-old worker fell 23 feet down an elevator shaft during the construction of a new residence. The worker was part of a three person framing crew raising a third story in the home. The two co-workers were installing ceiling joists while the victim handed up needed materials. The framing crew was busy setting and nailing joists into place when they heard a sound like that of a “nail gun falling and hitting something”. They went to investigate and discovered the victim, at the bottom of the shaft, seriously injured. At the time of the incident, the shaft opening was not covered according to witnesses.

The open elevator shaft in this incident was a serious fall hazard requiring preventive measures. The opening of the shaft needed a weight-supporting deck as a temporary cover to protect workers as well as incidental visitors or unauthorized persons who gained access to the site.

The shaft may provide a convenient passageway that necessitates removing the cover during work, and this likelihood raises the importance of guardrails as an additional safety measure. A top rail should be placed about 42 inches above the floor, with an additional mid-rail, and a toe board to prevent items from being kicked into the hole. The top of the rail should be capable of withstanding 200 pounds of force.
