## Fatality Investigation Report

OR 2015-12-1

### Construction worker died after falling 20-25 feet from a pump-jack scaffold

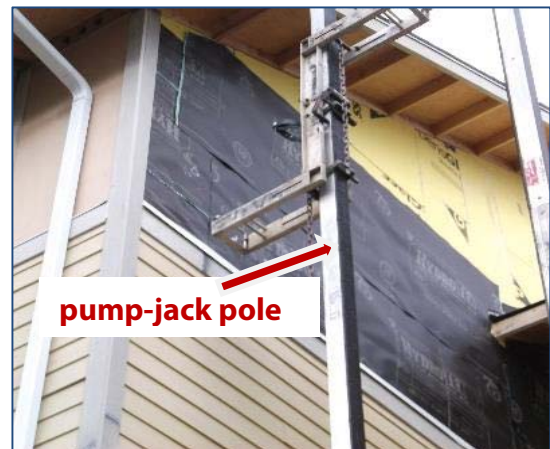
Figure 1 (above). Breezeway, pump jack pole.  
Figure 2 (below). Breezeway, 3<sup>rd</sup> floor stair landing with temporary railing.

stair landings, and related structures in the breezeway had hindered the ability to set up a standard scaffold system. This resulted in an incomplete scaffold system set-up around the stairs, with not all of the standard scaffold system components used. Instead they used only one pump-jack pole, supporting one end of the scaffold platform, and used the stair landing to support the other end of the platform. To raise the platform above stair landing height, an 8-foot step ladder was placed on the landing to support that end of the platform and the pump-jack pole was raised on the other side. No fall protection was used during siding work in this breezeway.

- Securing poles to the structure with rigid triangular bracing (see example in Figure 5);
    - Safe access to scaffolds and scaffold platforms; and

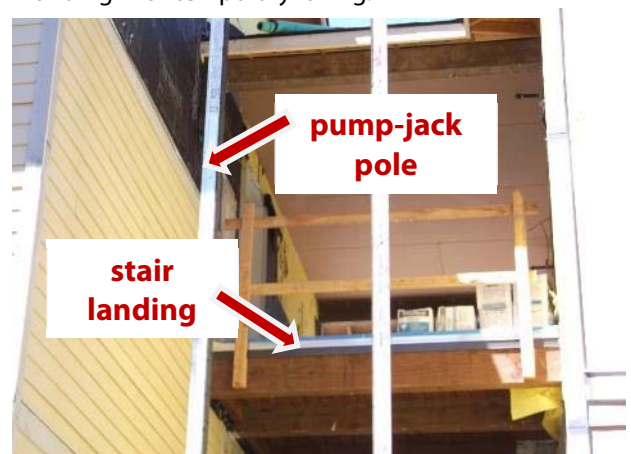
Scaffolds and ladders that are not properly installed or secured can tilt or sway and become unstable. In this case, two contributing factors may have affected the stability of the work platform and its ability to withstand side forces. The scaffold platform was not secured on the stair landing and was supported by a step ladder. It is possible that as a result the platform tilted or swayed, causing the victim to lose his balance, or he may have fallen because he lost his footing using the second step ladder while attempting to reach the peak section.

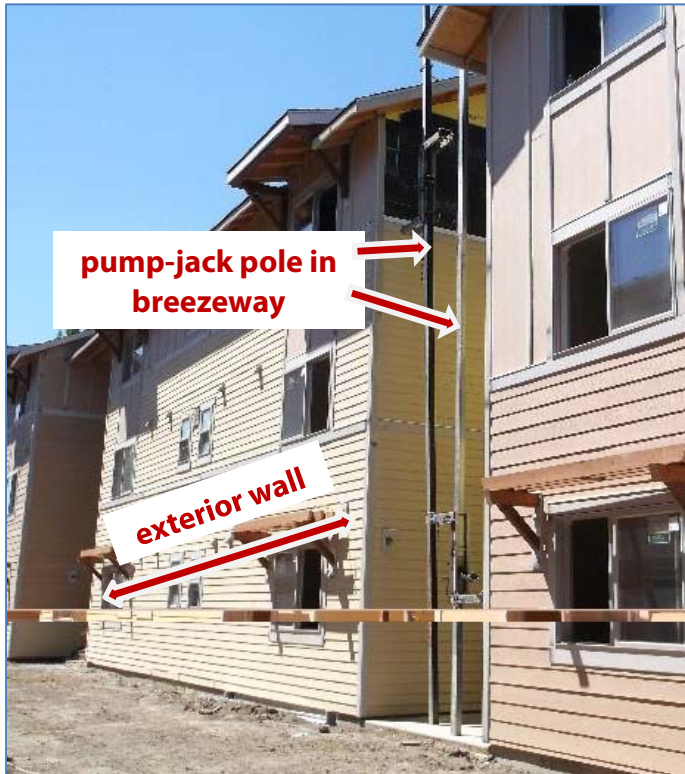
Figure 3. Exterior wall and breezeway.

The incident occurred at the last of the four buildings to be sided and painted. The siding work included applying and attaching building wrap and then installing siding boards. The victim and his crew of three workers had completed siding work on the exterior walls, then began work in the breezeway. Information obtained during interviews indicated that for work on the exterior walls the crew had set up a standard pump-jack scaffolding system. This included a minimum of three pump-jack poles to support scaffold platforms, and personal fall arrest. Specifically, the workers reported tying off to manufactured anchors that they installed on the roof. Given that fall protection equipment was available on site, it is not known why they were not used for the work in the breezeway where the incident occurred. The siding crew indicated there had been some discussion of using a beam under a sub-roof for a tie-off point in a previous breezeway. However, it is not known whether any fall protection system had been used in the previously sided breezeways.

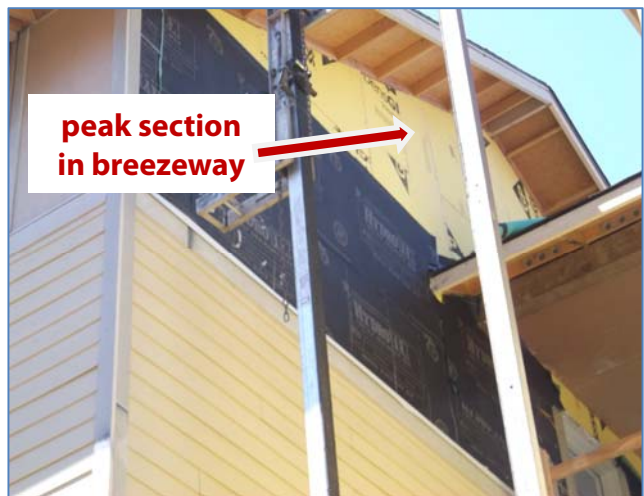
According to OR-OSHA observations and information obtained through interviews, building wrap and siding had been installed on two lower levels. The crew recalled seeing that the platform was level as the work progressed to the third level. To complete the top section siding required gaining additional height to reach the triangle shaped roof peak area above the third level landing (see Figure 4). It was assumed that to do this, the victim had placed a 6-foot step ladder on top of the scaffold platform. The victim was working alone at the time of the incident, and was not using fall protection. The three siding crew members who been assisting earlier in the day had been asked by a jobsite superintendent to perform a task on another building. Thus, they were not in the immediate vicinity at the time of the incident, nor were any other workers in the immediate vicinity. Therefore, no witnesses directly observed the specific configuration of the scaffold platform or the inferred use of the second step ladder on the platform, nor did anyone see what the victim was doing just prior to falling, or what may have triggered the fall.

Figure 4. Peak section of breezeway wall.

- In this case, given that the stairs impeded the ability to install a complete pump-jack scaffold system, an alternative method for more safely accessing the height should have been determined. For example, an aerial lift could have been used to access heights in the breezeway that could not be reached using standard pump-jack scaffolding.
