## OREGON FATALITY ASSESSMENT AND CONTROL EVALUATION

# Fatality Investigation Report

OR 2014-1-1

## Driver killed when ejected from logging truck

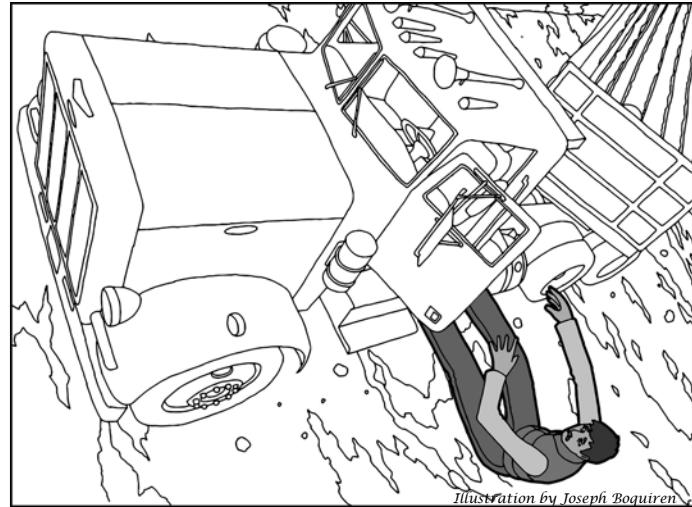
Figure 1. An illustration of the incident.

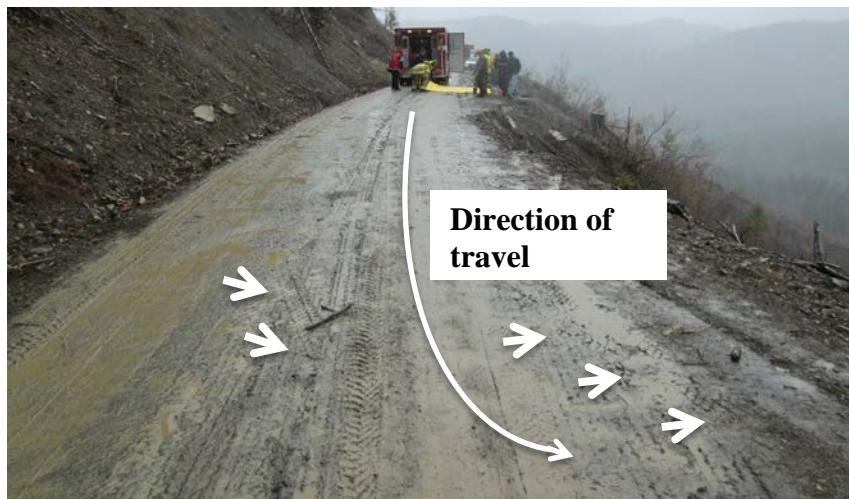
sharp drop off on the left side of the road, heading away from the landing. The right side was a steep embankment with a minor ditch between it and the road surface (see Figure 2).

Figure 2. White bold arrows point to the tire tracks on the road leading off the edge. White line shows the trucks direction of travel.

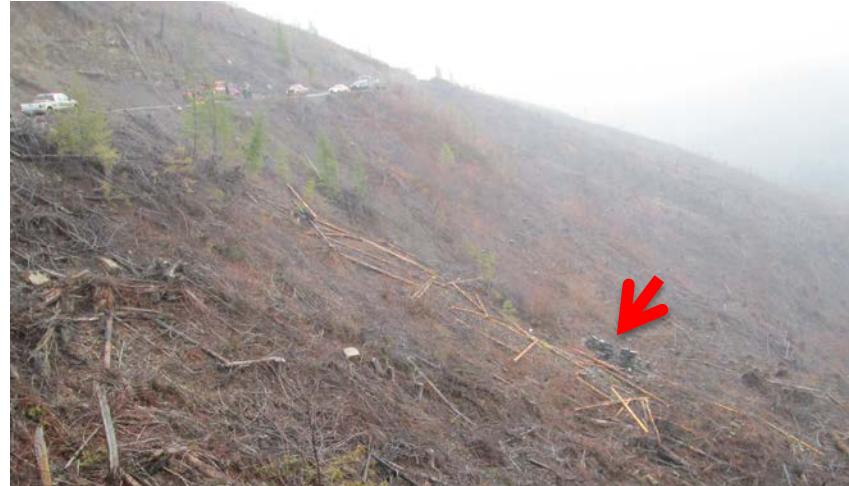
The driver and his truck were discovered below the log strewn slope. The truck was resting on a flat spot on the steep embankment, with the driver lying next to the drive wheels. It is speculated that the truck had rolled up to five times down the canyon wall. At some point during the tumble the driver was ejected from the cab and caught up in the debris rolling down the hill. It is unknown if the driver had attempted to jump from the truck or if he was ejected while not using his seat belt. The seat belt remained attached to the cab mounts but was not buckled. There was no damage to the belt or buckle. The seat belt was inspected later and shown to be fully functional. Additionally,

Figure 3. Photograph with red arrow showing where logging truck came to rest on the hillside.
