## OREGON FATALITY ASSESSMENT AND CONTROL EVALUATION

# Fatality Investigation Report

OR 2014-42-1

## Forestry worker in vehicle killed from timber falling activity

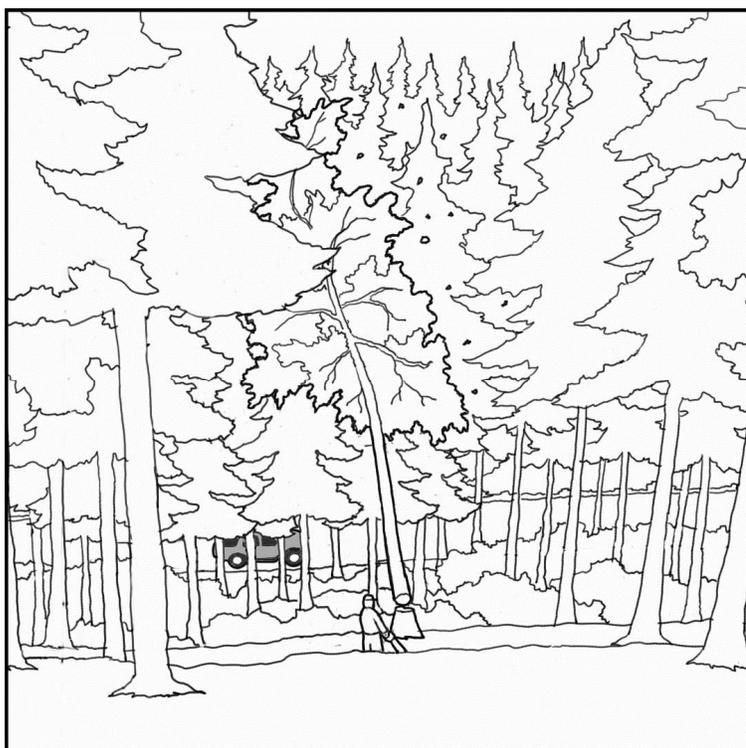
**A schematic of the incident.** The tree/limb density is reduced in the illustration to reveal the vehicle. At the actual site, tree/limb density was greater and the view of the road more obscured.

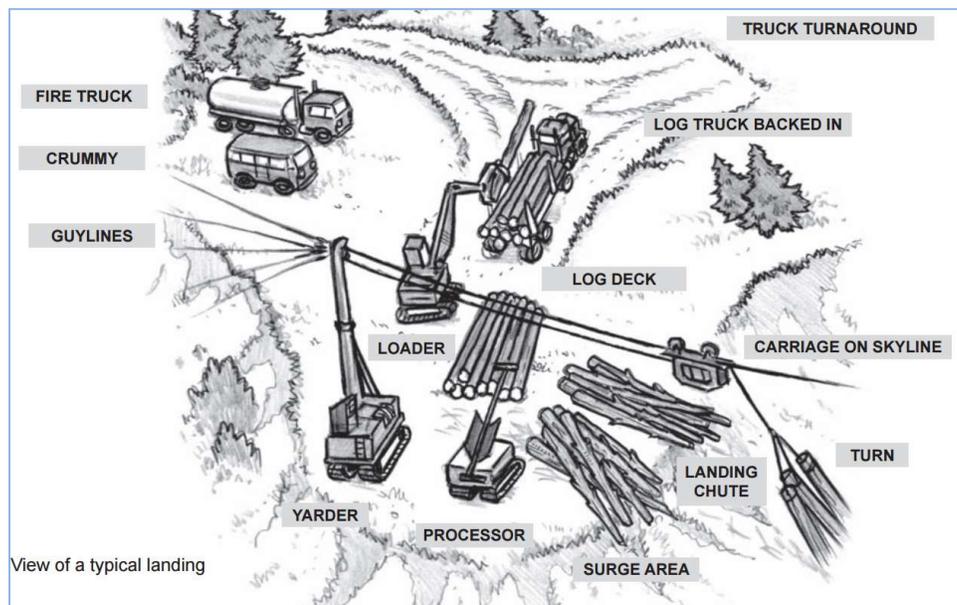
A schematic of a typical cable logging landing area  
(from "Yarding and Logging Handbook" published by OR-OSHA , 2010).

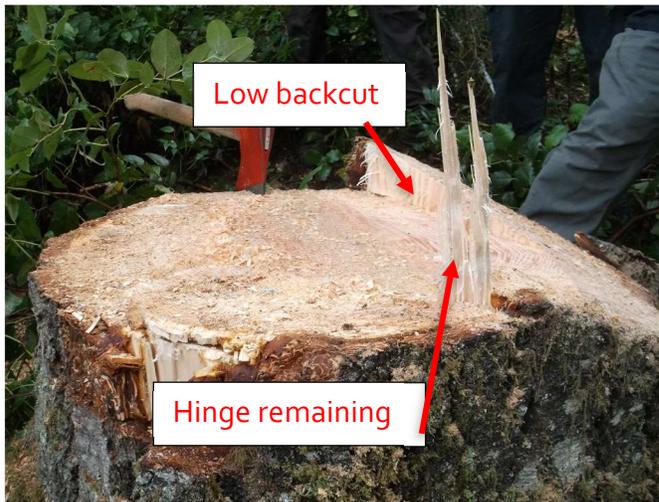
According to the employer's investigation report the tree that struck the log quality specialist's vehicle measured 160 feet tall (the OR-OSHA report stated more generally the tree was over 140 feet tall), with a diameter of 36

inches. The OR-OSHA report indicated the distance from the tree stump to the center of the road was approximately 145 feet. The ground below the stump sloped downward toward the road at an approximate 30% grade. The intended lay of the tree was parallel to the road. However, the tree fell 135 degrees away from the intended lay of the tree into the road. The OR-OSHA report noted that in their examination of the tree stump, several unsafe cutting practices were apparent (shown in adjacent photo): sufficient holding wood was not

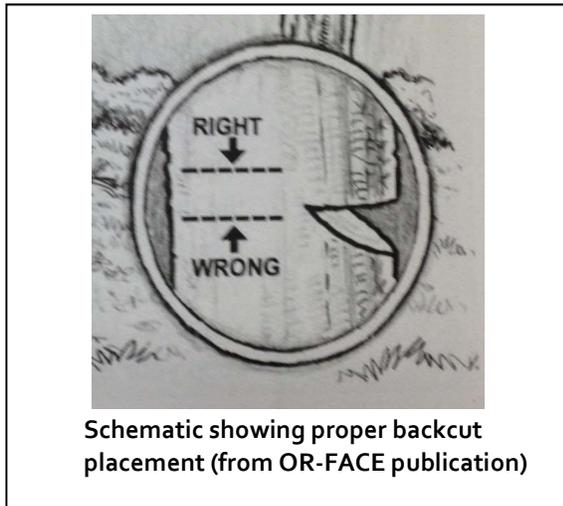
maintained<sup>2</sup>; low backcuts<sup>3</sup>; and improper cleaning of the face cut. The holding wood on the uphill side of the tree was nearly completely sawn off and only a small 2-inch x 2-1/2-inch hinge remained on the downhill side of the stump. These conditions would make it more difficult to

fall the tree in the intended direction, as its natural lean was toward the road. As the work was being performed the faller used three wedges in an attempt to fall the tree in its intended direction.

**Recommendation #2: Employers should assess tree fallers' skills for felling and bucking logs, and require that novice or inadequately performing workers are directly supervised by a qualified person until the faller demonstrates the ability to safely perform these tasks independently.**

- The faller's employer stated that he had confidence in the faller's abilities and that if he had identified unsafe cutting practices he would have corrected them. However, during OR-OSHA's investigation deficiencies in safe cutting practices by this faller were observed, with improper cuts found in several trees that were surveyed at this site in addition to the tree that struck the log quality specialist's vehicle. It is important, therefore, for logging employers to regularly evaluate their fallers' work practices, correct any unsafe cutting practices observed, and ensure that all fallers have the necessary skills to perform the task at hand before they are allowed to work independently (OAR 437-007-0800(10)).
