# Fatality Investigation Report

OR 2005-07-1

## Technician crushed when aerial platform lift engaged

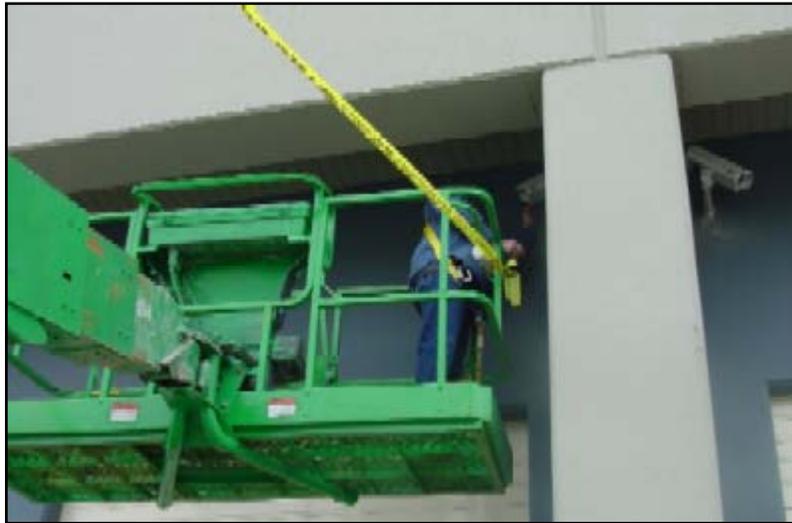
View of aerial platform during OR-OSHA investigation.

The technician may have had difficulty with the operation of the lift's foot pedal and control lever. He apparently depressed the foot pedal and the control lever, and was leaning over the platform railing when the mechanism engaged. When the lift rose, the technician's head hit the roof overhang. The lift continued to rise, pinning the bent-over technician between the base of the roof overhang and the lift railing.

### **Recommendation #1. All workers using mobile machinery should have adequate training on the proper use and safe operation of the equipment.**

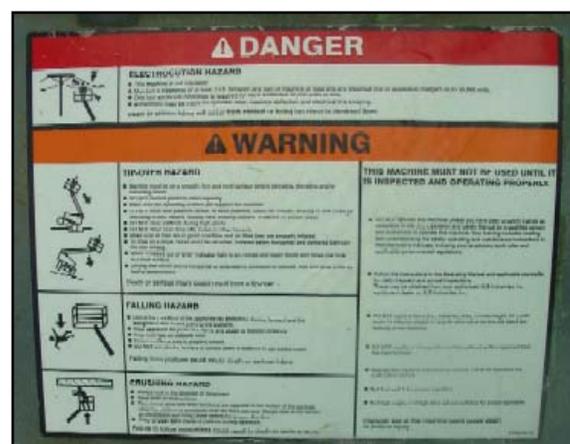
The warning label on the aerial platform illustrates the hazards of electrocution, falling, or striking an overhead obstacle.

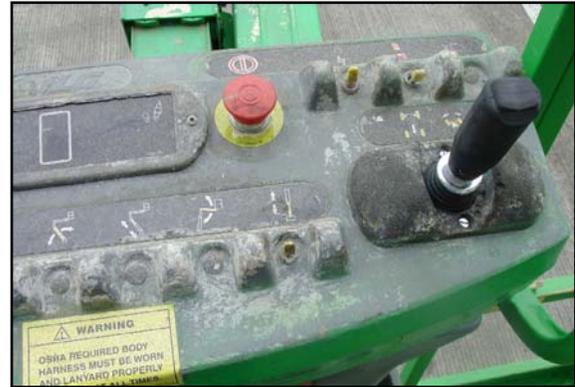
not depressed for a period of 7 seconds, and will not respond for 2 seconds after being reengaged. There is also a 2-second delay from leaving the control to stop, which equals about 9 in. of travel. Inspection of the machine by the rental company following the incident found no mechanical malfunction, but a separate inspection found the lift mechanism hesitated slightly longer than expected.

The lift mechanism involves both hand and foot controls.

## **Recommendation #2. Read and follow the manufacturer’s operating manual before using machinery.**
