Fatality Investigation Report

OR 2006-05-1

Mechanic killed when collar caught on PTO driveline

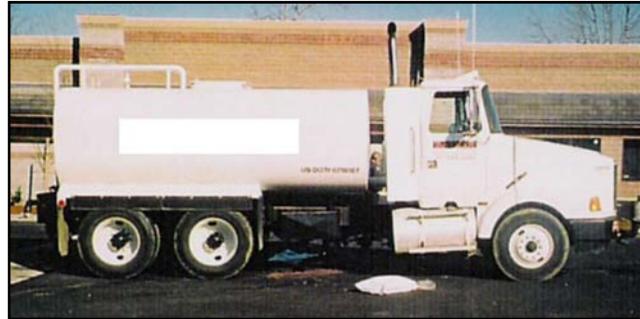
A field mechanic was apparently checking his repair work underneath this water truck when his collar caught and tangled in the rotating power take-off drive shaft.

While he was underneath the rear undercarriage of the water truck, the collar of the field mechanic's coveralls caught on the protruding set screw on the PTO driveline, which entangled his coveralls and shirt. His head was pulled against the rapidly rotating shaft, causing massive trauma as the set screw repeatedly struck him on the back of his head and neck.

- **Prior to performing maintenance operations on any machine, make sure to de-energize, isolate, and block all forms of hazardous energy.**
- **Do not crawl under, on, or over unguarded power take-off (PTO) drivelines while the PTO is operating.**
- **Equipment should be designed or retrofitted to shield any open, unguarded power take-off drivelines.**
- **Employers should develop and implement a comprehensive safety program that includes training in hazard recognition and avoidance for all tasks that may expose workers to the release of hazardous energy.**

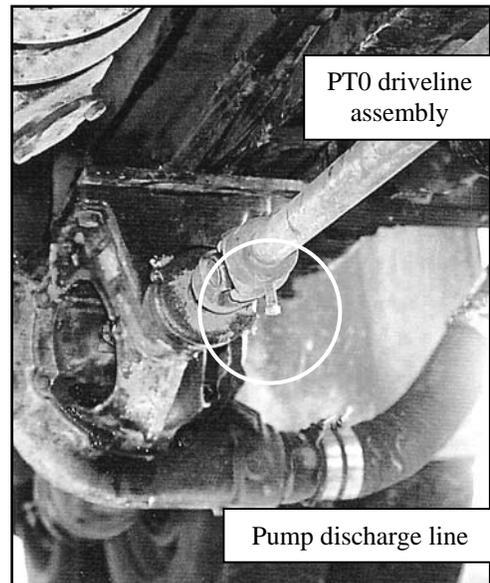
The 1989 Volvo truck was equipped with an unguarded 32½ in. power take off (PTO) driveline on the rear undercarriage of the vehicle, transferring power from the truck's engine to the water pump. The driveline is fitted with a smooth metal collar held in position by a 3/8 in. diameter set screw that projects from the collar by 1 in. The driveline rotates at about 1600 rpm, with a 21 in. clearance between the turning shaft and the roadbed.

On the rear undercarriage of the water truck, the protruding set screw can be seen on the PTO driveline, near the U-joint connection, which caught the collar of the victim's coveralls and entangled him.

Recommendation #3. Equipment should be designed or retrofitted to shield any open, unguarded power take-off drivelines.

Power take-off equipment should be properly fitted with guards that fully enclose the entire exposed driveline. The guard should enclose all power take-off stubs, driveline collars, and any protruding bolts, pins, or set screws. Kits are available to retrofit shields on older equipment.
