Fatality Investigation Report

OR 2005-05-1

Operator crushed while repairing running machine

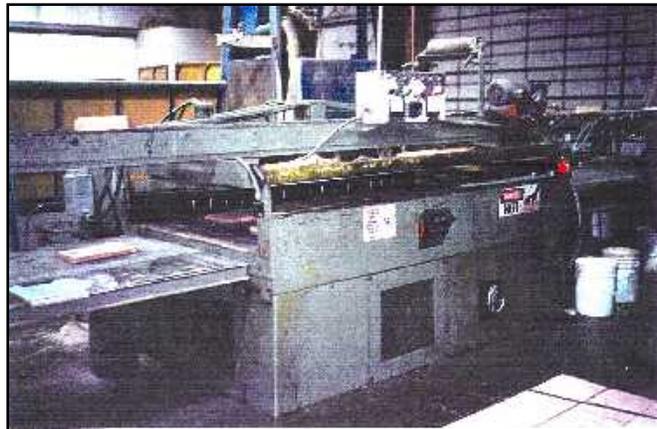
The glue press operates on an automatic cycle, with a conveyor running beneath a glue roller and into the press.

At the time of the incident, the glue-press conveyor chain and sprocket system, press opening, glue feed rolls, and loading-table mechanisms were unguarded. A makeshift repair to correct a

Employers need to assess all machinery, especially older machinery, and install guards to prevent access to all moving, shear, and pinch points. In this incident, the glue press was an older machine, manufactured without guards, but a retrofit guard is available through the press manufacturer. In cases where specific retrofit guards are not available, private suppliers can provide a wide variety of guards to bring older machinery into compliance with safety standards.

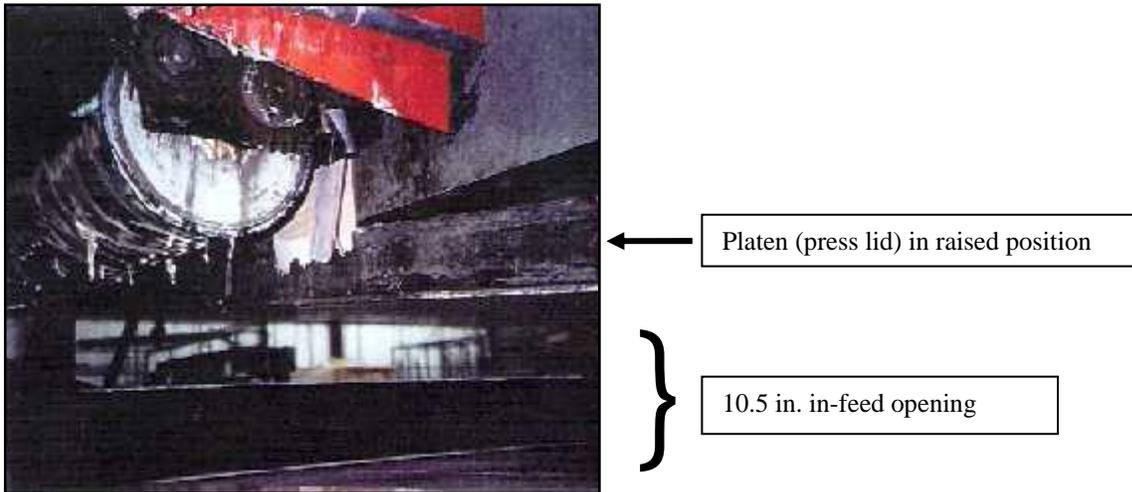
glue-dripping problem had been made by the operator 2 weeks earlier, using a piece of duct tape to hold a piece of wood veneer to direct dripping glue from the roller into the glue tray. The glue tray in front of the press in-feed had been removed to correct the glue-dripping problem.

A close-up view of the glue press in-feed opening shows the platen above, and the glue roller in front with a piece of duct tape attached.

Recommendation #1. Completely shut down and lockout machinery before conducting maintenance.

Machine maintenance should never be conducted while a machine is running, except in limited cases where operation is a necessary part of a routine maintenance procedure and the worker is not exposed to hazardous energy.
