Fatality Investigation Report

OR 2011-16-1

Millwright fatality involving a hydraulic accumulator

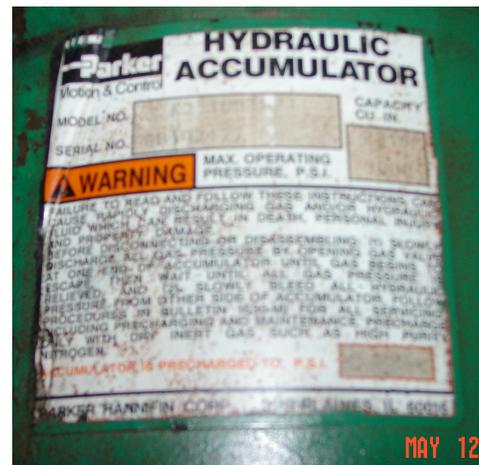
Warning label on the side of the hydraulic accumulator warns that contents are under pressure and should be released by opening and removing the gas valve prior to disassembly.

release gas pressure was stated in warning labels on the side of the accumulator, and in the maintenance and repair kit bulletin.

- There were two warning labels on the accumulator stating the nitrogen gas had to be released prior to performing repairs. This is also mentioned in the service bulletin that was in the shop. A pressure gauge was available in the shop that if used, would have

- Changing the warning label location so it is readily visible when attempting to remove the cap may prevent fatalities of this type. The label explicitly stated the potentially fatal nature of the hazard “Failure to read and follow these instructions can cause rapidly discharging gas and/or hydraulic fluid which can result in death, property damage or injury.” However, it’s unknown if the label located on the side of the accumulator was visible to the victim once the accumulator had been laid on the work bench. Relocating the label to the ends, or requiring the worker to break a seal that included this warning, might increase the chance that the warning would be viewed and followed.

Recommendation #5: Manufacturers or employers should consider altering the placement of warning labels, or applying additional labels or seals, on the cap area of accumulators to ensure they remain visible while removing the caps.

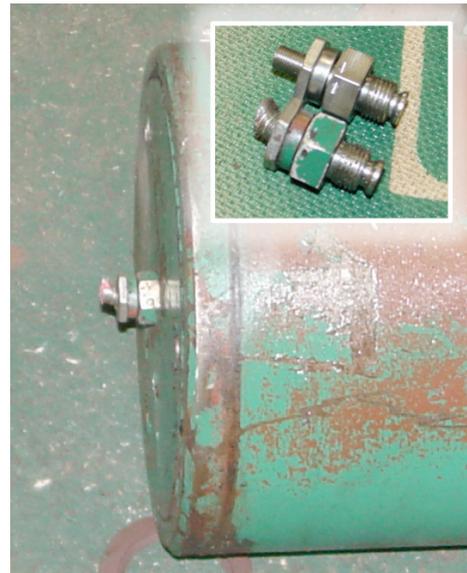
As per the rebuilding kit instruction manual, once the gas has been released using the manufacturer recommended charging and gauging assembly, the gas valve must be removed. After removal of the gas valve, the accumulator can then be strapped down in order to release hydraulic pressure and remove the hydraulic end cap on the opposite end. The gas pressure release valve (shown at upper right) is the only externally visible part of the accumulator in addition to the hydraulic valve end cap (lower photo in red circle), and it functions similarly to a bike tire or "schrader" valve. It is used to add nitrogen and to bleed off gas pressure. Evidence suggested that the damage to the valve as shown in the photo at right occurred when the accumulator flew off the table during the incident.

However, Oregon OSHA investigated the functionality of the damaged gas pressure release valve. Some orange/red material was wedged in the valve, so it was investigated whether the valve port was plugged with debris. No evidence was found to show a plugged valve port. The valve also includes an engineering control feature, which

ABOVE: Gas pressure release valve in incident, believed to be damaged when accumulator flew off the table. Shown removed next to a new valve.

is a small hole bored through the side of the valve body that will relieve accumulator pressure as the valve is removed, should pressure still exist from port blockage or failure to release. However, evidence was clear that the valve had not been removed before the fatal attempt was made to disassemble the accumulator.

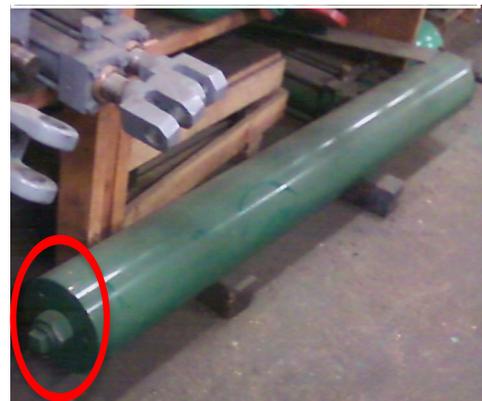
BELOW: Hydraulic accumulator (same model as in incident) with hydraulic pressure end cap shown in the red oval.

Based on the witness interviews, the accumulator had been strapped to a metal workbench. It is unknown if the side-located warning label was visible to the victim after the accumulator had been strapped to the bench. A steel plate adapter with a large nut welded to the center had been bolted onto the end cap (in red circle in

photo on prior page) so a socket “breaker bar” wrench could be attached to help turn the cap. A “cheater bar” had been attached to the breaker bar for even more leverage and one millwright was assigned to apply pressure to the cheater bar. A pipe wrench had also been placed over the socket. The deceased hooked the pipe wrench to a small electric hoist that was also applying pressure to the cap and a second assistant millwright was helping to hold the pipe wrench. With time and considerable effort the cap was slowly unscrewed and was almost completely off when the pressurized nitrogen gas caused the cap to “explode” off the end of the accumulator. Actual gas pressure was unknown, but presumed to be up to 750 psi, which is the normal operating pressure specified by the manufacturer. The deceased was standing directly in front of the cap when it released and was struck in the pelvic area by the cap and other tools, and his right femoral artery was lacerated. The other two millwrights sustained non-life threatening injuries from being struck by other flying tools.

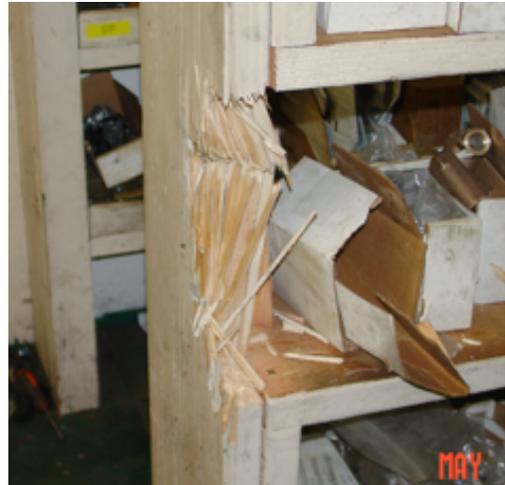
Shelf damaged by flying tools demonstrates violent nature of the event.
