Fatality Investigation Report

OR 2004-04-01

Parked forklift crushes operator against semi-trailer

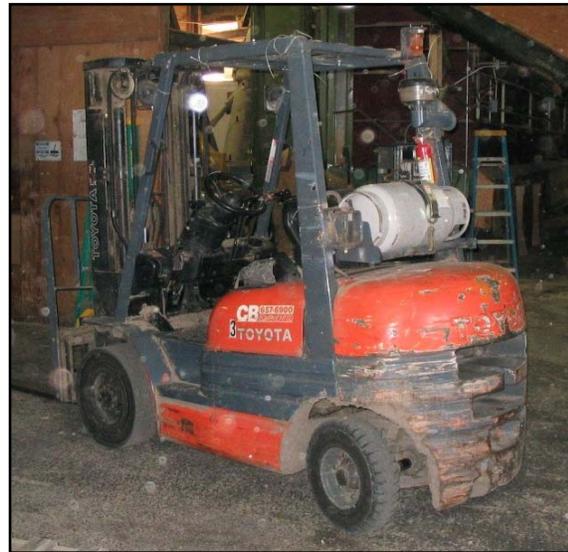
Twin of forklift that backed into and crushed the operator after he jumped out to help load a truck.

The forklift was parked approximately parallel with the trailer, an estimated 4-6 feet away. The forks were on the ground, in accordance with safe practice, but the engine was left running, and the wheels were turned in the direction where the worker was standing. The mechanism by which the forklift drive engaged and moved from its parked position remains uncertain. The following points bear on the issue.

- The surface of the yard where the forklift was parked next to the semi-truck is hard-packed gravel with a 2.5% slope. Testing determined the slope was not sufficient to cause the forklift to roll without power.

- The forklift was equipped with an operational backup alarm system, but the backup alarm did not sound before the forklift struck the victim. After repeated testing and some difficulty, it was found the gearshift could be adjusted to move the machine in reverse without the alarm sounding.

- The second forklift at the company was under repair on the day of the incident, so the single forklift performed all activity, and the brakes may have overheated and failed. The truck driver was apparently able to put the machine in gear and move it forward without releasing the brake. Later inspection showed the brake system on the forklift, though poorly maintained, met safety specifications.

Recommendation #1. Before exiting any powered industrial truck, even briefly, completely shut down power, place controls in neutral and apply parking brake.

The forklift should be secured so that it will not move when the operator is not in the driver's seat. Operators should always: (a) place the front forks in firm contact with the ground, (b) turn the steering wheels away from the direction where work will be performed, (c) put the shift in neutral and set the parking brake, (d) shut off the engine, and (e) block wheels if parked on an incline.

Recommendation #3. Maintain the machine in safe operating condition.

Although the mechanical basis of this incident is difficult to reproduce, there is some indication that the forklifts at the worksite were heavily used and may have been in need of preventive maintenance or repairs. Equipment should not be used unless needed repairs are completed and the machine is in safe operating condition. Written documentation is an important component of a safety program. A standard checklist helps to identify hazards, and encourages accountability for regular inspections and a timely response to safety concerns.

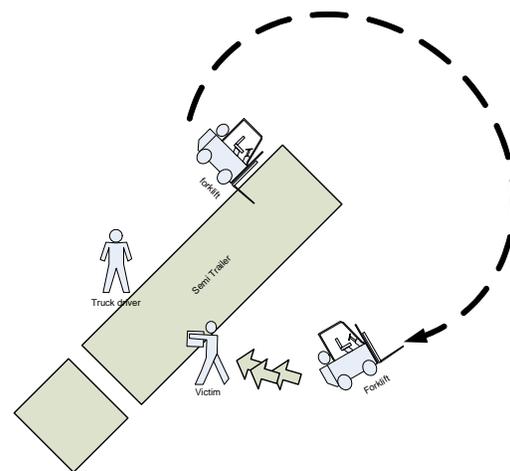
While the operator was facing the trailer, the forklift unexpectedly engaged in reverse and backed into him, crushing him against the trailer with enough force to make the trailer shudder. The truck driver looked under the trailer and saw the operator's legs dangling in the air. He ran to the other side, heard the operator having difficulty breathing, and hurriedly engaged the gearshift on the forklift into forward to release him. The victim fell to the ground, with extensive chest and airway injuries. Efforts to revive him

Victim's position when the forklift struck him.
