Fatality Investigation Report

OR 2013-05-1

Vineyard worker killed in fall from trailer

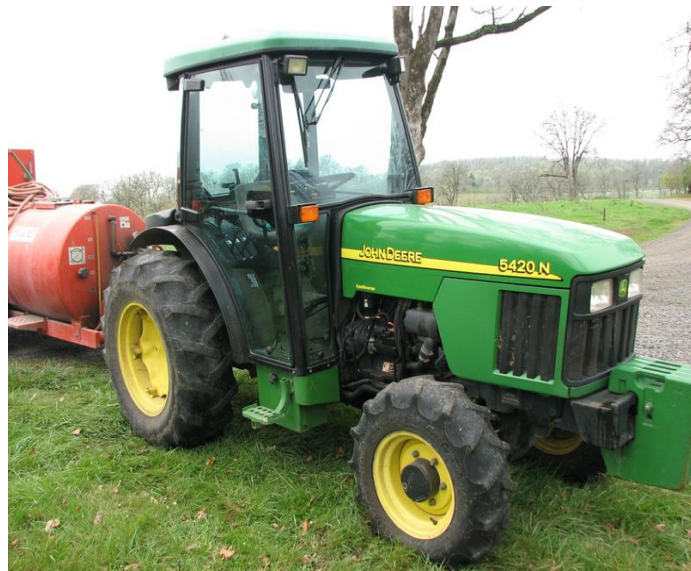
Figure 1. Tractor and trailer mounted 400 gallon chemical tank.

Three workers had been applying pesticide in the vineyard. The pesticide was contained in a trailer mounted chemical tank hitched to a tractor that pulled the tank through the vineyard (see Figure 1). Workers applied the pesticide by using hoses connected to the chemical tank and walked alongside the trailer while spraying the base of the grape vines. To allow the workers to ride the trailer to and from the field, the employer constructed a wooden platform toward the rear of the trailer (see Figures 2 and 3) and attached a nylon rope to the tank for use as a handhold by workers while on the platform. The crew finished their application and was returning to the equipment shop.

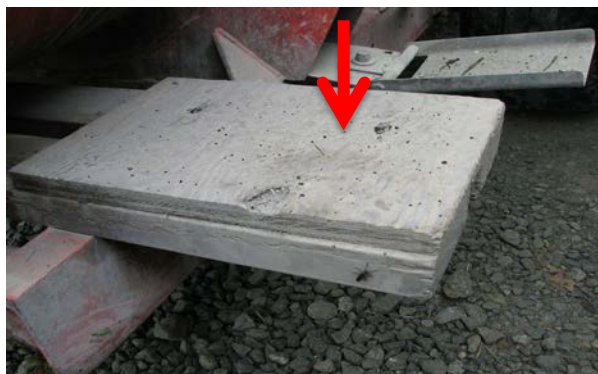
Figure 2. Close-up of wooden platform constructed by employer.

The employer had previously modified the trailer by adding wooden platforms, one on each side of the trailer (see Figures 2 and 3). The intended use of these platforms was for workers to stand on and ride the trailer to and from the field as it was towed by a tractor. These platforms were constructed with 2-inch by 4-inch lumber approximately 48 inches long, placed beneath the fan housing on the back of the trailer and on top of the frame holding the tank. Attached to the top of the 2X4's were pieces of 12-inch by 8 ½-inch plywood. The top of the improvised platforms were approximately 17 inches from the ground. The employer stated that a nylon line approximately ¼-inch was added around the top of the framework to the fan to be used by workers as a handle while they were standing on the platform. Employee interviews indicated that standing on these make-shift platforms had been done many times without incident.

The day of the incident was clear without precipitation. The surface condition of the wooden platform was not affected by weather conditions, however, it is possible that the boots worn by the employees may have been wet from the spray process, or the platform may have been slippery due to chemical overspray during the day.

Recommendation #1: Employers should consult the manufacturer or a professional engineer before modifying, installing or retrofitting components of equipment.

- The employer added the platforms to provide worker transportation to and from the field. The modification may have created additional hazards or altered safe operating parameters. Although not known, the wooden surface of the platform may have been slippery and contributed to the incident. Other consideration when modifying machines or equipment is whether the design capacity would be exceeded and structural stability and strength compromised. As required by OAR 437-004-3460(1), "The manufacturer or a professional engineer must direct modifications and additions that affect capacity and safe operation of industrial vehicles...."

- Oregon Administrative Rule 437-004-3410(3)(a)(c) specifically states, "persons are never to ride on fenders, axles, hitches, tongues, buckets, forks, drawbars or any other area not intended to carry passengers." The platforms were created for passengers; however, the trailer was not designed to carry passengers.

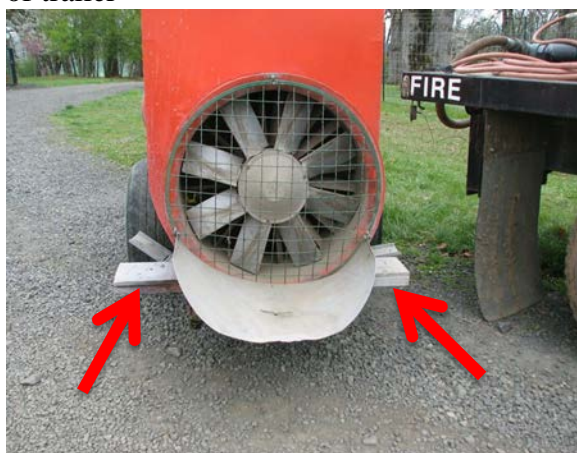
Figure 3. Wooden platforms from rear view of trailer

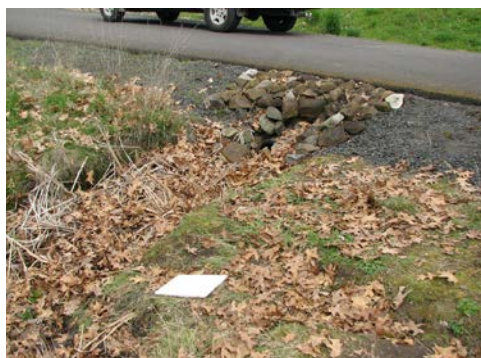
The worker wore a baseball cap that fell off his head while he was standing on the platform. Just prior to the incident the trailer was in tow along a paved roadway (see Figure 4). According to the police report, the foreman stopped the tractor for the worker to retrieve his cap and did not start movement until the worker returned to the platform. Another interview indicated that the worker was attempting to step onto the platform while the trailer was moving when he lost his balance and fell. The worker on the opposing platform did not see the fall but claimed to have heard the worker's head hit the pavement and then saw his body roll into the ditch. He immediately alerted the foreman who stopped the tractor and called the vineyard manager. According to this coworker, the fall happened a few seconds after the trailer started moving.

Figure 4. Landscape culvert and sloped surface on edge of roadway traveled.
