Fatality Investigation Report

OR 2007-11-1

Salesman killed when forklift falls off truck loading ramp

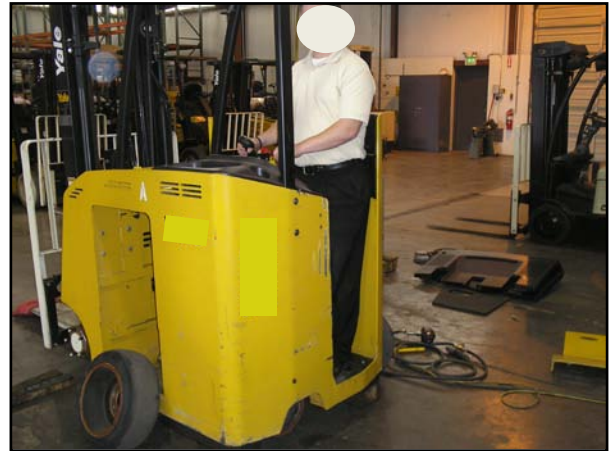
The actual forklift in this incident (with identifying images masked out) was a stand-up model for warehouse work.

The truck driver backed the flatbed up to the loading dock until it stopped against the dock. The dock was about 4 feet high, and about 9 inches higher than the loaded truck bed. The forklift weighed nearly 5 tons, which depressed the truck bed by 7 inches. The hinged dock plate lowered onto the bed of the truck extended out only 15 inches, so when in place, it sloped down to the truck bed at an angle of roughly 37 degrees. The back frame of the forklift had a clearance of only 4 inches and could clear a slope of 44 degrees.
