Fatality Investigation Report

OR2003-01-01

Roofer's family member helping at worksite dies after falling through skylight.

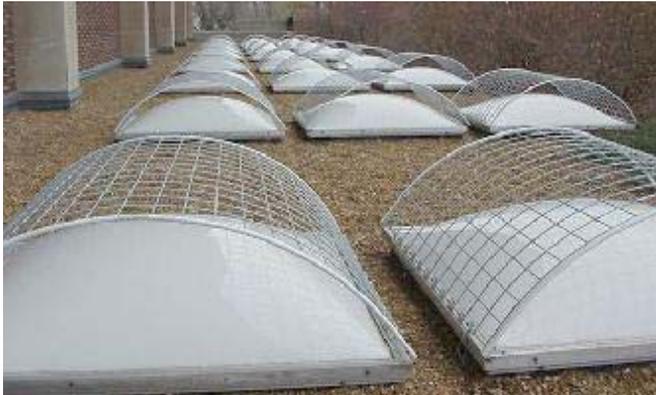
Photo. Skylight (typ.) with outer grids installed to prevent falls through them to the floor, below.

The 1997 version of the Uniformed Building Code, requires the installation of a steel grill with all acrylic plastic skylights, to prevent workers from falling through them. Polycarbonate or Lexan™, is more commonly used in the manufacturing of skylights today and is better at withstanding sudden changes of weight load and effects of weathering. Increasingly building permits for new construction (commercial buildings) are not being approved unless skylights are constructed with polycarbonate plastics, tempered or reinforced glass. Acrylic "plastics" can still be found and are being used in structures, especially on buildings, and homes, built before 1990. Acrylic domed skylights do provide advantages in that they provide explosion relief and will melt out during a fire creating a chimney effect (a desirable effect in an industrial fire). At minimum, all acrylic domed skylights, (those not incorporating tempered or reinforced glass) should have a steel grill installed

beneath them (or over them) to prevent workers from accidentally falling through them. This is an industry wide issue and must be addressed by building trades organizations, municipal code approval agencies, rental and leasing agencies, Fire inspectors, Safety Officers and housing authorities. Building owners need to decide how to best manage this risk for the older structures. Workers must adjust to the risk and take measures to prevent catastrophic incidents from occurring.
