OREGON FATALITY ASSESSMENT AND CONTROL EVALUATION

Fatality Investigation Report

OR 2013-08-1

Contract sanitation worker killed cleaning meat blending equipment.

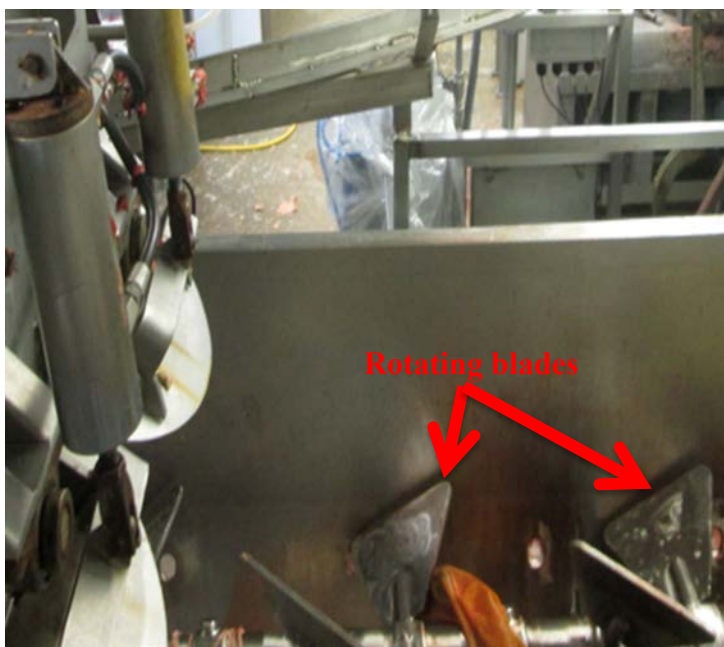
On April 2013, a 41-year old sanitation worker was killed when he fell into an industrial meat blender (see Figure 1). The worker was a member of a contract cleaning crew for a meat processing facility. On the day of the incident he reported to work and began routine cleaning and sanitation. Cleaning procedures began with a hot water wash of the rotating blades and mechanical parts to remove residual meat product. The hoses used in rinsing were long, and it was a common practice for workers to wrap the excess hose around their bodies (torso and/or legs). The

Figure 1. Open top of meat blender where the incident occurred.

clean consisted of two horizontal shafts between 6 and 7 feet long and approximately 24 to 30 inches wide. Each shaft had blades/paddles that rotated in opposite directions (see Figure 1). The blender was used to adjust the fat content by mixing product (~3000 pounds) together until the desired content was achieved. It was the only blender in the room. The room was separated by walls from the rest of the processing area. The worker was working alone cleaning his assigned equipment. Other employees were in the building but none had a direct sight line to the worker.

- The top of the blender was open exposing blades/paddles rotating while the worker was on the platform cleaning from above. It is not known whether a guard such as that pictured in figure 5 was onsite and could have been installed. If not available, the equipment manufacturer could have been contacted for a similar retrofit. An online review of meat processing equipment showed advances in interlocked safety guards for grinding/blending equipment. The OR-OSHA report mentioned that moving feed augers and conveyor chain/sprocket were also exposed and running. Similarly, guards/screens could have been installed to prevent contact with these moving parts.

Recommendation #1: Host employers should remove or reduce worker exposures to moving machine parts by identifying and installing guards or interlock features.

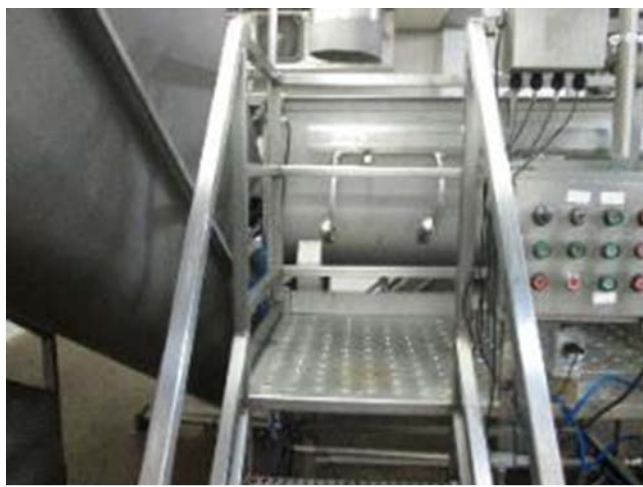
Figure 2. Platform to access the top of the blender vat.

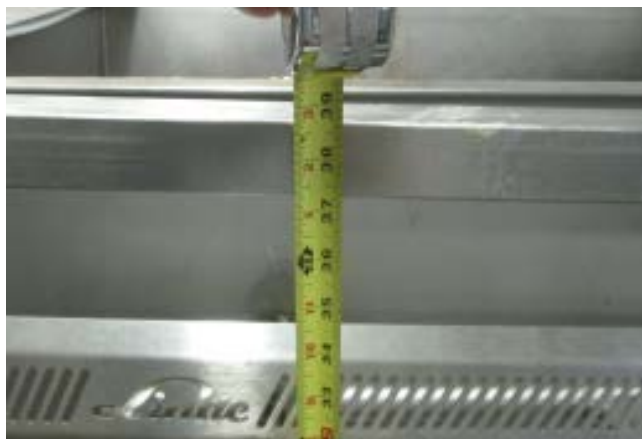
The meat processing company (host employer) workers were responsible for some cleaning-related preparation prior to the arrival of the cleaning crew and had slid the blender top cover to the side to provide access to the interior of the blender vat. While standing on a raised platform, workers would wash the interior of the vat with hot water. The platform (see Figure 2) was approximately 38 inches above the floor. The top guard rail of the platform was measured at 38 11/16th inches above the platform surface, see Figure 3.

Figure 3. Top rail height on platform. It's not known how the victim entered the vat, but evidence suggests that he fell over the railing.

- The use and length of hoses during cleaning exposed contract workers to the risk for entanglement, tripping, or ergonomics.
 - Cleaning the blender may have required the worker to reach over the railing, increasing the risk of falling into the vat. Additional safety precautions could have been identified to prevent falls into the vat, e.g. metal grate (see Figure 5), higher railing, power jet wand (wand would minimize need to reach into vat). The working/walking surfaces were slippery from production residue. The cleaning procedure may have been revised to start with washing the walking surfaces to prevent slips and falls. In addition, requiring slip-resistant footwear/boots for employees should be considered for this work environment.

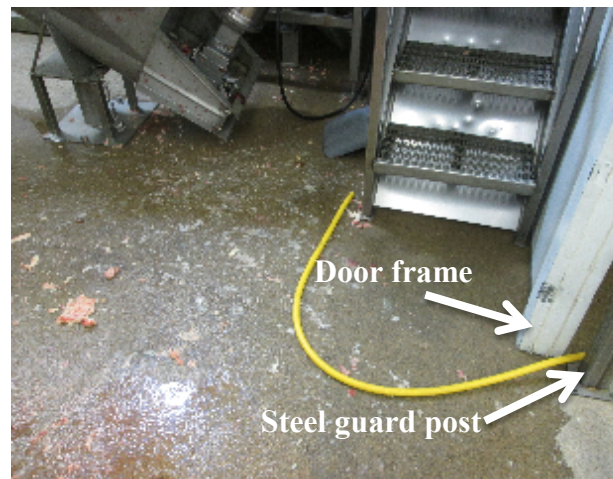
There was a galvanized pipe coupler that connected the hoses found inside the blender vat, which may have caused the unusual sound that brought the incident to the supervisor's attention. It appeared that the hose had been pulled into the room from the location of the spigot between an overhead door frame and a steel guard post, see Figure 4.

Although not known, it is believed that while the worker was on the platform, washing down the blender, the hose splice may have caught on the overhead door frame. When he pulled to free the hose, its sudden release allowed the slack in the hose to fall into the blender. During cleaning, the flowing hot water into cold blender vat would have created steam, preventing the worker from seeing the slack fall into the blender. It is likely that he was pulled into the blender when the hose that appeared to have been wrapped around his leg

Figure 4. Hose looped between door frame and steel guard post.

- In a routine hazard review, the unguarded moving parts and unsafe practice with hoses might have been identified, prompting facility redesign or procedure modification to prevent injuries.
 - Using prevention through design practices (see Renshaw) may have mitigated the risks of hose entanglement and falling into the blender vat. Spigots near equipment where washing was required would have reduced the length of hose and eliminated the need to pull hose through the overhead door frame thus reducing entanglement, tripping, and ergonomic hazards. Another method for mitigating these hazards would

be self-coiling, retracting hoses or overhead connections that would have reduced the slack in the hose.

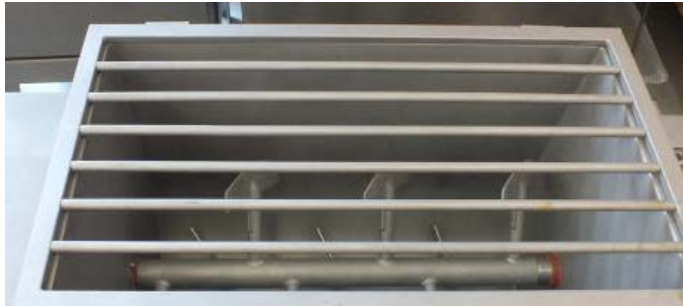
Figure 5. Example of guard for blender/grinder to prevent access to moving parts but allow cleaning.
