# Fatality Investigation Report

OR 2006-25-1

## Ranch worker killed by pressurized water striking eye

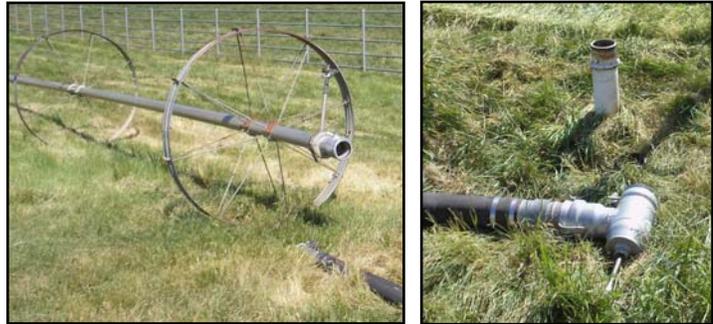
The irrigation wheel (left) connects to a heavy rubber supply line, which attaches to a removable valve (right foreground). The valve mounts over pressurized risers installed in the field, like the one shown here that failed (right background).

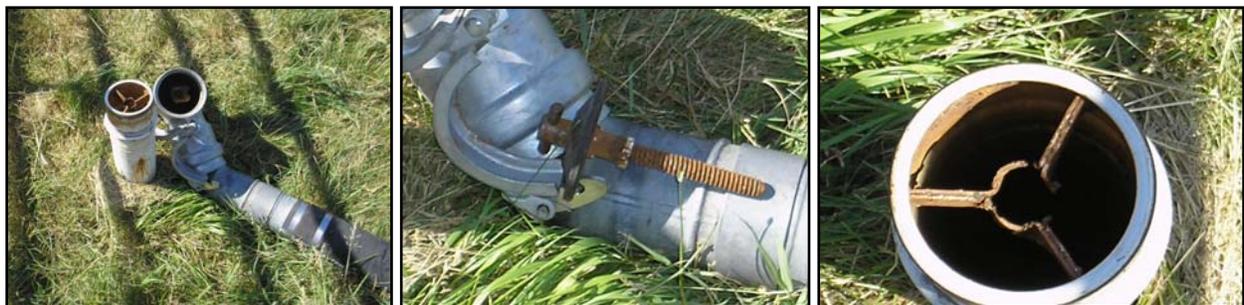
Following the incident, the entire irrigation system was immediately shut down and inspected. Examination of the riser shut-off cap showed heavy corrosion on the inside anchor nut, threaded stem, and metal retainer. The metal retainer had broken, allowing the stem to slip free and release the cap.

The corroded stem from the riser (middle), displayed in perspective with the connecting valve, shows the anchor nut screwed up tight under the shut-off plate, indicating the riser was closed when the incident occurred. The corroded retainer inside the riser failed (right).

All riser caps on the ranch were opened and inspected for corrosion following this incident. Those with slack in the anchor nut or corroded elements were replaced.

Components in an irrigation valve are subject to corrosion and pressure damage. Defects in a stem, nut or retainer that result in a leak, can also result in an explosion as in this instance. The timing of this incident suggests a final twist or pull when a person is working on the system can trigger the failure. Employers should consider performing scheduled inspections and preventive maintenance on depressurized irrigation systems at least annually.
