FATALITY INVESTIGATION REPORT

Farm mechanic died after torch cutting explosion – Oregon

REPORT#: 2017-07-1

REPORT DATE: March 2019

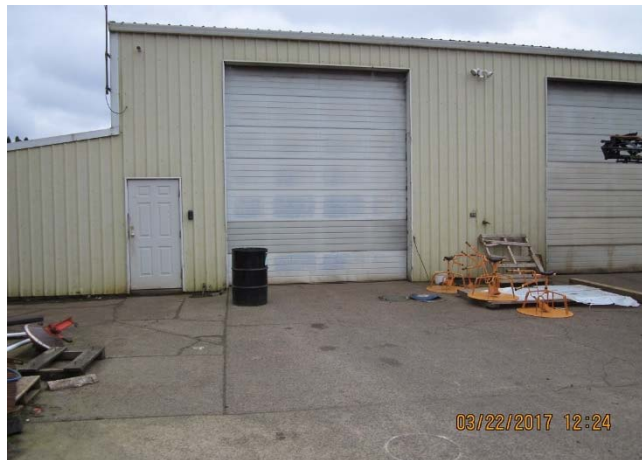
The incident occurred near the front of the farm's mechanical shop building (see photo 1) on an approximately 15-acre farm. The purpose of removing the drum lids was to repurpose the drums for use as trash containers. He had opened the shop's bay door part way, presumably for ventilation, because smoke was produced when he used the torch to remove the lid from a different drum earlier that morning.

Photo 1. Shop exterior; bay door reportedly had been partway open at time of incident, presumably for ventilation (*Photo courtesy of OR-OSHA*).

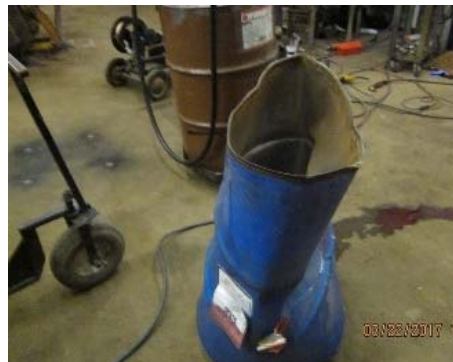
Evidence indicated that the mechanic's first cut with the torch on the drum lid caused a flash and an explosion that blew the bottom off the drum and knocked the mechanic to the ground. His supervisor was approximately 100 yards away when the explosion occurred. Two other workers and a neighbor reported hearing a loud explosion. Co-workers ran to the shop where they found the mechanic lying on the concrete floor of the shop, unconscious but breathing, with the operating plasma torch still in his hand. It was reported he had been wearing shaded safety glasses, welding gloves, and work coveralls. Co-workers called 911; emergency responders arrived shortly thereafter and life-flighted the mechanic to a hospital burn center. He never regained consciousness and died at the hospital three months later.

The cause of death was reported as traumatic head injury. Evidence suggested that the explosion blew the bottom off the drum and propelled the drum against his face and head, knocking him to the ground. Discussion with the OR-OSHA investigator indicated that his injuries appeared to involve a combination of being struck by the top of the drum as it

Photo 4. View of damaged drum following explosion; bottom of drum was blown off.
(Photo courtesy of OR-OSHA)

- **Recommendation #1: Never weld, cut, or perform other hot work on a drum or other metal container unless it has been cleaned and vented thoroughly.**

Discussion: Avoid hot work on drums or any metal containers that contain or previously contained flammable or toxic substances, or if you do not know the nature of its contents. This includes containers that appear to be empty because residues inside the container may present explosion or fire hazards, or toxic exposures.
