OREGON FATALITY ASSESSMENT AND CONTROL EVALUATION

Fatality Investigation Report

OR 2015-02-1

Crane operator killed by falling steel beam

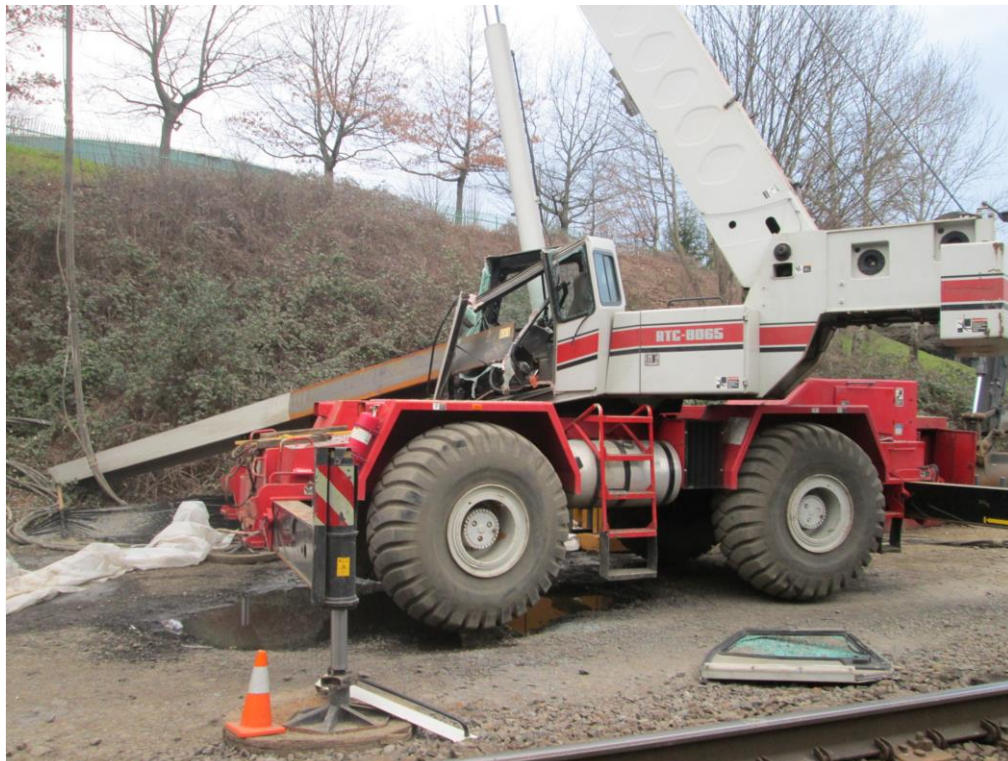
A 40-year old crane operator was killed when a 35-foot (5600 lb) H-beam fell crushing the crane cab and striking him in the head. During a pile driving operation, the H-beam pile had been placed in a drilled 25-foot hole. While using a vibratory hammer to force the pile further into the hole, the pile shifted. After several failed attempts to correctly position the pile it was extracted using the hydraulic clamp of the vibratory hammer and moved 12 feet from the hole. It was held in a vertical position with the bottom of the pile resting on the ground. The clamp holding the top of the pile unexpectedly released. The pile was not rigged to the clamp housing or attached to the whipline. The 5600 lb pile fell, struck and crushed the crane cab, and killed the operator.

Figure1. Crane cab struck by H-beam.

- **Employers should ensure that pile driving operations include redundant measures (e.g., two switch safety feature, restraints) to prevent release of piles from lifting and pile driving equipment.**

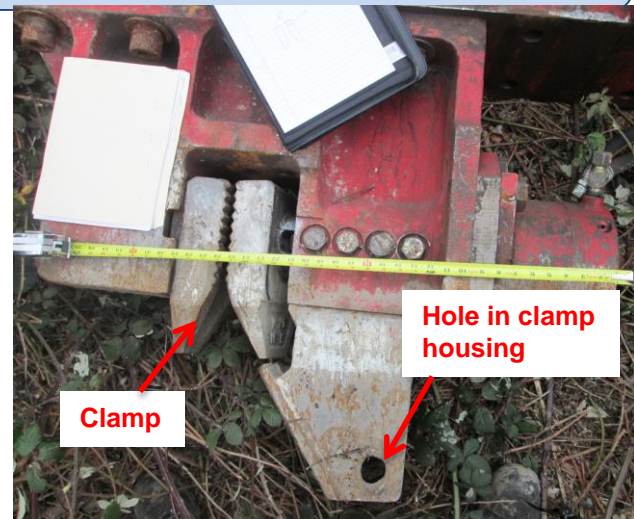
Figure 2. Close up of the vibratory hammer clamp housing.

The pile was extracted while it was clamped to the vibratory hammer. The pile did not have a safety chain or line connecting it to the vibratory hammer housing nor was the crane's whip line attached to the pile. The pile was lowered approximately 12 feet away from the hole and set in a vertical position with the lower end resting on the ground. The track drill was then moved back into position and the crew began re-drilling. The crew worked within the fall zone of the pile. At approximately 5:30 pm the vibratory hammer clamp unexpectedly released the pile which fell, struck the crane cab and killed the operator.

- (1) Air could have entered the hydraulic system during the site assembly of the hydraulic power unit. Specific instructions in the manufacturer's Operation, Maintenance and Parts Manual (p. 12) states *"Whenever the hydraulic lines of the system has been reconnected THE CLAMP CYLINDER CIRCUIT MUST BE BLED OF ENTRAINED AIR..... CAUTION: FAILURE TO*

COMPLETELY BLEED THE CLAMP CIRCUIT OF AIR MAY IMPAIR CLAMPING FORCE AND DAMAGE JAWS." When interviewed during the investigation, the crew was not aware of this requirement.

- **Employers should ensure that workers are trained on the hazards of equipment and follow manufacturer's operating manual (e.g., bleeding entrained air from the line to prevent clamp failure).**

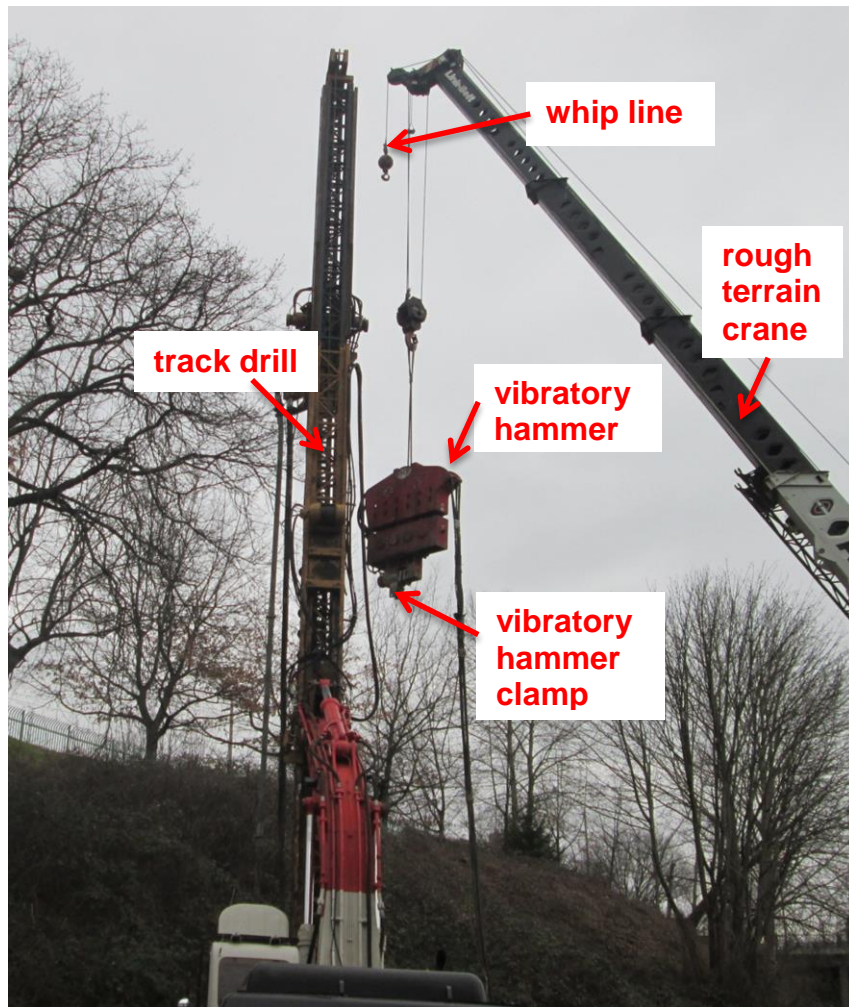
Figure 3. The equipment

the clamp holding the top of the pile unexpectedly failed releasing the pile which struck the crane cab and the operator.

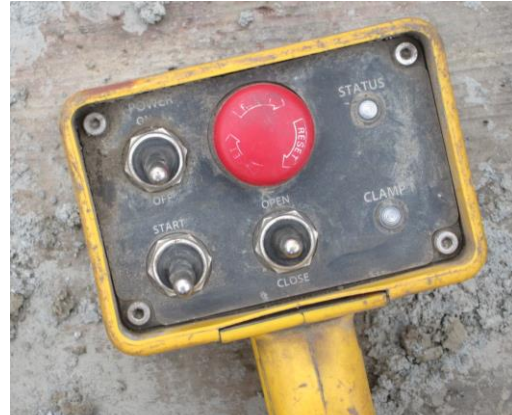
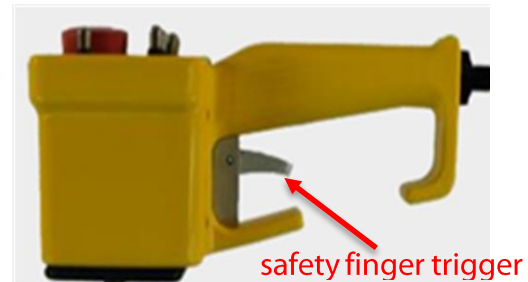
A hydraulic vibratory model MKT V-17/HP-325 hammer (MKT Manufacturing Inc., St. Louis, MO) was then attached to the crane rigging and swung into place over the pile. The vibratory hammer was built in 1979, and was powered by a diesel driven, hydraulic power unit with a 150-foot hydraulic hose bundle. It was originally operated through a control panel located on the power unit or remotely with a 50-foot electrical control pendant cable assembly. However, the employer had contracted a company to design and supply a wireless remote control (see Figure 4) to replace the pendant device. The design options for the remote control included an optional safety finger trigger that must be activated before any vibratory hammer action controls would function. However, this "safety trigger" (see Figure 5) option

was not selected for the wireless remote control unit that was ultimately used during the incident.

The foreman using the handheld wireless remote control (see Figure 4) opened the clamp on the base of the hammer. The open clamp was dropped over the web of the H-beam pile then closed remotely. The crane operator repositioned the pile by lifting it while clamped to the vibratory hammer to straighten it while in the hole. The foreman then started the vibratory hammer using the remote control.

Figures 4 and 5. Vibratory hammer wireless remote control. Below is a drawing with the safety trigger option.

(2) The toggle switch on the wireless remote control (see Figure 4) may have been inadvertently activated by brushing against an object while hanging on the foreman's belt releasing the clamp on the vibratory hammer. For this investigation the vibratory hammer manufacturer was contacted to determine whether remote controls for vibratory hammers were available. A picture of their remote control was provided (see Figure 6) and the safety features they described included recessed buttons and two buttons, PTO and clamp or vibro, must be pressed simultaneously to initiate action. This prevented inadvertent action when only one button is pressed. Whereas the remote control unit used in the incident had toggle switches extending beyond the case (See figures 4 and 5) and it did not include a safety trigger, a two switch safety feature, to prevent action of the vibratory hammer when the toggle switch was inadvertently pressed.

(3) Radio frequency interference with the 900 MHz wireless remote control may have initiated clamp release. The incident occurred in the city where the site was surrounded by city streets, freeways, a convention center, and industrial area. Without testing or additional information, this scenario could not be ruled out. Correspondence three months prior to the incident revealed problems with the remote control. Problems, although not described in the documents, were also reported during a previous job.

Recommendation # 2: Employers should consult the equipment manufacturer prior to modification or addition to equipment. The wireless remote control that replaced the original pendant control may have unexpectedly opened the clamp and released the pile.

- The replacement of the pendant control on the vibratory hammer for a wireless remote was a significant modification. The unexpected release of the pile by the vibratory hammer clamp may have been as a result of an inadvertent movement of the toggle switch or radio frequency interference. For critical and hazardous equipment, the manufacturer should be consulted before devices/equipment alterations or modifications occur. In a telephone conversation with the vibratory hammer manufacturer, they indicated that they were not contacted prior to the incident. In this case, the manufacturer would have offered their unit or recommended what safety features should be incorporated in a remote control.

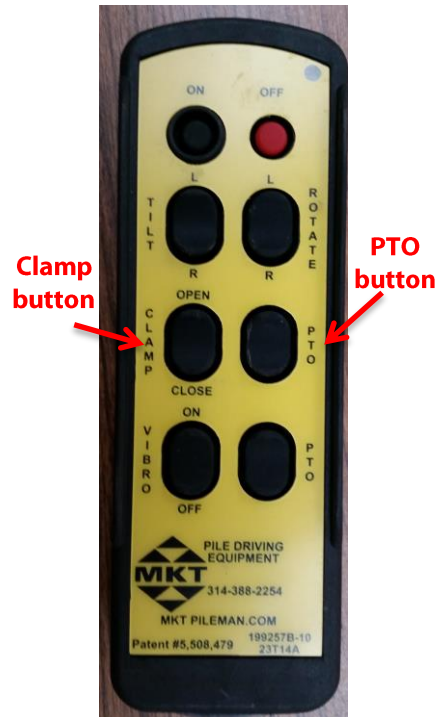
Figure 6. MKT remote control for a vibratory hammer
