FATALITY INVESTIGATION REPORT

Rubber equipment operator died after his head was caught between bars of operating machinery

REPORT#: 2018-29-1

REPORT DATE: June 2019

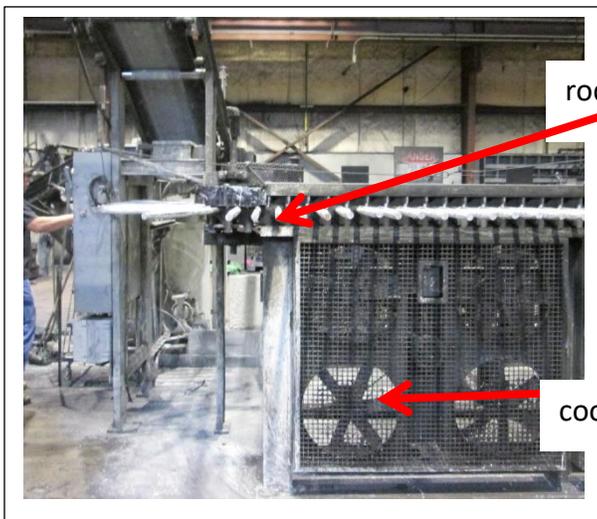
On August 23, 2018, a 23-year-old rubber cutter was killed when he attempted to retrieve a rubber strip on the cooling line (Festoon, see photos 1 and 2) that had passed the point where it should have been fed onto a conveyor. He raised his head between two horizontal bars, and as the line began to move, it forced his head against the electrical panel support. OR-FACE received notification of the incident from Oregon OSHA (OR-OSHA). This investigation report is based on OR-FACE site visit with an OR-OSHA investigator, review of OR-OSHA investigation documents, follow-up discussions with the OR-OSHA investigator, and best practices research.

Photo 1. Unguarded festoon (cooling line) (Photo courtesy of OR-OSHA).

There were other similar festoons on site. None were safeguarded to prevent entry into danger zones or contact with rotating bars/rods. Employees were allowed to reach into the machine to make minor alterations while operating.

- **Recommendation #1: Safeguard machinery to protect machine operators and others who work in the area from hazards. The safeguard should prevent employees from having any part of their body in the danger zone during the machine operating cycle.**

Discussion: Rubber manufacturing machinery are comprised of rolling machines, extruders, mixing and cutting. The employer's primary focus prior to the fatality was safeguards for these equipment, which they may have believed to be more hazardous. However, any machine part, function, or process that may cause injury must be safeguarded. This includes slow moving machine parts like the cooling festoon.

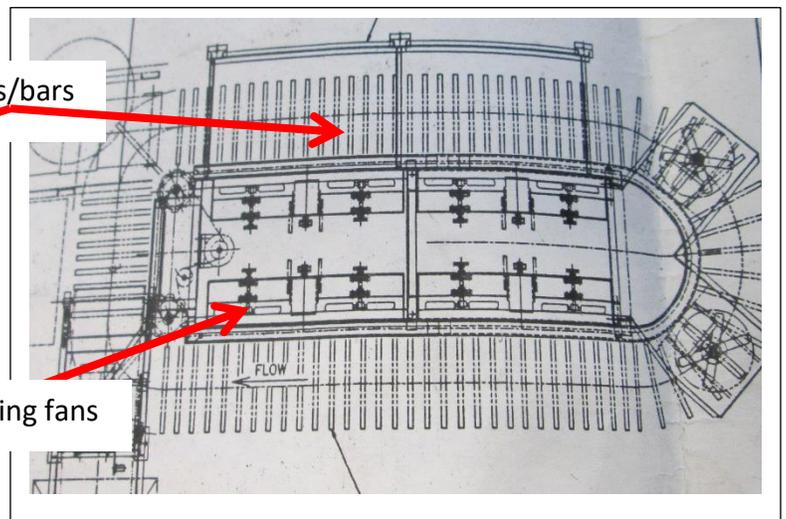
Photo 2: Schematic of festoon (cooling line) (Photo courtesy of OR-OSHA).

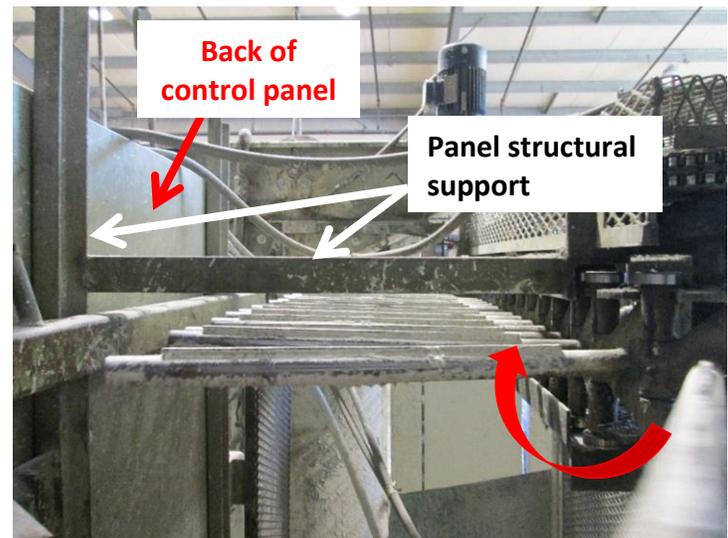
There were no witnesses to the incident (the decedent was not within visual sight of the Rubber Lacer, who was at the other end of the festoon), and no one observed the worker entering the unguarded festoon area. It is speculated that the lead strip had passed the point where it would normally be fed to the conveyor and had made its way around the corner, where the worker likely entered the festoon. As the bars rotate around the corner of its elliptical path, the bars separate (see Photos 2 and 3) at the outside end. It appeared that the worker raised his head between two bars, and when the equipment began to rotate, his neck was caught between the bars, forcing his head against the control panel support.

Photo 3. Festoon corner section; note the distance between two bars (Photo courtesy of OR-OSHA).

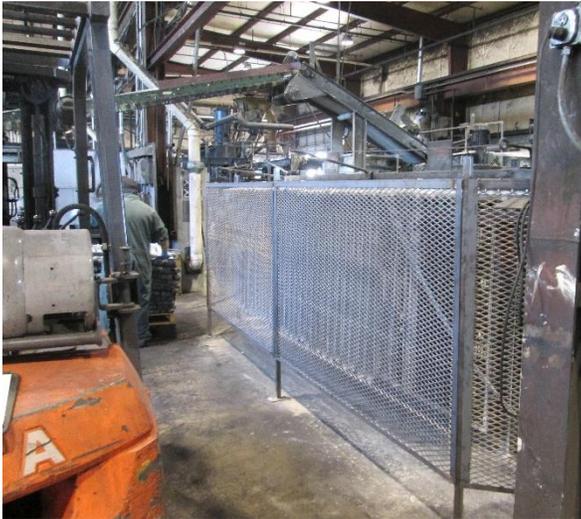
Photo 4. Installed guard at festoon line
(Photo courtesy of OR-OSHA).

One of the festoons is situated near the locker room and employees walked passed rotating rods several times daily. According to the employer investigation report, unguarded festoons are common throughout the rubber industry. It is unknown if festoon manufacturers recommended guards/barriers or notified buyers of potential entanglement hazards. After the incident, the employer halted production until physical guards were installed (see Photos 4 and 5).

OSHA's publication, "Basics of Machine Guarding" (see references), states that equipment safeguards must be secure such that workers cannot easily remove or tamper with the safeguard. The physical barriers (see Photos 4 and 5) installed by the employer after the incident appeared to be secure and fixed. However, such barriers should not create interference. If the guard impedes the worker from completing his task efficiently and comfortably the guard will likely be overridden or disregarded. It was not determined in the investigation how often the rubber strip required redirection from the festoon line to the off-loading conveyor. When doing so, the safeguard must prevent hands, arms, and any other part of a worker's body from making contact with hazardous moving parts. A tool to reach over the guards to capture and direct the strip may be a consideration. However, this action should not create new hazards.

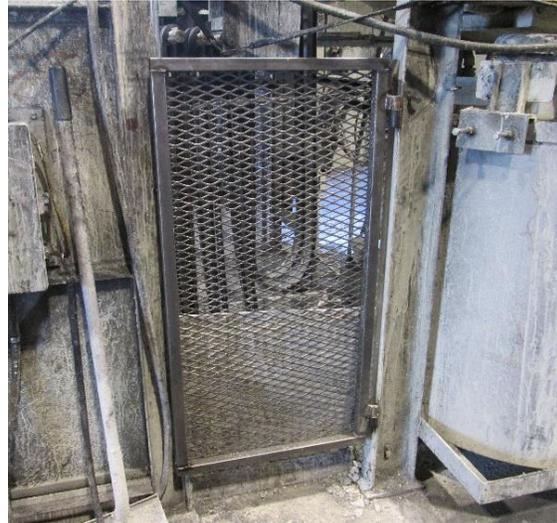
Photo 5. Installed guard with serpentine rubber strip visible (Photo courtesy of OR-OSHA).
