FATALITY INVESTIGATION REPORT

Maintenance Mechanic Crushed Working Inside of a Vertical Storage Machine

REPORT#: 2017-22-1

REPORT DATE: June 2019

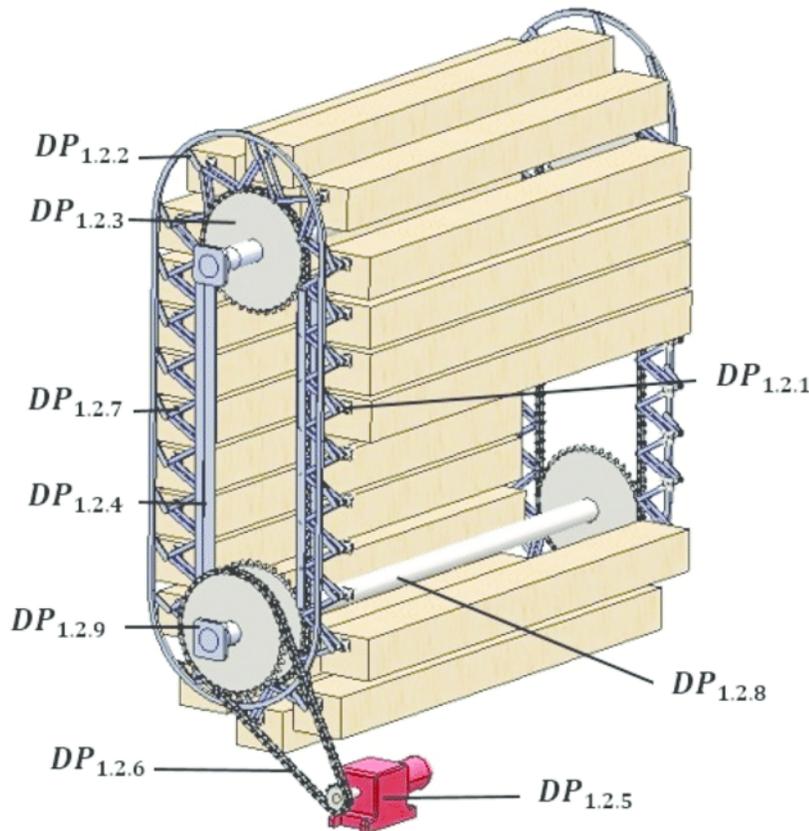
Example vertical storage unit design. *The unit involved in the incident was 12 feet high, 8 feet wide, and 11 feet deep. The machine exterior was a sheet metal housing with front and back access panels, but with only the front panel accessible. A hand crank was available to rotate carriers while the machine was powered off.*
