# Fatality Investigation Report

OR 2006-19-1

## Young logger killed when yarder topples during setup

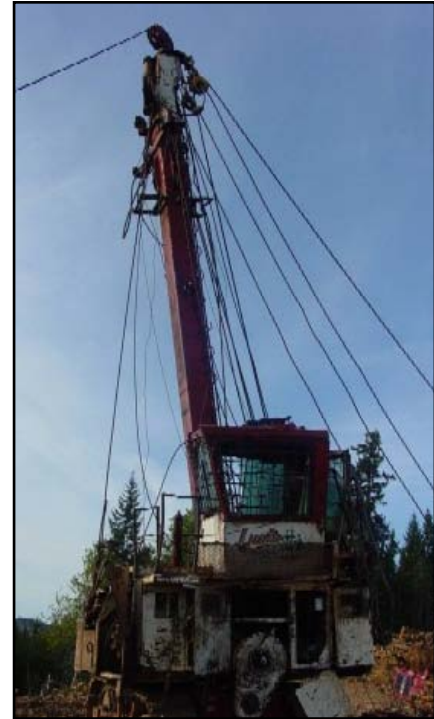
The yarder in this incident toppled over backward as the guylines were being spooled taut on the drums during setup.

Once the guylines were laid out and anchored, the young chaser and the siderod started to spool the guylines onto the guyline drums at the rear of the yarder. The chaser mounted the deck of the yarder to spool the top two drums, and the siderod worked from the ground on the bottom two drums. Three of the guylines were spooled, but not drawn taut, waiting for final adjustment once the skyline was raised on the front. As the yarder operator began to spool the fourth guyline, the siderod heard a coworker yelling, and looking over, he saw the man motioning with his arm over his head, indicating the yarder was going over. He took off running and just made it past the tracks when the yarder toppled over the steep hillside. The chaser, on the deck of the yarder, ran toward the cab, where the yarder operator was sitting. He did not manage to reach the cab before the yarder went over, and he was crushed beneath it. The yarder operator, protected inside the cab, emerged with minor injuries.

According to the Oregon OSHA report, the yarder operator had placed the guyline locking dogs into the locked position as he was raising the guylines. By placing the dogs in the locked position, the operator is able to ratchet the guylines in, but unable to spool them off quickly. The dogs do need to be locked during the yarding phase of the operation to prevent the guylines from unspooling when a load is placed on the skyline, but it is generally not necessary to lock the dogs during the initial tightening of the guylines. There is usually enough resistive force in the guyline motors and assembly to prevent the guylines from unspooling. The dogs can be locked once the final point of tension is reached.

No rule or standard operating procedure relates to the guyline dogs during the initial tightening of the guylines. In this instance, if the dogs had not been in the locked position, the operator might have been able to dump the guylines and prevent the tower from going over.

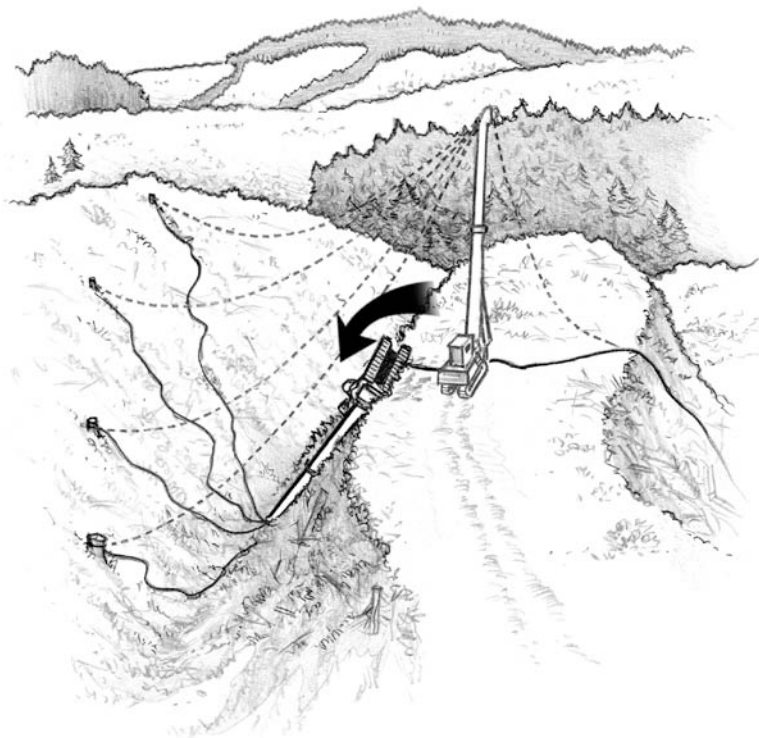
The yarder sat on a rock road atop a ridgeline and the ground fell off steeply, which created a challenge in rigging the rear guylines. The usable anchor stumps were quite a distance away from the yarder, located on a separate hillside.

Even on level ground, with a 60-foot tower, the guyline anchors need to be at least 50-60 feet away to achieve an angle for the guyline that is no more than 45 or 50 degrees from the horizontal. In this case, the most distant guyline was well over 700 feet away. To reach the anchors, at least 1,100 feet of 1-1/8 inch cables, called “tags,” were attached to three of the four rear guylines. The tags added over 3,000 pounds to the weight of the guylines pulling on the top of the yarder tower. The additional weight put the total weight of the guylines dangerously close to the load limit of the tower.

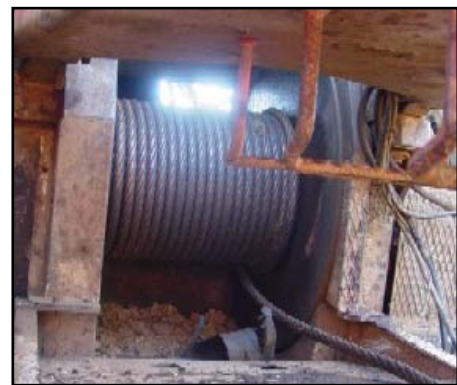
Additional torque on the line due to the far extension of the guylines and the reduced diameter of the drum may have helped topple the tower.

The first point, the weight of the guylines, was indicated by Oregon OSHA as one probable cause that contributed to this incident. The second point, the pulling force (torque) on the guyline drum, may have been an additional factor. When a guyline drum is almost empty, the diameter is reduced and the torque on the line is increased to as much as twice the pulling power as when the drum is nearly full (torque on a line is inversely proportional to the diameter of the drum; think of the variable forces of bicycle gears on the chain – refer to Samset, 1985). With the guylines extended nearly the maximum distance, the yarder operator may have misjudged the force on the line while spooling it taut.
