REPORT#: 2018OR030

REPORT DATE: July 8, 2020

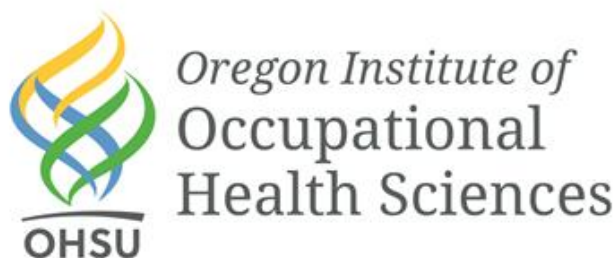
OR-FACE supports the prioritization of safety interventions using a hierarchy of safety controls, where top priorities are hazard elimination or substitution, followed by engineering controls, administrative controls (including training and work practices), and personal protective equipment.

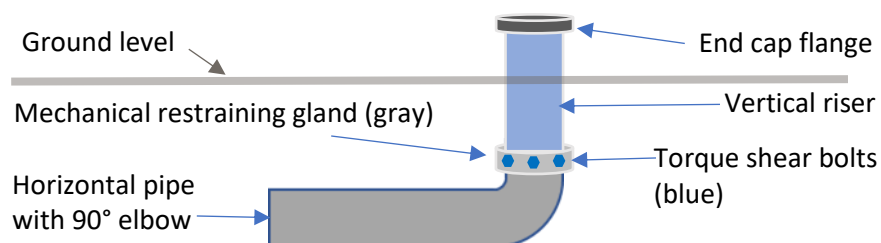
Diagram 1. Schematic of vertical riser connection to horizontal section of pipe, with mechanical restraining gland and torque shear bolts.

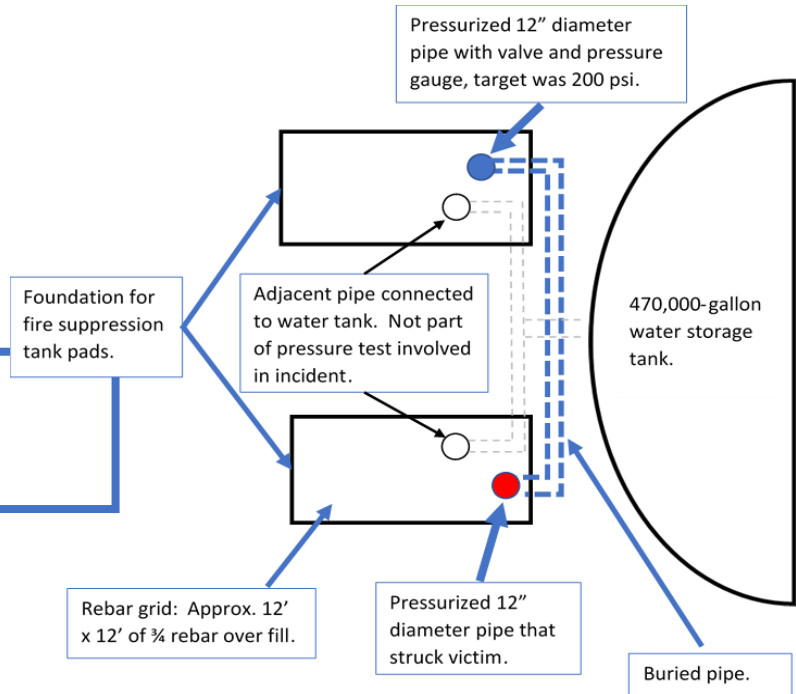
Diagram 2. Schematic of Incident scene.

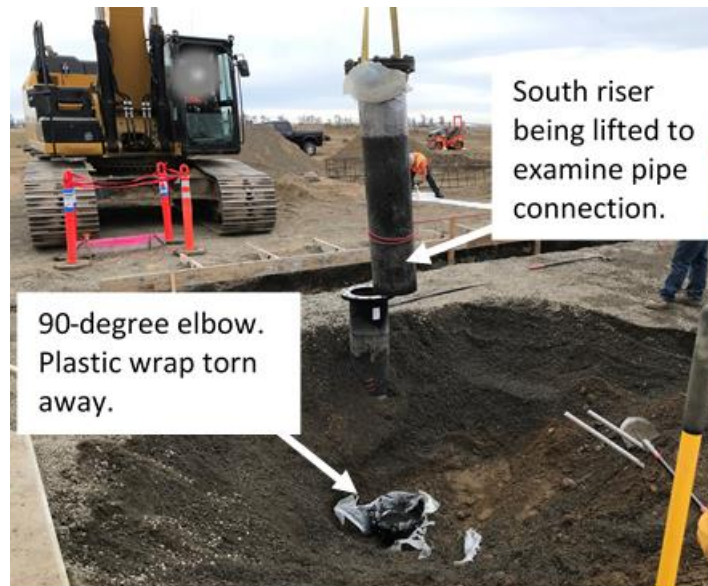
Photo 3. Post-incident excavation. South vertical riser to connection point with 90-degree elbow of horizontal pipe section. (Photo courtesy of OR-OSHA)

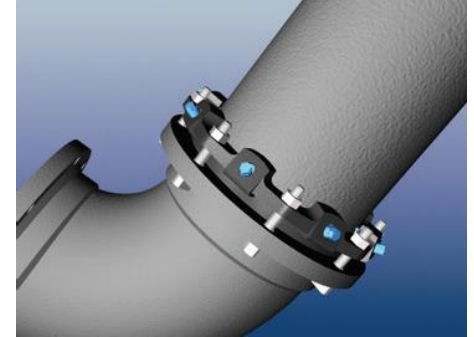
Image 3. The hex-heads of the torque shear bolts (blue) are broken off when sufficiently tightened.

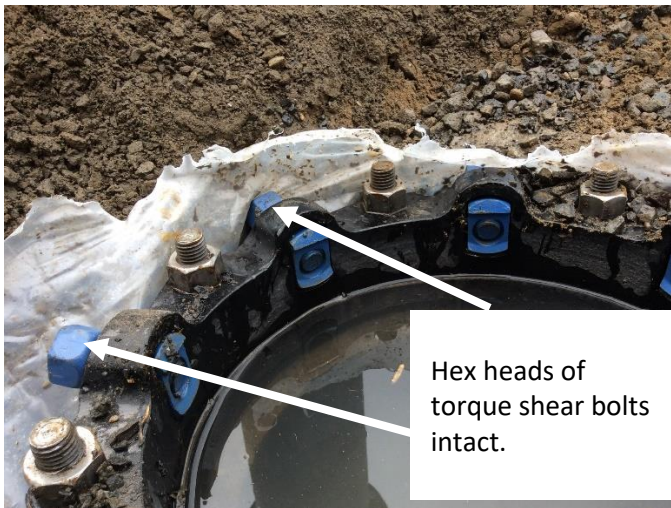
Photo 4. Flange bolts (silver) and torque shear (blue) on gland. Vertical riser has been removed. Note hex-heads of torque shear bolts are still attached.
(Photo courtesy of OR-OSHA.)

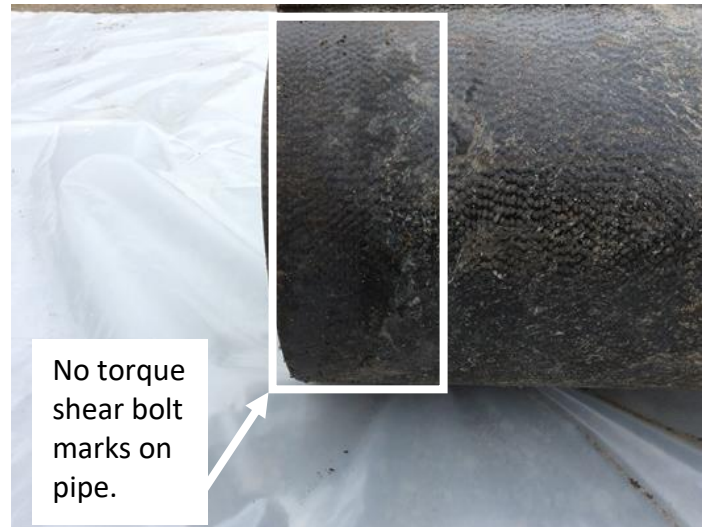
Photo 5. Bottom end of south vertical riser. Note there are no torque shear bolt marks on the outside of the pipe, indicating torque shear bolts were not tightened.
(Photo courtesy of OR-OSHA.)
