REPORT#: 2021OR01

REPORT DATE: May 23, 2023

Heavy Equipment Operator and Rancher Crushed by Excavator—Oregon

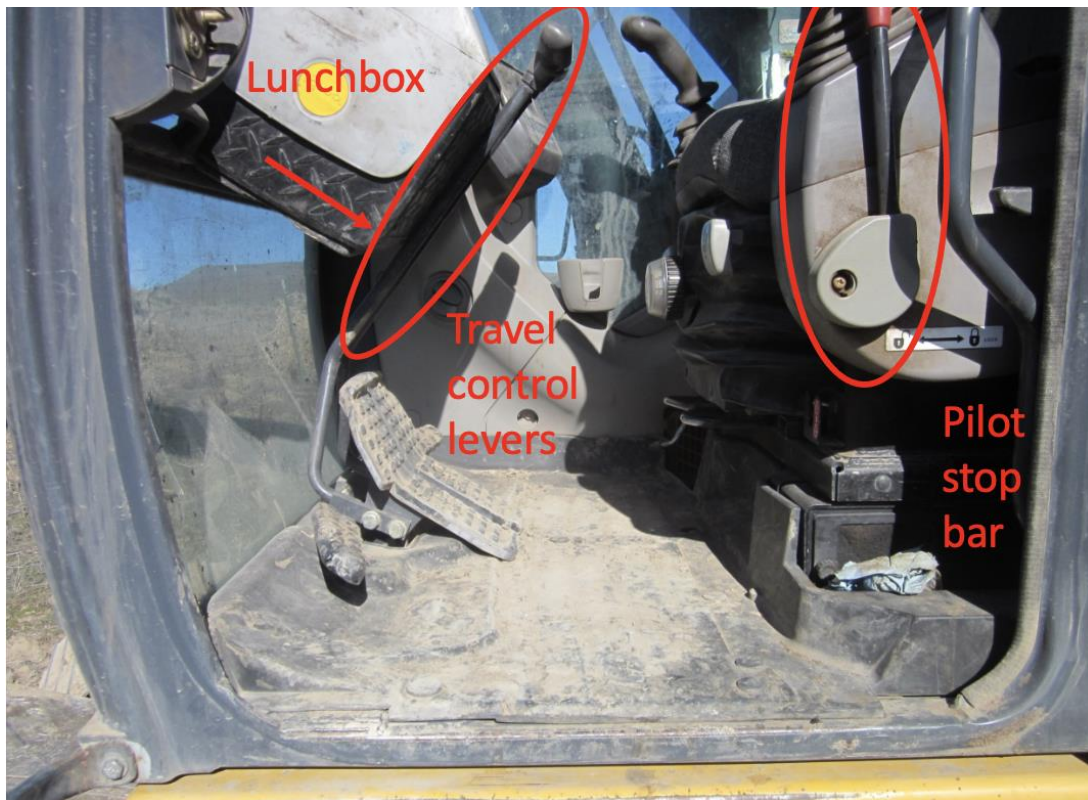
The holding company employer owned the John Deere 225D LC excavator. Based on the serial number, it was manufactured in 2010. The investigation found controls operated as designed, i.e., there were no malfunctions identified that would have contributed to the fatality. However, there was an approximately 20-pound lunch box wedged between the front window and the directional control levers. The weight of the lunch box depressed the lever causing the machine to travel when the pilot control stop bar was released. How or why this occurred was not determined. A third person used the pilot control stop bar to stop the movement. The pilot control stop bar or shut off lever is located near the cab exit and shuts off the hydraulic pressure to all control valves. When the lever is in the up or locked position the machine will not move even if the controls are accidentally depressed. However, when the pilot control stop bar was unintentionally moved to the down or unlocked position, the travel controls were able to be activated. The excavator traveled approximately 25 feet before being stopped.

Photo 1. Operator's lunchbox wedged behind the control levers as found after the incident. Note the travel control levers have been moved toward the seat by the weight of the box. (Photo courtesy of OR-OSHA.)

added, the decedent “always had his lunch box in the excavator with him”. The cab of the excavator is small so anytime the deceased, “exits the machine he places his lunchbox up against the front window and it also rests against the lever of the machine.”

Best practices including no loose items in the cab should also be included in the training and employer requirements. Based on a quote in the investigation, at least one other employee knew the equipment operator placed his lunchbox on the travel levers when getting into the cab. Had this been identified and prohibited by the employer, the incident may have been prevented.

Recommendation #4: Employers should develop and enforce a clear policy stipulating that any items stored in the equipment cab must be properly secured.

Cab storage options are limited. The only storage option in this piece of equipment was a cup holder in the arm rest area. Loose equipment is a well-recognized hazard as it can interfere with the pedals and potentially move under or behind them. The employer could have been aware of the limited storage options on the equipment. Until the cab area could be modified to accommodate storage of additional items, or storage in other locations on the machine, employers should develop and enforce a clear policy stipulating nothing is permitted in the cab that cannot be properly secured.

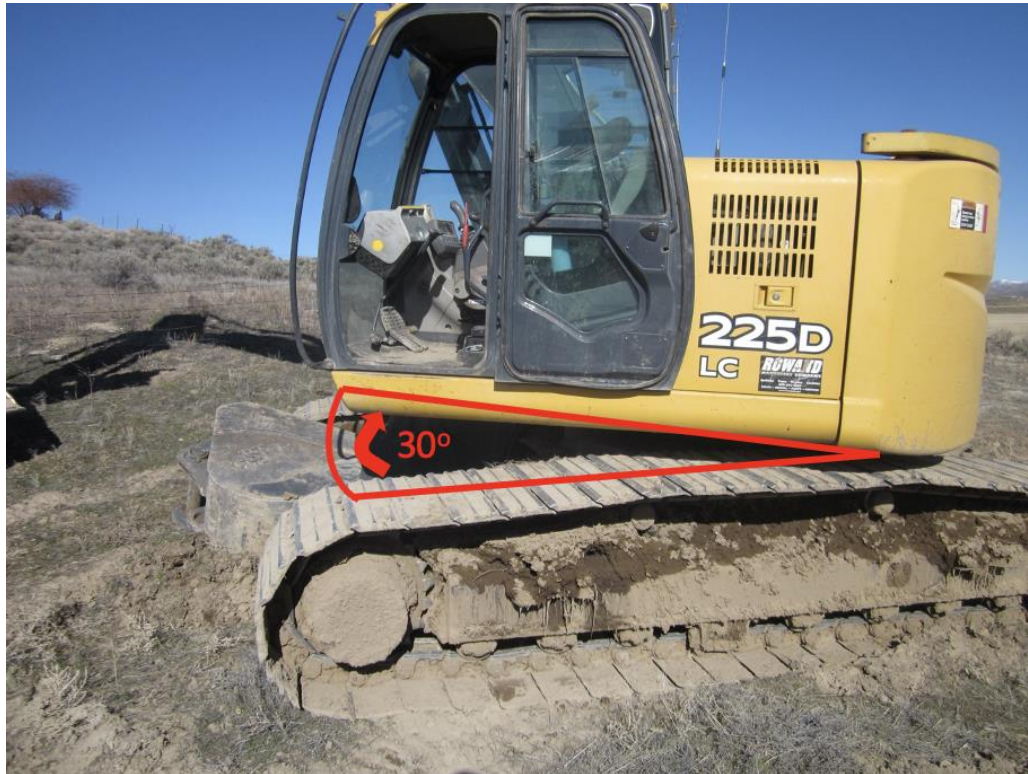
The equipment operator was using the excavator to build a road across a small creek and prepare the site for a new horse barn. The employee operating the excavator was outside of the cab with the engine running and was seen walking back from the bucket by the witness, who had arrived with the ranch manager. The bucket was in the air, approximately 1 foot above grade. The operator had rotated the cab approximately 30 degrees toward the right track as shown in Photo 2 below. The operator climbed on the track and started to reach into or get back into the excavator, when the ranch manager approached him. The operator stood on the track while they talked. The equipment operator had stored his lunchbox on the control levers, but with the pilot control stop bar still engaged, the machine remained stationary. After the conversation with the equipment operator, the ranch manager started to walk back toward the witness. The excavator suddenly started moving in reverse with the equipment operator still standing on the track. The operator's employer speculated that as his employee re-entered the cab, possibly to turn the excavator off, his coat hooked on the pilot control stop bar shifting it and allowing the machine to move. This is just one possible scenario that could have caused the pilot control stop part to be moved into the unlocked position.

Photo 2. Rotated position of the excavator cab at the time of incident
(Photo courtesy of OR-OSHA.)

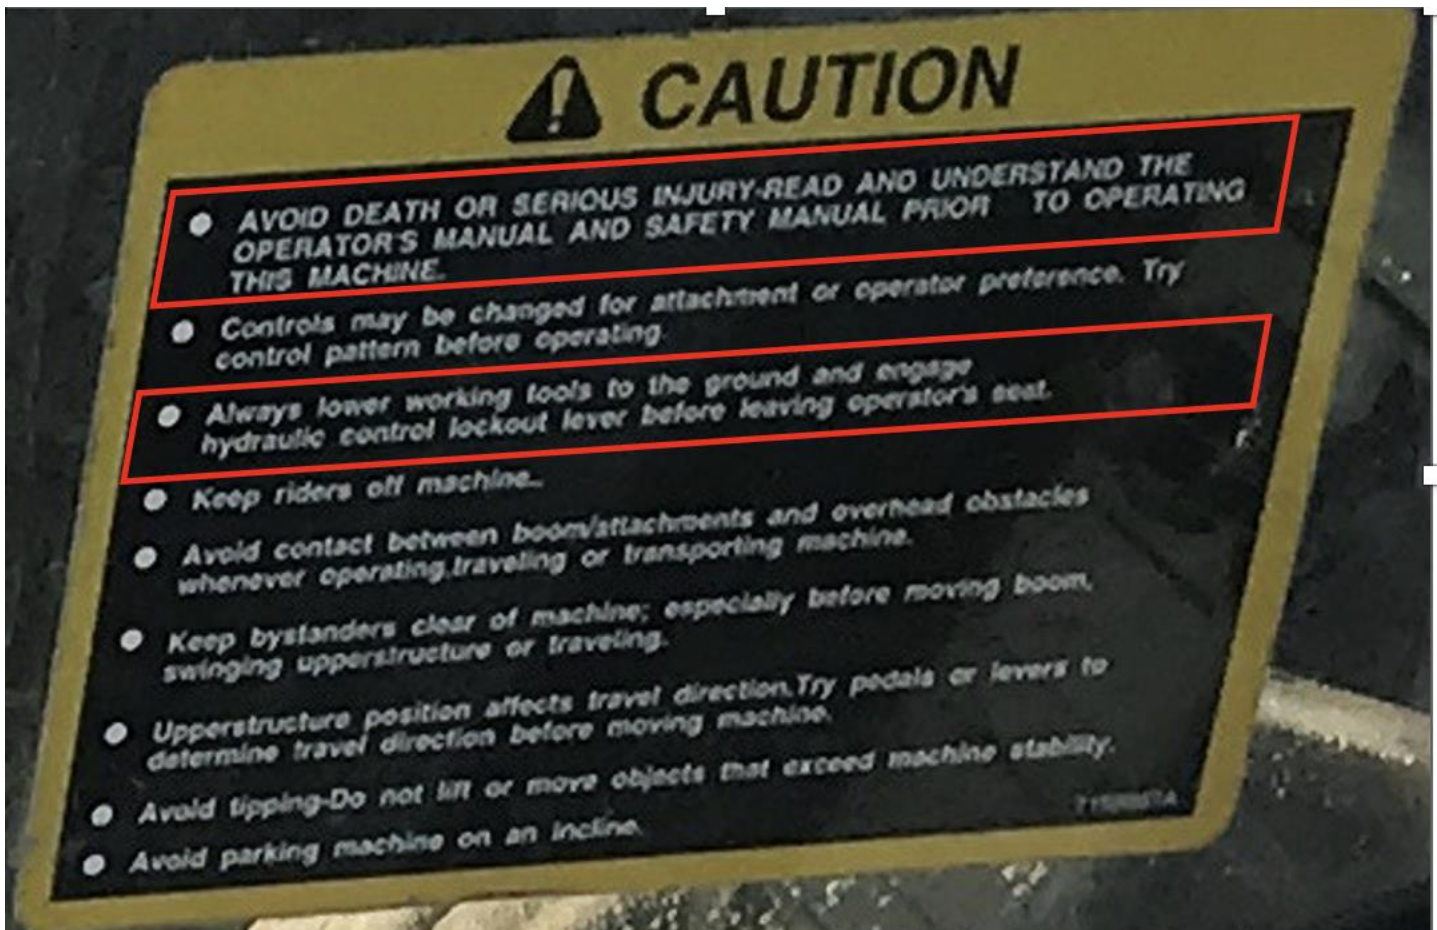
The operator left the cab with the bucket raised approximately one foot above grade, despite the manufacturer’s instructions to lower the tool to the ground before exiting the cab. The employer did not require employees to comply with these instructions. As shown in Photo 3 below, the prominent warning sticker from inside of the excavator cab lists this safety instruction. Other safety instructions are included the equipment manual.

Photo 3. Window sticker with warnings to ensure safe operation (Photo courtesy of OR-OSHA).

Recommendation #3: Employers should ensure that employees follow manufacturer’s safety manual instructions, best practices, and warnings on the cab window sticker.

The equipment manufacturer specified that an operator should always lower the excavating bucket or other working tools to the ground and apply the pilot control locking lever when parking or leaving the machine. The machine should have also been turned off before leaving the cab. By following the manufacturer’s instructions, the inadvertent activation of the machine that caused the fatality may have been prevented.
