REPORT#: 2019OR01

REPORT DATE: June 29, 2023

Two Workers Killed in Boom Lift Rollover - Oregon

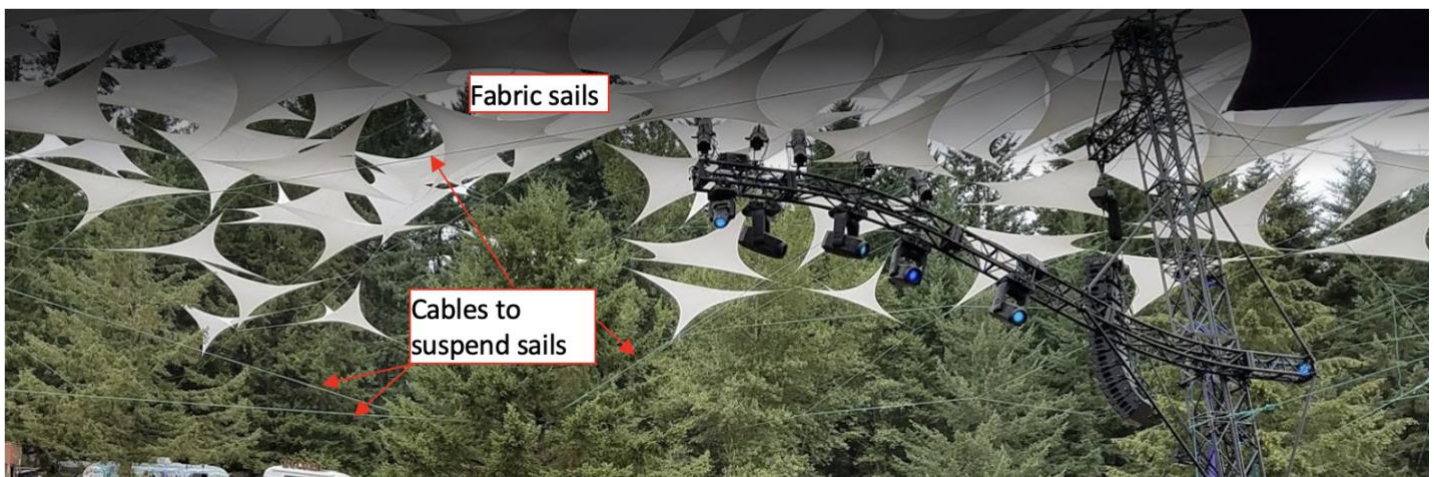
Image 1. Image of a fabric sails installation at the music festival venue. Note the cables attached to the sails are secured to trees in the background.

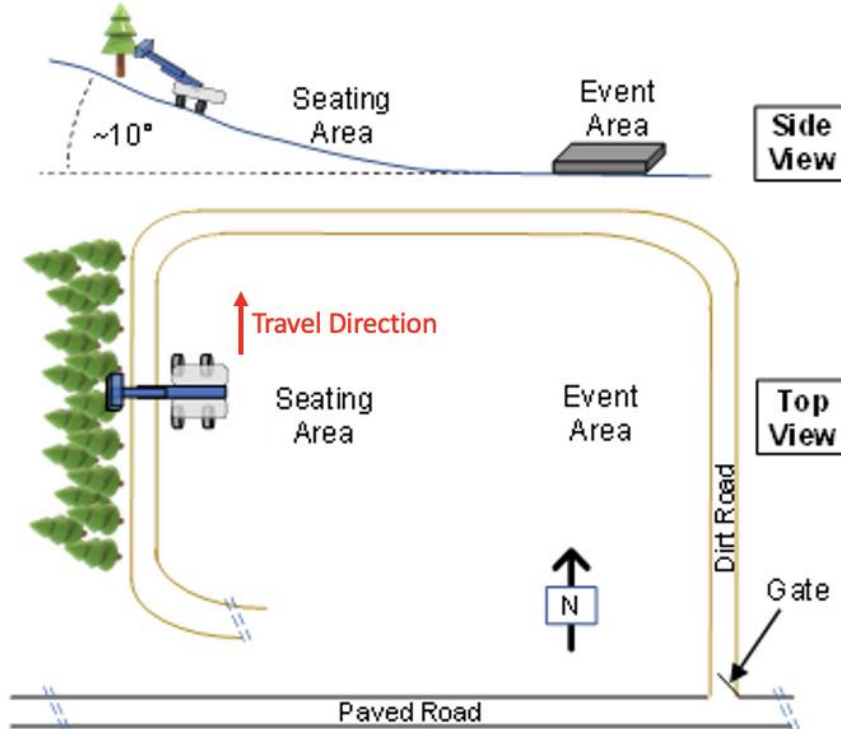
The incident occurred on a sloping hillside of a private farm field bordered by tall trees on the west and north side (*See Image 2*). The trees are used to anchor cables that suspend fabric over the audience seating area, the event stage, and other event areas. The highest elevation of the field is on the west side, sloping downward approximately 10° to the east, where it flattens out, creating a bowl shape. The field is made available as a music venue for about two weeks during the summer, including set-up and tear-down of equipment and effects.

Image 2. Side and top view of the incident scene. Wheels on boom lift are parallel to the dirt road to the west. Not to scale.
