**REPORT#: 2025-01    REPORT DATE: 10/28/2025**

## Choker Setter Fatally Struck by Skyline—Oregon

### SUMMARY

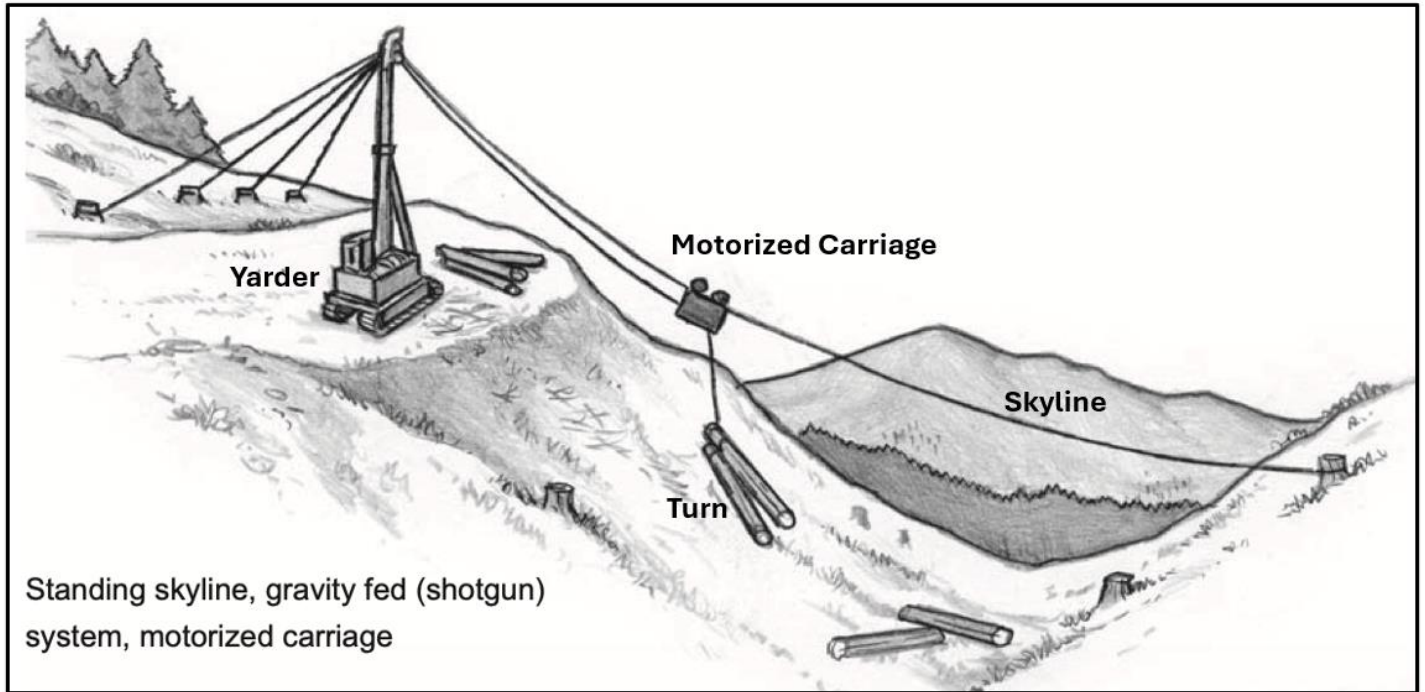
The yarding system configuration used that day was a standing skyline in gravity-fed mode with a motorized carriage. In this type of yarding system, the skyline is stationary, and the motorized carriage brings logs (referred to as the turn) up to the landing. For the outhaul, gravity is used to move the carriage down the slope to the rigging crew. According to the Oregon Occupational Safety and Health Administration (OSHA) Yarding and Loading Handbook, this is the most common cable yarding system that is used in the region [OR-OSHA 2010]. **Image 1** below shows an illustration of this type of yarding system.

Image 11: Illustration of the yarding system configuration with labels added (OR-OSHA Yarding and Loading Handbook).

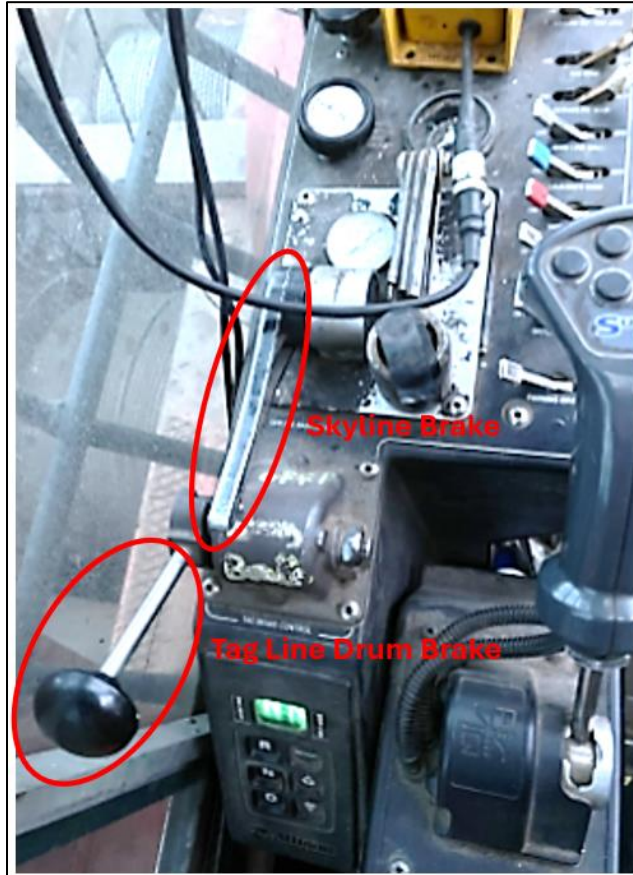
After sending the carriage back, a member of the landing crew working as the chaser asked the yarder operator to release the yarder's tag line drum brake so that the rope could be pulled off the tag drum. This was requested of the yarder operator because the crew was preparing to move the yarding road. The yarder operator reached for the lever on the left side of the operator controls and accidentally released the skyline brake instead of the tag line drum brake, which was adjacent.

As shown in **Image 2** below, the tag line, drum brake, and skyline brake are similar in size but differ in shape on the left side of the control panel. These brake levers also require the same motion to release.

Image 2: **Photo of operator controls on Madill 172B Yarder with labels added.**  
(Photo courtesy of Oregon OSHA).

The yarder operator accidentally released the upper lever, the skyline brake, instead of the lower lever, the tag line drum brake. The yarder operator was looking outside the window as he operated the lever because the tag line is released quickly. When the skyline brake was accidentally released, the 3,200 feet of elevated skyline immediately fell from its position approximately 200 feet in the air. The decedent was standing under the skyline and was struck in the head, neck, and shoulder by the skyline.

***Recommendation #3: Employers should assess older equipment models, including yarders with lever controls, and consider upgrading the control system.***

Many yarders, like the Madill 172B yarder, have multiple levers and switches that are used to operate the skyline, main line and haul back drums. These mechanical systems require significant coordination and have the potential for operator error. Newer control systems, which can be retrofitted to older equipment models, typically use two joystick controls with a computer control system and interface. These systems can incorporate built-in safety features, such as a warning screen prompting the operator to confirm when switching modes. The newer control systems also reduce the likelihood of accidentally bumping a switch. Another benefit of a newer control system is a more ergonomic setup for operators that can reduce fatigue [Viser & Harrill, 2017].

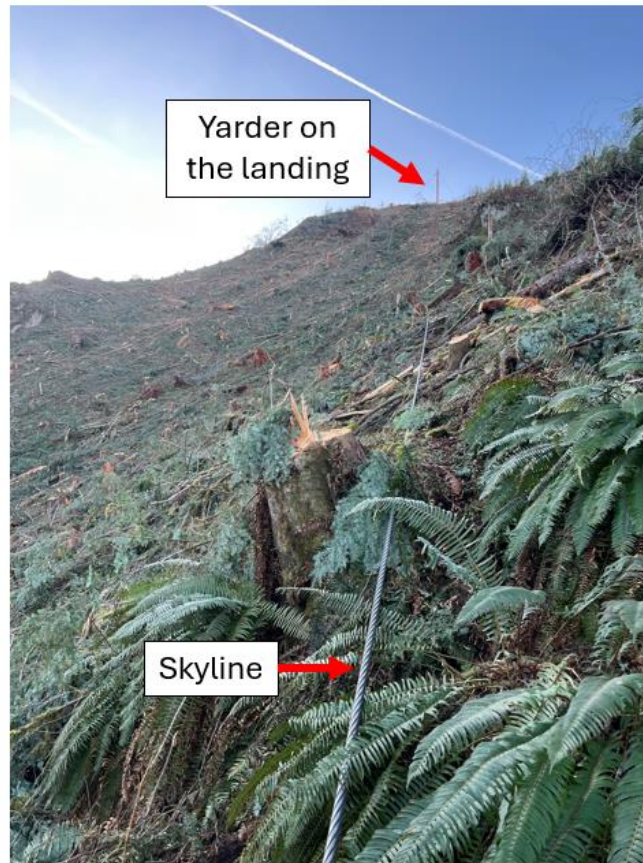
At the time he was struck, he was not wearing his hard hat. He had removed his hard hat to shed layers of clothing. His clothing and hard hat were on the ground near the location where he was struck. **Image 3** below shows the skyline on the ground close to where the employee was injured. The image shows the steep terrain and the yarder's location on the landing above. For this image, the skyline was lowered in a controlled manner. At the time of the incident, the skyline would have fallen in a much more haphazard manner.

Image 3: **Photo of the sloped terrain, skyline on the ground, and yarder on the landing above.**  
(Photo courtesy of Oregon OSHA).
