## Fatality Investigation Report

OR 2015-12-1

### Construction worker died after falling 20-25 feet from a pump-jack scaffold

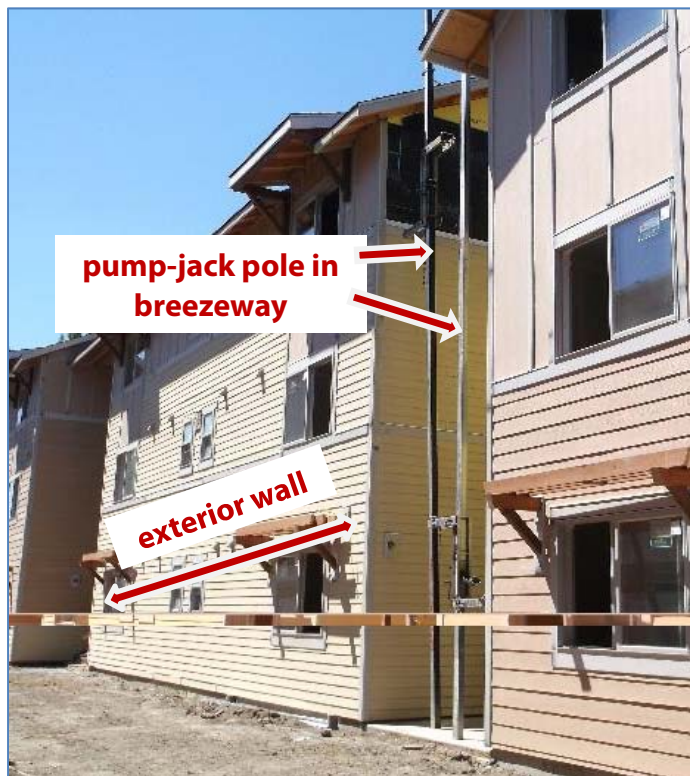
Figure 3. Exterior wall and breezeway.

The incident occurred at the last of the four buildings to be sided and painted. The siding work included applying and attaching building wrap and then installing siding boards. The victim and his crew of three workers had completed siding work on the exterior walls, then began work in the breezeway. Information obtained during interviews indicated that for work on the exterior walls the crew had set up a standard pump-jack scaffolding system. This included a minimum of three pump-jack poles to support scaffold platforms, and personal fall arrest. Specifically, the workers reported tying off to manufactured anchors that they installed on the roof. Given that fall protection equipment was available on site, it is not known why they were not used for the work in the breezeway where the incident occurred. The siding crew indicated there had been some discussion of using a beam under a sub-roof for a tie-off point in a previous breezeway. However, it is not known whether any fall protection system had been used in the previously sided breezeways.

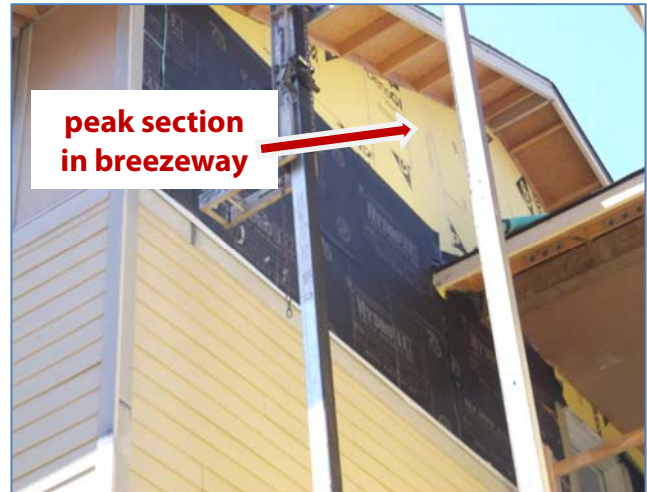
According to OR-OSHA observations and information obtained through interviews, building wrap and siding had been installed on two lower levels. The crew recalled seeing that the platform was level as the work progressed to the third level. To complete the top section siding required gaining additional height to reach the triangle shaped roof peak area above the third level landing (see Figure 4). It was assumed that to do this, the victim had placed a 6-foot step ladder on top of the scaffold platform. The victim was working alone at the time of the incident, and was not using fall protection. The three siding crew members who been assisting earlier in the day had been asked by a jobsite superintendent to perform a task on another building. Thus, they were not in the immediate vicinity at the time of the incident, nor were any other workers in the immediate vicinity. Therefore, no witnesses directly observed the specific configuration of the scaffold platform or the inferred use of the second step ladder on the platform, nor did anyone see what the victim was doing just prior to falling, or what may have triggered the fall.

Figure 4. Peak section of breezeway wall.

Scaffolds and ladders that are not properly installed or secured can tilt or sway and become unstable. In this case, two contributing factors may have affected the stability of the work platform and its ability to withstand side forces. The scaffold platform was not secured on the stair landing and was supported by a step ladder. It is possible that as a result the platform tilted or swayed, causing the victim to lose his balance, or he may have fallen because he lost his footing using the second step ladder while attempting to reach the peak section.

- Alternate methods should be considered when site conditions warrant. For example, for the breezeways on this site, an aerial lift could have been used to access heights that could not be reached using standard pump-jack scaffolding.
