# Fatality Investigation Report

OR 2007-57-1

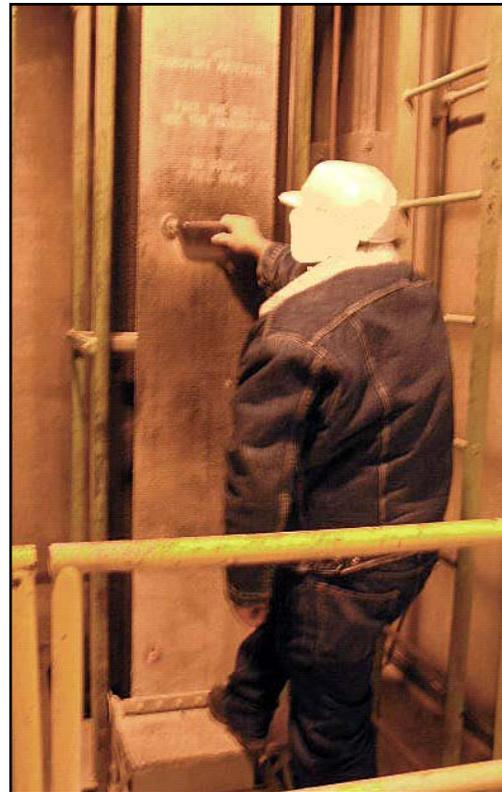
A worker at the mill demonstrates use of the manlift to ride between floors.

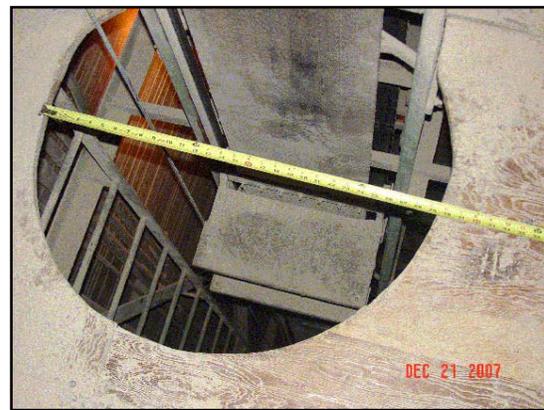
The victim fell through this manlift shaft opening. A platform step is shown on the lift belt, and the fixed ladder and stop cord at left.
