Fatality Investigation Report

OR 2005-24-1

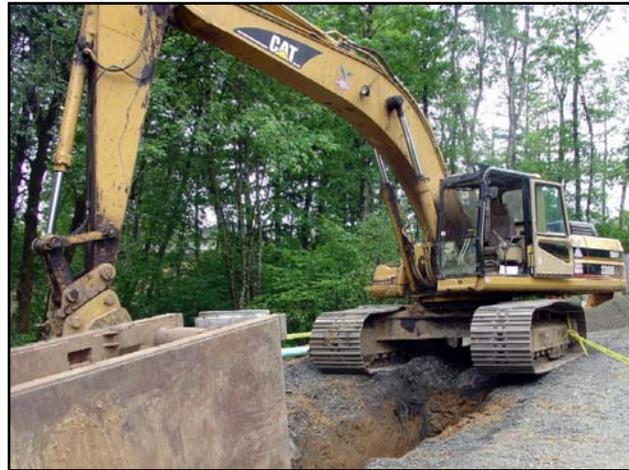
The track-hoe involved in this incident was pulling a trench shield forward in a trench for a sewer system when a hook failed and the rigging snapped loose.

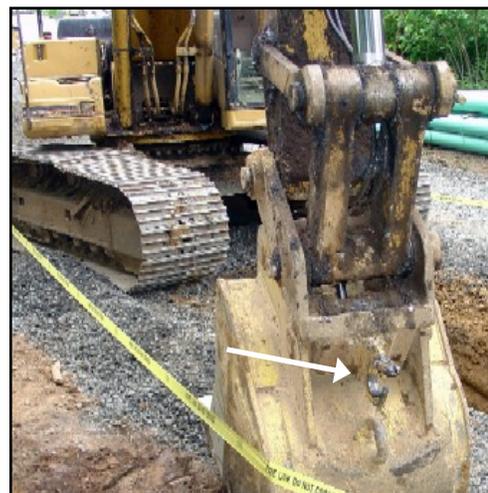
latched hook welded onto the quick-coupler to replace the original closed "lifting eye" supplied by the manufacturer.

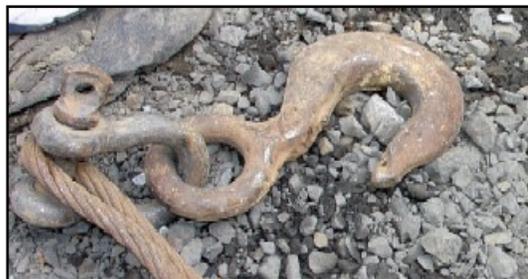
The hook and shackle attached to the track-hoe, like the one shown here (without the cable), snapped loose when the rigging failed and struck the pipelayer.

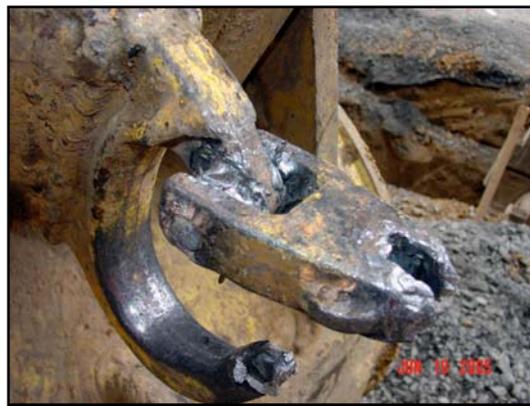
Part of the latch remained attached to the hook welded on the Hendrix Quick Coupler on the arm of the track-hoe.

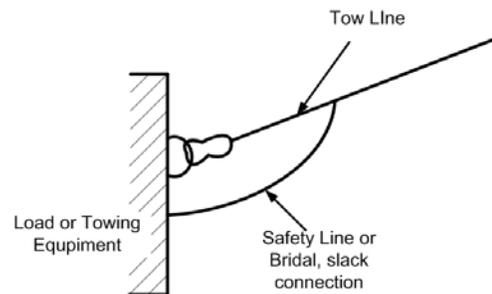
Figure 1, Diagram of safety line hook up
