# Fatality Investigation Report

OR 2005-18-1

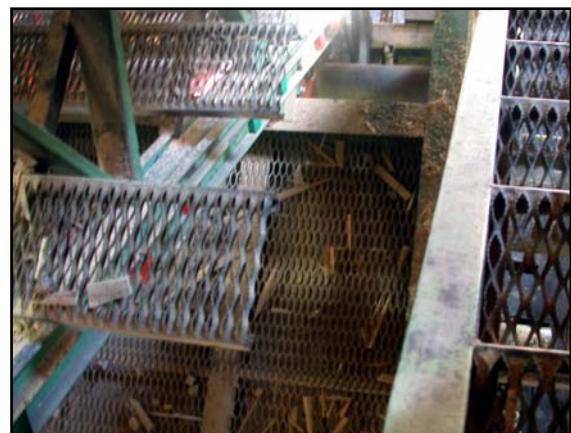
While backing off the catwalk pulling a board, the tower operator fell when he missed his footing at the end of the narrow catwalk.
