Research and Resources on Traumatic Occupational Incidents

March 12, 2015

Fatality Investigation Report

Experienced Journeyman Machinist Killed While Operating an Engine Lathe

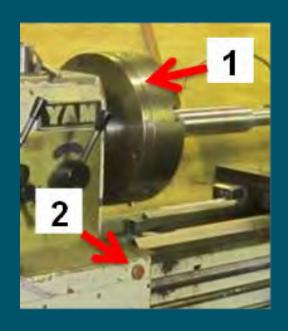
Engine lathe involved in incident

- 40 years old
- Manufactured in Taiwan in 1968
- 1 unguarded chuck
- 2 red "inch" button

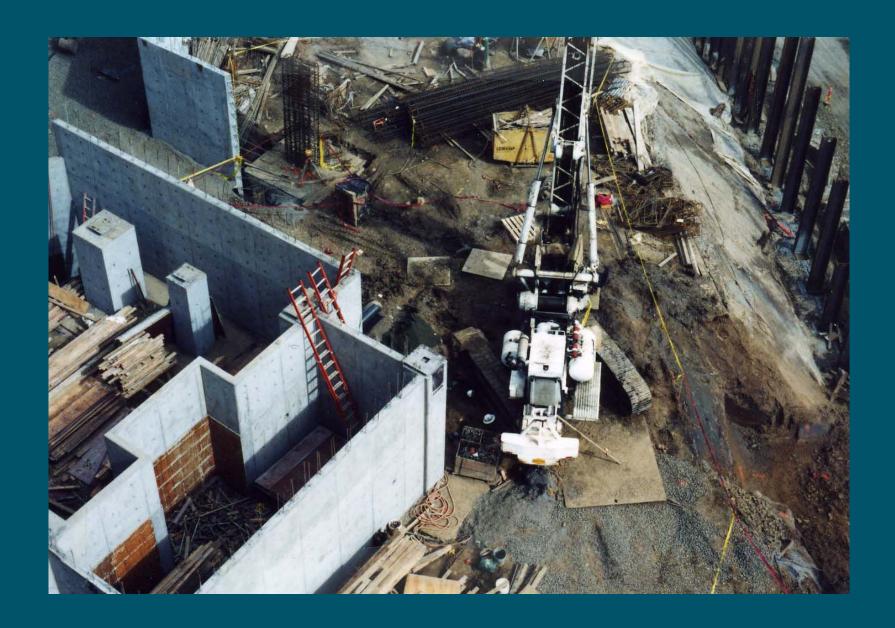
OAR437-003-0085

An unimpaired horizontal clearance of not less than 3 feet shall be maintained between the rotating superstructure of any mechanical equipment and any adjacent object or surface. If this clearance cannot be maintained, barricades shall be installed to isolate the hazardous area.

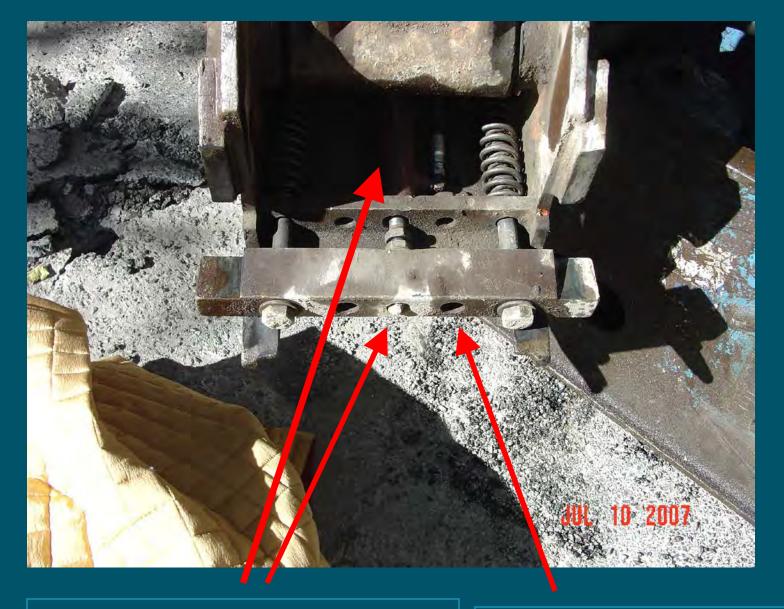
Missing Cover / Fastener

No Safety Bolt
