## Fatality Investigation Report

OR 2013-08-1

# Contract sanitation worker killed cleaning meat blending equipment

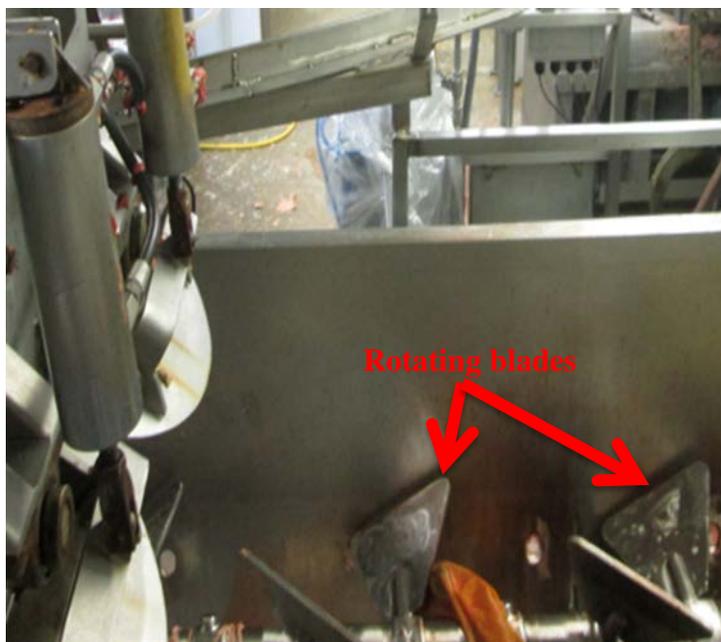
Figure 1. Open top of meat blender where the incident occurred.

was assigned to clean consisted of two horizontal shafts between 6 and 7 feet long and approximately 24 to 30 inches wide. Each shaft had blades/paddles that rotated in opposite directions (see Figure 1). The blender was used to adjust the fat content by mixing product (~3000 pounds) together until the desired content was achieved. It was the only blender in the room. The room was separated by walls from the rest of the processing area. The worker was working alone cleaning his assigned equipment. Other employees were in the building but none had a direct sight line to the worker.

**Recommendation #1: Host employers should remove or reduce worker exposures to moving machine parts by identifying and installing guards or interlock features.**

- The top of the blender was open exposing blades/paddles rotating while the worker was on the platform cleaning from above. It is not known whether a guard such as that pictured in figure 5 was onsite and could have been installed. If not available, the equipment manufacturer could have been contacted for a similar retrofit. An online review of meat processing equipment showed advances in interlocked safety guards for grinding/blending equipment. The OR-OSHA report mentioned that moving feed augers and conveyor chain/sprocket were also exposed and running. Similarly, guards/screens could have been installed to prevent contact with these moving parts.

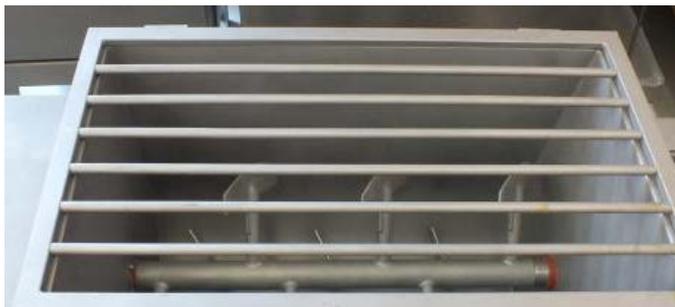
Figure 5. Example of guard for blender/grinder to prevent access to moving parts but allow cleaning.
