Fatality Investigation Report

OR 2003-39-1

Worker is thrown from cab of crane and is crushed.

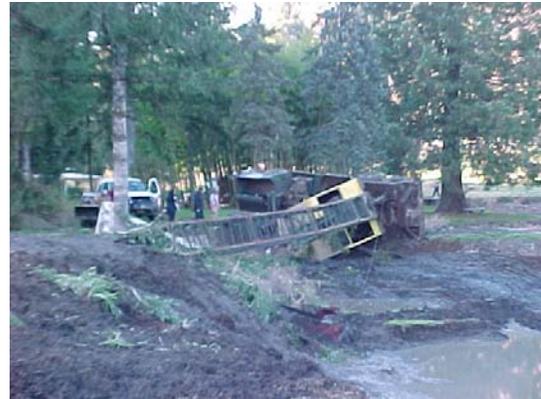
On November 6, 2003 at approximately 1430 hrs, a carrier-mounted lattice boom crane toppled over killing the operator. The 66-year old victim had more than 30 years of experience operating heavy equipment in the logging industry.

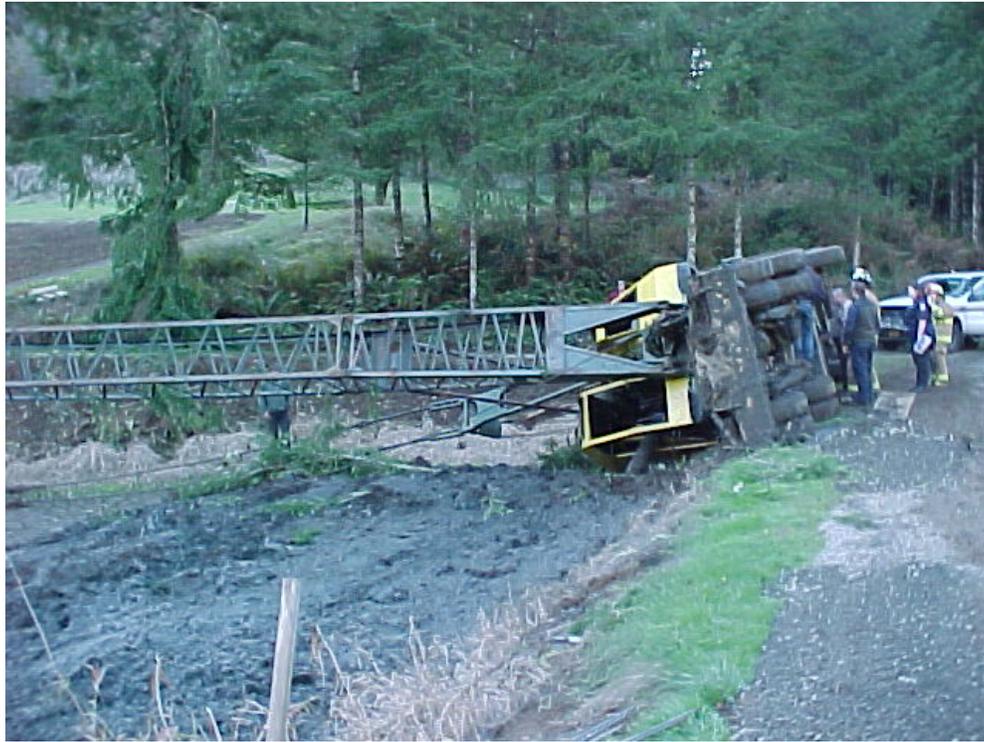
The victim maneuvered the crane onto a slip of land between two adjacent fishponds so that he could clean out some bypass canals. He had completed his bypass cleanout and had moved the crane back towards the shore of the pond when he stopped the crane. He dropped the bucket before getting back to shore, without resetting the outriggers, to dredge some mud and debris that was a little too far to reach from the position on shore. The victim had the boom of the crane angled about 30 degrees from the carriage and as the dragline bucket was being retrieved, the pull on the load of mud caused the crane to tip off balance. The crane fell over on its right side (see Photos 1 and 2). The property owner, who was out in the dry pond operating a small tractor moving gravel around on the pond's bottom, recalls seeing the crane tip over "as if in slow motion". The property owner reported saying that he saw the victim jump from the operator cab landing on the ground just inside the pond. The crane then continued tipping over and fell onto the victim. The soft earth cushioned and partially sheltered the victim from the full impact of the crane's weight. He survived the initial crane falling on him only to succumb, under the equipment, a short time later. No other equipment was immediately available to lift the crane or extricate the victim and assistance to remove the victim from beneath the crane was delayed due to the remote location and distance. The county sheriff and the local medical examiner arrived on scene a short time after the incident. The operator was pronounced dead on the scene.

Photo 2. Crane topples over, crushing worker, while dredging dry fish pond.
Note: outriggers were not deployed.

The crane operator over extended the operational envelope of the dredging system when he attempted to dredge at an approximate 30-degree angle to the centerline of the crane's carriage without using the outriggers. The dredging bucket was being dragged back to the crane, when the crane became unbalanced and tipped over.

- ✓ **Proper set-up is essential to safe crane operation. Always deploy outriggers before operating the crane. Understand the center of gravity of the load being lifted and avoid side or end pulls.**

The crane was equipped with outriggers. The victim had stopped to bring some silt material closer to shore so that he could then finish dredging the pond from the shore presumably with the outriggers deployed.
