Fatality Investigation Report

OR FACE 2003-16-01

Load of lumber shifts and falls on construction worker killing him

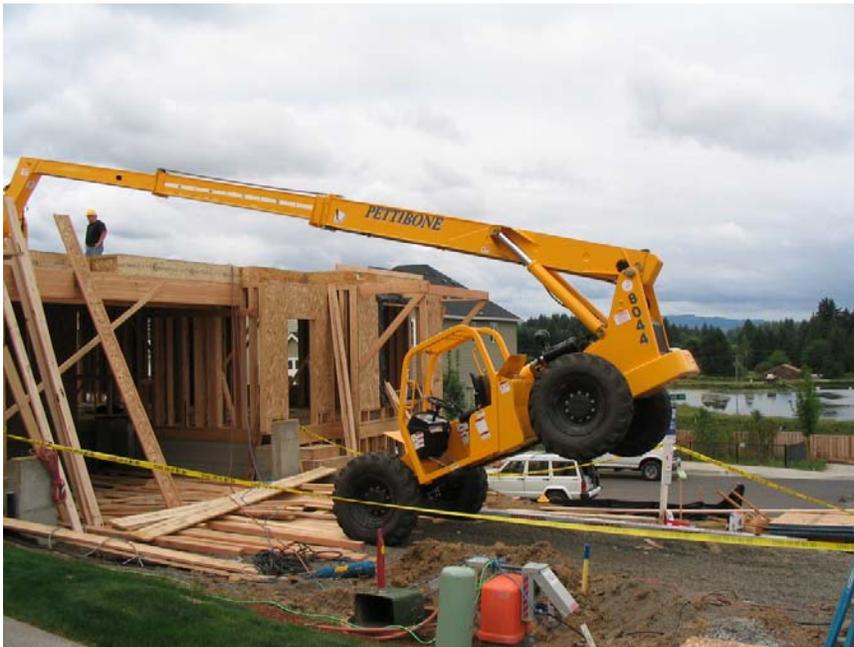
Photo 1. Forklift in position after the load came down. Note board pile in front of the forklift, preventing the forklift from getting closer to the second story.

A wire wrapped bundle of lumber was being lifted into position using a rented rough terrain forklift. A worker on the second floor was assisting the operator in moving the bundle of lumber into position as a spotter. The crane boom was fully extended while the forklift was positioned approximately 10 ft in front of the home to place the load in the center of the second floor. Photo 2 demonstrates the vertical height above the second floor, crane extension and equipment placement from home. This photo was taken immediately after the forklift had its load removed and its rear tires were lowered onto the ground. This is similar to the position that it would have been in, before the forklift was upended. The load being lifted was estimated to weigh approximately 3600-3800 lbs. The maximum load for the forklift with the boom fully extended at this arc was 2000-3000 lbs.

Once proper reach and height have been determined either by load charts, the forklift should be placed as close to the building as possible to transfer the load.

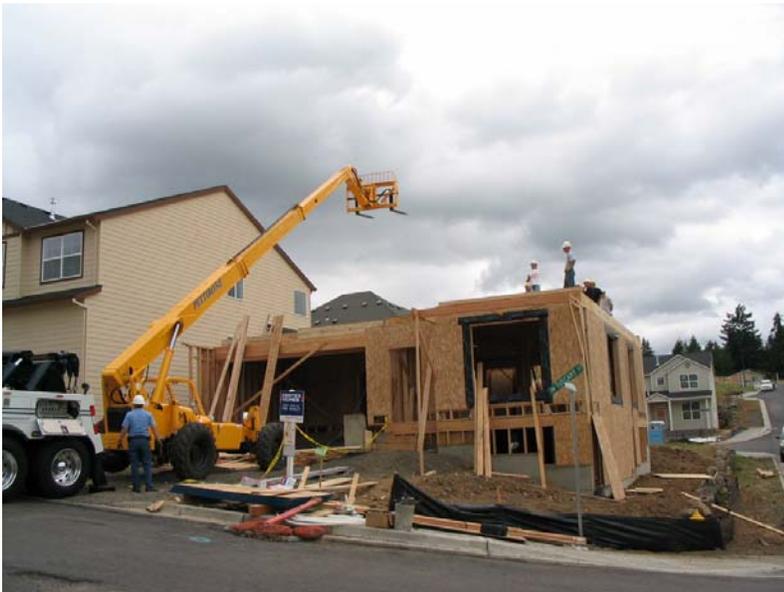
Photo 2.

Rough terrain forklift in approximately the position it would have been in just before coming down. Traverse boom is in the position it was in, when sitting on the roof (boom extension unchanged). Note height of lift from ground (~22-24 ft). The equipment has not been moved out of position.

Guidance obtained from a local forklift safety expert suggests that a significant proportion of forklift up-endings occur when operators attempt to obtain maximum reach, by first achieving maximum height. When the load is lowered, however, the center of gravity moves far out in front of the machine causing it to up-end. Loading is a function of lift angle (height), the weight of the load and the reach of the forklift. After achieving design maximum reach/height the reach of the rough terrain forklift is reduced as height is increased (see attached load chart in appendix). This means the farther the boom is extended the less high it can be lifted. Static load testing should be done away from workers, on flat ground. Never attempt to move any forklift under load with its boom extended up or out.

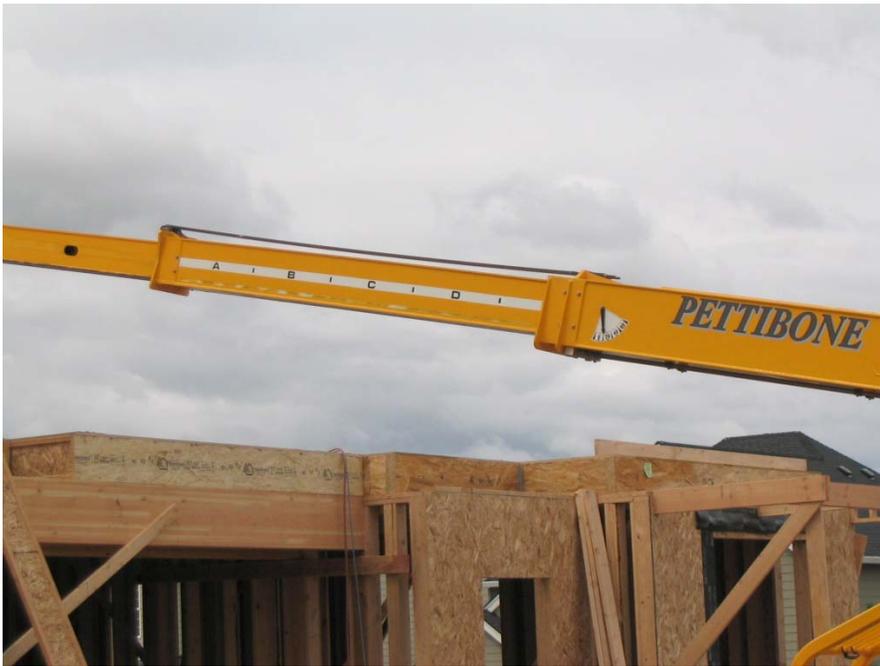
Photo 4. In upended position, the boom is extended between "D" and "E" load rating. Weight of load was calculated to be 3600-3800 lbs. extended ~24ft. The maximum load range at this reach and arc is 2000-3000 lbs.

- ✓ **Stay within the safe working parameters of the crane or lift and do not exceed the recommended load or reach specifications. Ensure that all mobile equipment operators are trained or certified in the operation of the equipment prior to use.**

Consult the lift specifications tables in the equipment handbook and determine lifting design parameters. Load charts on this rough terrain forklift can be easily accessed. For example, many manufacturers' post links to their web sites: e.g., <http://saesections.org/cis/links.html>, (under OEMs/Pettibone LLC).
