Fatality Investigation Report

OR 2007-17-1

Highway worker crushed by swinging backhoe boom

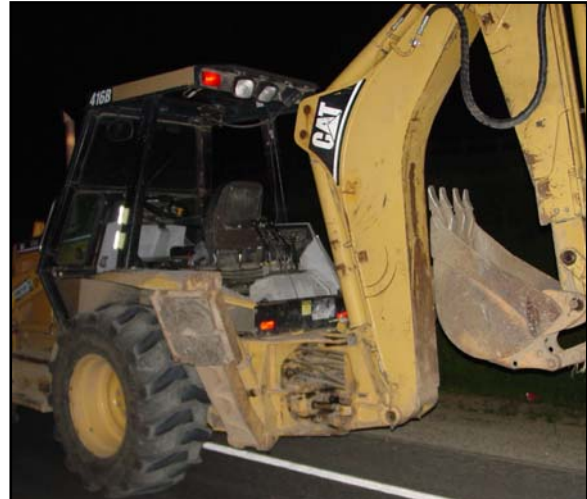
The construction worker was crushed at the pinch point on the backhoe between the rear boom arm and the raised stabilizer.

Recommendation #1. Workers on the ground near an operating backhoe must never stand in the pinch point of the backhoe boom.

Stay away from an operating backhoe. A swinging backhoe boom is a common source of injury (see references for other state FACE reports of similar incidents). To avoid the hazard, the operator must always shut down the machine and secure the attachments before exiting the cab. Never put the machine in idle to exit. Workers on the ground must not approach within reach of a backhoe excavator or loader until they signal the operator to shut down the machine and receive acknowledgment from the operator. Backhoe operators must ensure that no one is on the ground within the working area of the machine.

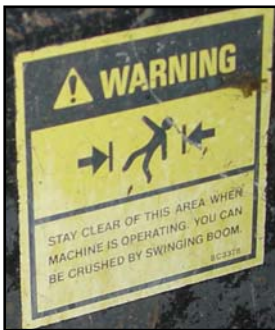
The employer had a comprehensive generic safety and health policy, which included job descriptions with job safety analyses. The job information instructed that no one should be allowed in hazard areas, but did not specify the pinch point between the backhoe's boom and the stabilizer as a hazard area. A warning label was visible on the back of the backhoe, however, bearing a graphic image and the message: **STAY CLEAR OF THIS AREA WHEN MACHINE IS OPERATING. YOU CAN BE CRUSHED BY SWINGING BOOM.**

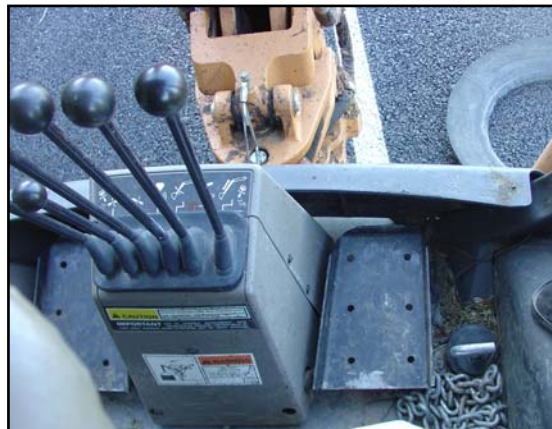
At the rear, the backhoe excavator arm was fully retracted and the stabilizer arms were not yet lowered into place. As the journeyman walked along the left side of the backhoe, he tossed one of the pin pullers and a large lag bolt onto the floor of the cab. The pin landed on the foot pedal that controlled the boom swing, and the boom instantly swung sideways and crushed the journeyman operator against the raised rear stabilizer.

The foot-pedal control for the backhoe boom was unguarded.

Recommendation #2. Foot-pedal controls on a backhoe should have a guard or other disabling mechanism to prevent accidental activation of the boom when not in use.

Unintentional activation of the boom foot pedal on a backhoe is a serious risk, either by the operator stepping on the pedal, or as in this instance by a person outside the machine reaching in or placing a heavy object in the cab that inadvertently depresses the foot pedal. This incident emphasizes the general rule that a backhoe cab should never be used for storing equipment, even temporarily.

In 2004, one heavy equipment manufacturer recognized the hazard posed by the foot-pedal control on older backhoe models and issued a safety notice to product owners, announcing that guards must be installed over the foot pedals, and that a dealer would install the guard without charge. At least 23 substantially similar incidents of injury or death due to activation of the backhoe boom-swing foot pedal, nearly all since 2000, were documented in many different states for this one manufacturer (the memo is archived in the Oregon OSHA investigation file for this incident).

Only specific backhoe models are equipped with foot-pedal controls, and since 2000, those models are switching to a joystick or other hand control for the boom to avoid the risk of unintentional activation of the equipment by the foot pedal. The foot pedal, however, remains an option on new backhoes.

Occupational safety regulations for foot-pedal controls on mechanical power presses and other specific industrial machines require a guard – e.g., “The pedal mechanism shall be protected to prevent unintended operation from falling or moving objects or by accidental stepping onto the pedal” (1910.217(b)(4)(i)). Yet no similar rule applies to foot-pedal controls on a backhoe, and no standard guard or retrofit guard kit is available for backhoes. In view of the manufacturer’s initiative noted above, the design of a suitable guard is feasible.

Manufacturers and government regulators should consider requiring the use of foot-pedal guards or some other method to disable the foot-pedal control on the backhoe boom when not in use. A boom-swing lock pin is currently available to secure the boom during travel, but the pin is not a useful alternative to a guard, because it is not intended to be used during work activities. In this incident, for example, the boom was part of the operation and was unlocked in preparation for use. This incident emphasizes the need to develop a guard or disabling mechanism for backhoe foot pedals, in addition to the locking pin. Similar to foot controls in other industrial machines, occupational safety regulations could require a guard or other disabling mechanism on all backhoe foot-pedal controls.
