Fatality Investigation Report

OR 2004-15-1

Fabricator killed by ruptured hydraulic press fitting

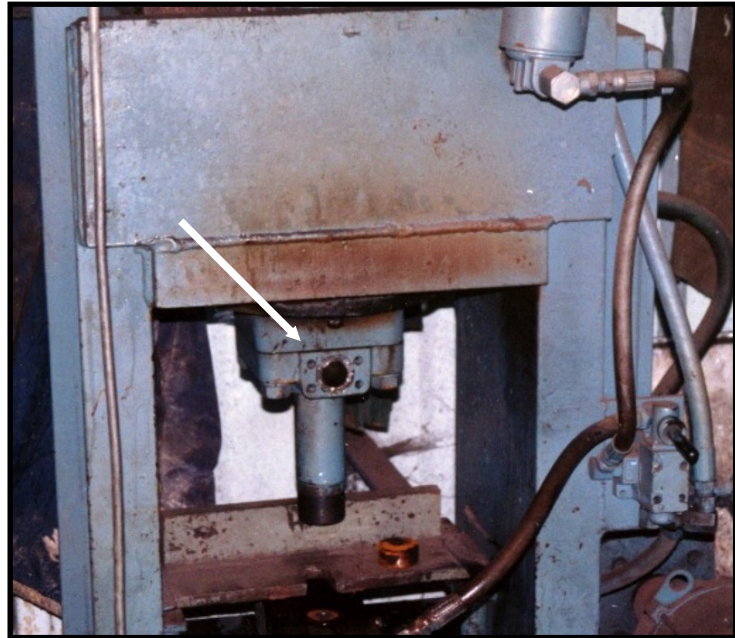
The lower front part of the shop-fabricated hydraulic press involved in this incident shows a hole where a hose was attached to the hydraulic cylinder.

The hydraulic press was reportedly fabricated by the previous owner of the business, and remained in the shop on loan. The shop-fabricated press was not equipped with guards on the hose connections. The fitting for the hose on the return cylinder consisted of a 45-degree elbow screwed onto a piece of galvanized pipe, 2 in. long and 1 in. diameter. The pipe was shoved, not threaded, into the return opening, and secured with a welded flange around the outside edge. A weld on galvanized pipe tends to produce a porous, weak weld. There were no signs of failure in the weld on the outside surface, such as swelling or a leak, but failure was visible on the internal surfaces of the break. The hydraulic pressure gauge on the press was damaged and inoperable prior to the incident.

Recommendation #1. Points of operation and all pressurized hoses should be guarded on a hydraulic press.

- Hose ends must be secured to prevent whipping if an accidental cut or break occurs.
- Only standard fittings should be used on hydraulic lines.
- The rated strength of hoses, gauges, fittings, and couplings installed during machinery fabrication, as well as replacement parts, should be matched to the operating pressures of the equipment, including an appropriate safety factor.
- Hydraulic connections should be located on the side or rear of the machine, away from the operator or other workers.

Custom-built hydraulic presses are fairly common in small shops. Owners should ensure that unique features of their shop equipment do not compromise safety. Expert advice may be useful. The 45-degree elbow in this incident, for example, may have contributed to excessive pressure on the weld. Additionally, the press was not equipped with a bleed-off valve to regulate pressure.

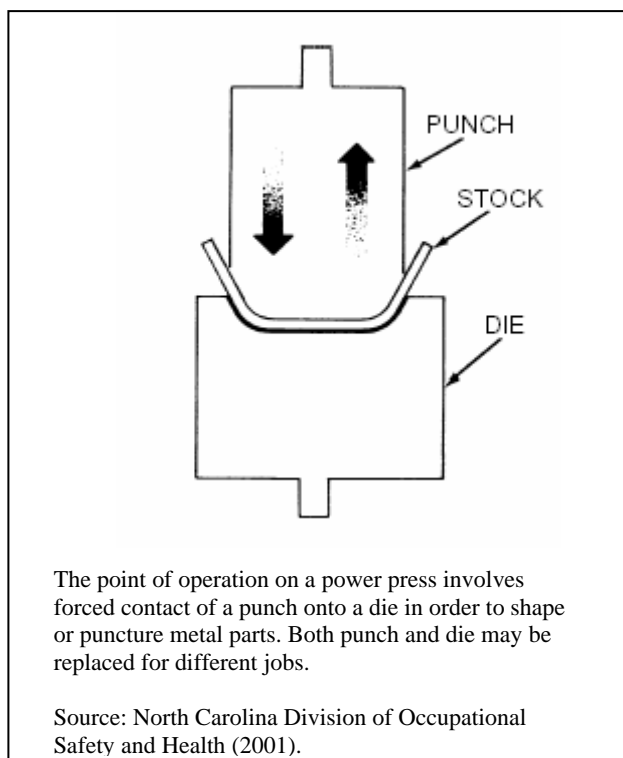
The fabricator removed the punch that had been in the press and retracted the cylinder to its maximum return position in order to install a different punch. At some point during the return stroke, the hydraulic fitting attached to the return-stroke cylinder burst and broke free from the press and its hose attachment. The return hose was attached to the cylinder 33 inches above the ground. The fabricator was evidently sitting on a rolling cart in front of the press and leaning forward, putting his

upper body in direct line with the trajectory of the burst fitting. The fitting struck the victim near the collarbone, and traveled through his body to settle in his lower back without exiting. Death was probably instantaneous, according to the medical examiner.
