Fatality Investigation Report

OR 2003-19-1

Farmer is killed when he falls beneath moving combine.

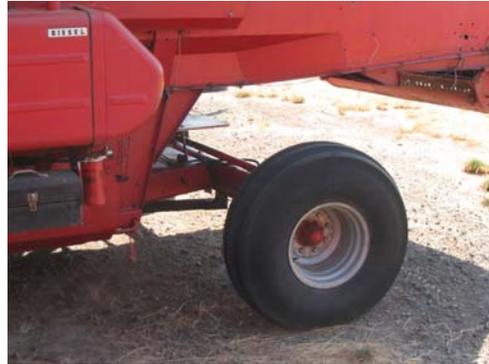
Photo 2. Space between rear tires and combine body and short narrow deflection shield.

More recent models of combines have had engineering improvements to reduce the risk of this kind of incident: (1) the rear steering wheels have been placed more forward on the combine and track with the front drive wheels, and (2) the width and length of the deflection shield (Fig. 3) has been increased to throw chaff and seed further behind the rear wheels making it unnecessary to stand near or in front of them. Additionally, by placing the rear wheels towards the front of the combine the space between the rear wheels and body of the combine is reduced preventing operators from entering into this area while the combine is moving.

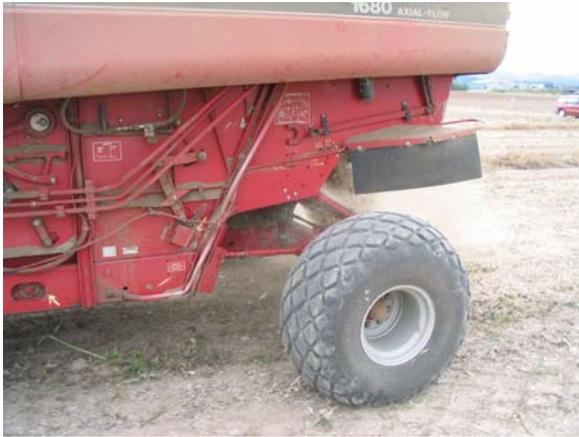
Note. Newer models like the one in these photos, direct the outflow behind the rear steering wheels. Newer models also have deflection shields that are much wider than those on older machines. Wider shields are better at getting the chaff over the rear axles and past the rear steering tires. Proximity to the spinners makes it extremely dangerous to be in this area for any reason.

Photo 3. Above/Below. Newer combine and larger straw deflection shield.

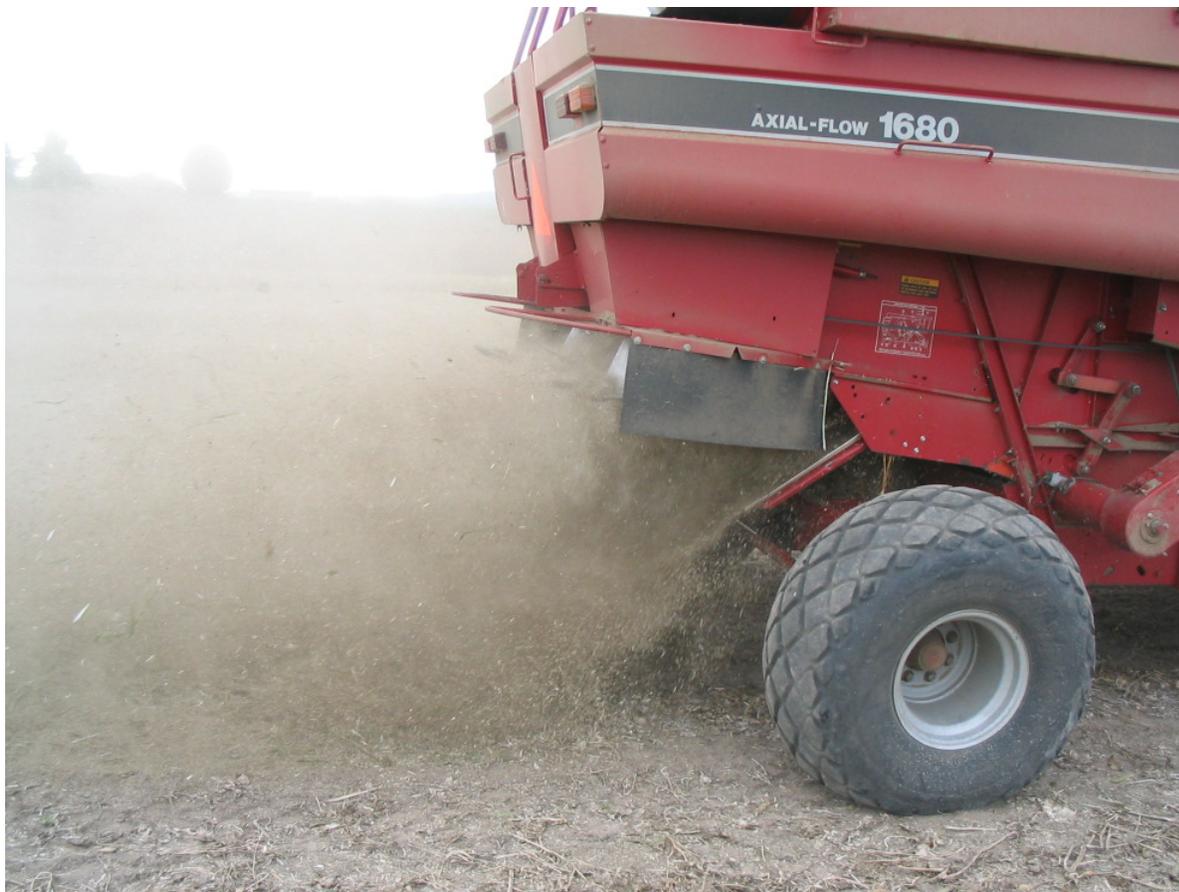
Photo 4. Combine processing seed.
