# Fatality Investigation Report

OR 2004-07-1

## Nursery laborer killed in skid-steer loader

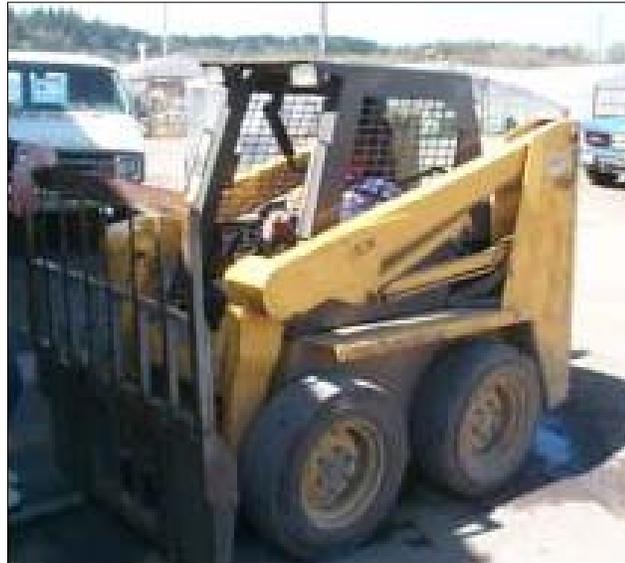
One of three similar skid steers operated at the worksite.

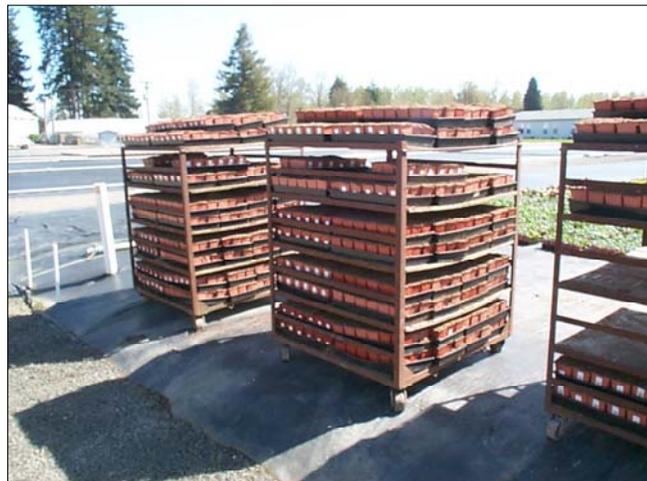
On the day of the incident, the skid-steer operator was moving metal carts, about 5 ft. tall, from an outdoor location to the inside of a greenhouse. The process involved driving the skid steer up to the cart so that the front forks went underneath the cart. The operator was then supposed to shut off the machine and exit the cab in order to secure the load with a short length of chain welded to the skid steer. The cart was then moved to the greenhouse where other workers released the cart, and then unloaded the individual plant containers. The operator performed this work for several hours in the morning before greenhouse workers noticed his absence.

Metal carts containing plants, which the victim was picking up with the skid steer and moving into greenhouses.
