Fatality Investigation Report

OR FACE 2003-15-01

Construction worker dies when he leans out of the protective cage of a skid steer forklift and is crushed.

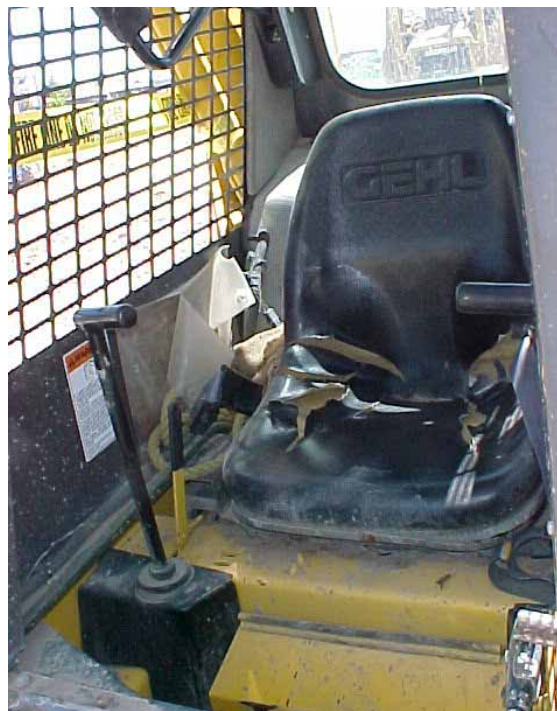
Photo 2. Position of safety bar following the incident.

A representative of the equipment manufacturer stated that the seat and the safety bar had an interlock function that should have prevented the lift mechanism from raising or lowering. Interviews with witnesses suggest that the safety interlock was not functioning properly at the time of the incident and may have been deactivated.

- ✓ **Never modify, defeat, or override safety features. Similarly, never operate equipment in which safety systems or features have been modified or are not working properly.**

Discussion: Check all equipment and ensure that all safety systems are operational. All safety features that are not working properly should be reported and the equipment should not be used until repaired. Before returning equipment to service, check to ensure that all systems are operational and functioning as intended.

Discussion: The protective cage is designed to keep the operator safe while operating the skid steer loader. The front of the cage is open to maximize visibility from the operator's seat. The safety bar is designed to deactivate the hydraulic systems if the worker leaves the seat and to remind the operator to stay seated inside the protective cage when operating the equipment.
