Research and Resources on Traumatic Occupational Incidents

March 12, 2015

Fatality Investigation Report

Experienced Journeyman Machinist Killed While Operating an Engine Lathe

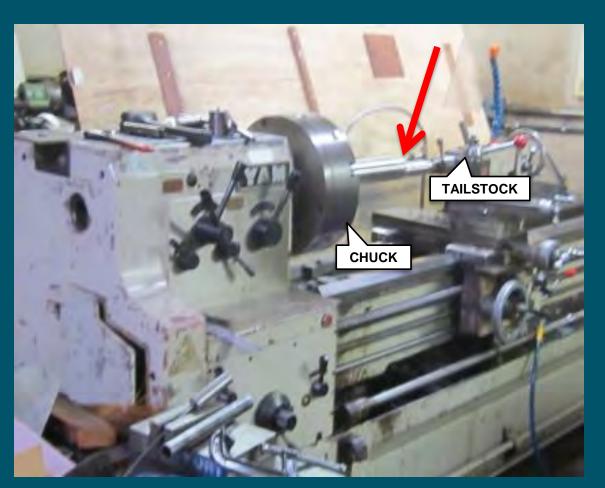
OR 2012-18-1

- Machinist turning his first short length (30.5 inches long)
 eccentric shaft (workpiece), had completed a few longer shafts
- Rough machining completed (7 hours)
- Part slipped in chuck jaws and had damaged end
- Told to smooth radius transition using emery cloth then reverse part
- Spindle speed set at 590 rpm (supervisor sets speed at 330 rpm)
- Operator of nearby CNC machine heard "winding up" sound and pushed red button repeatedly
- Gloves found on equipment

- Defective tool (bent chuck key)
- New employee, high expectations, minimal guidance
- Clothing cut-off sleeve sweatshirt
- New task short piece
- Older equipment (different safety features)

- 1. Employers should establish, <u>communicate and</u> <u>enforce a clothing policy</u> specific to the work environment and particularly for machine operators.
- 2. Employers should establish formal <u>training</u> on recognized <u>hazards</u>, <u>injury prevention</u> and <u>emergency procedures</u>, and to communicate expectations to adhere to safe practices and policies.
- 3. Supervision should <u>monitor</u>, reinforce safe behaviors, and <u>immediately correct unsafe behaviors</u> or conditions.

- 4. Job hazard analyses should be conducted by operators and supervisors and should include a review of the manufacturer's equipment/operator's manual, machine labeling, color coding, etc., especially for legacy machines.
- 5. Employers should implement preventive maintenance and inspection processes for hazardous machines. Where necessary, employers should install, adjust, label and/or repair appropriate controls (e.g., machine guards, emergency stops).

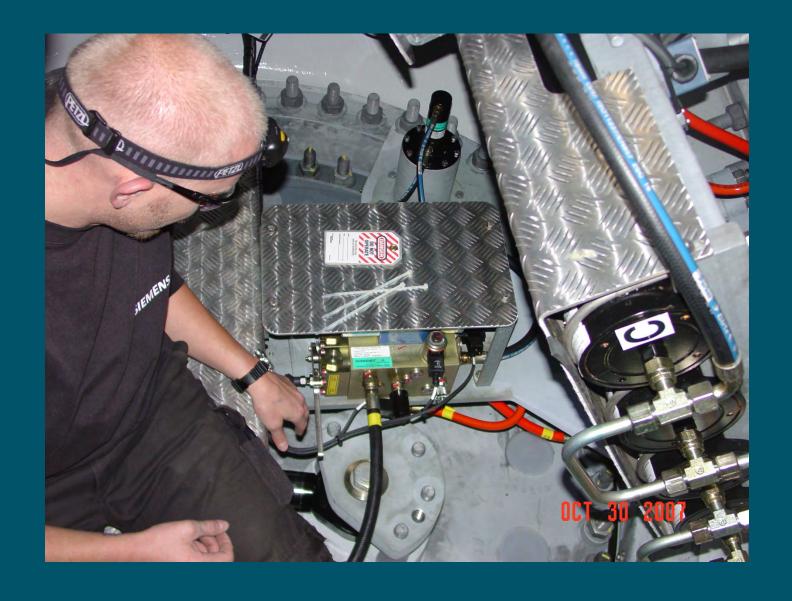
Closing one of the three pitch safety valves in the hub

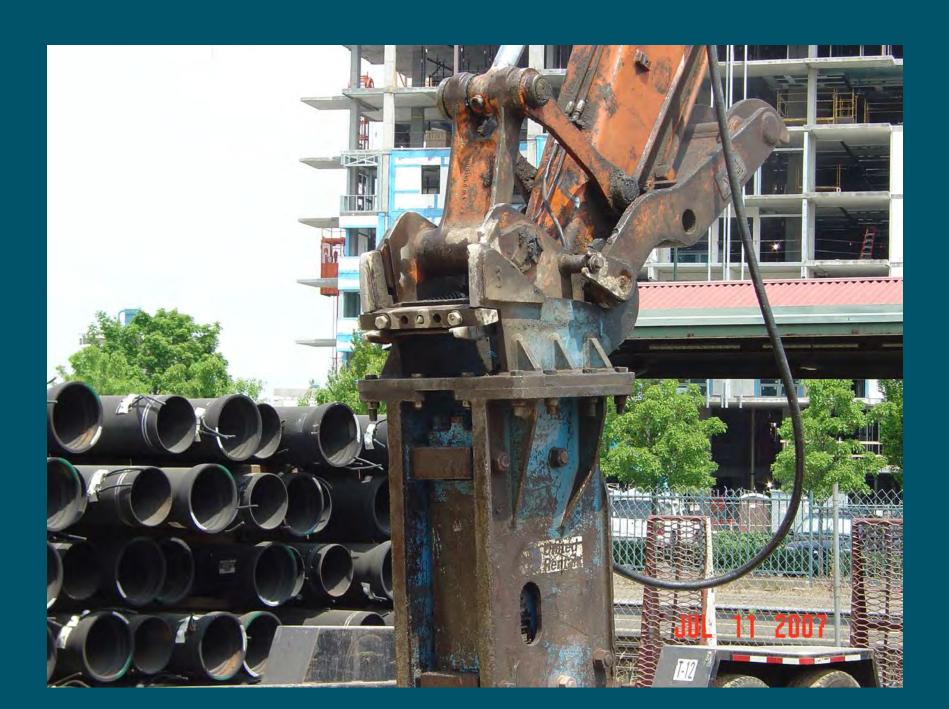
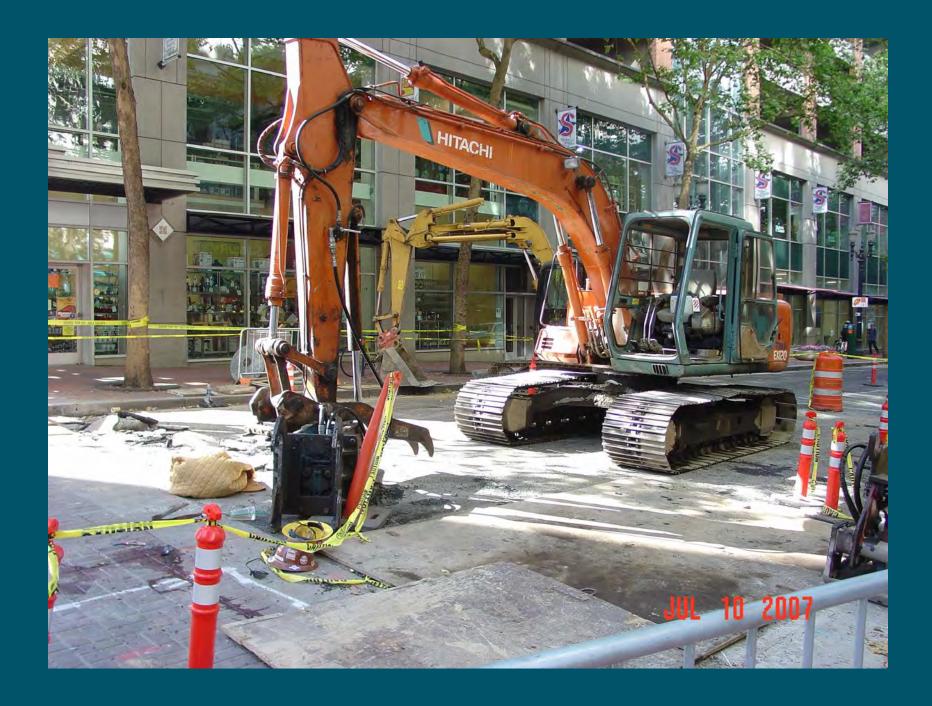
OAR437-003-0085

An unimpaired horizontal clearance of not less than 3 feet shall be maintained between the rotating superstructure of any mechanical equipment and any adjacent object or surface. If this clearance cannot be maintained, barricades shall be installed to isolate the hazardous area.

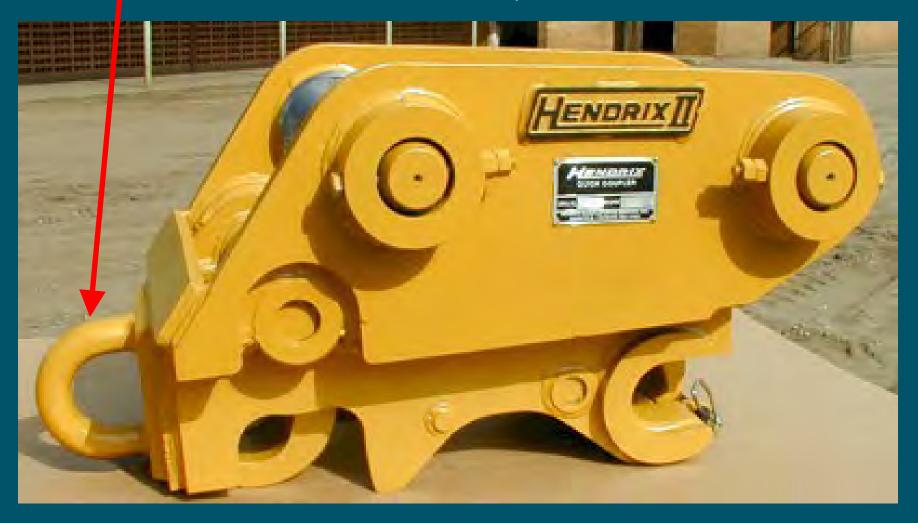
Closed Lifting Eye
