FATALITY INVESTIGATION REPORT

Rubber equipment operator died after his head was caught between bars of operating machinery

REPORT#: 2018-29-1

REPORT DATE: June 2019

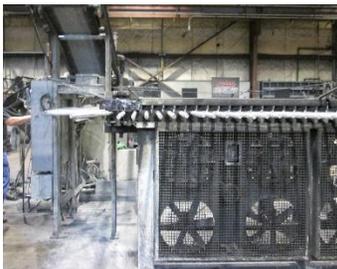
On August 23, 2018, a 23-year-old male Caucasian rubber cutter was found caught between two bars of a festoon rubber processing line (cooling line). The event was unwitnessed; however, circumstances suggested that the employee entered the festoon area to retrieve and redirect a rubber strip on a cooling bar that had passed the point where it should have fed onto a conveyor. It is believed that the worker raised his head between the moving cooling bars, and that the bars then forced his head against a structural support for an electrical panel. He was pronounced dead at the scene. ([Full report begins on p. 3](#))
