Fatality Investigation Report

OR 2004-03-01

Sawmill worker crushed during debarker maintenance

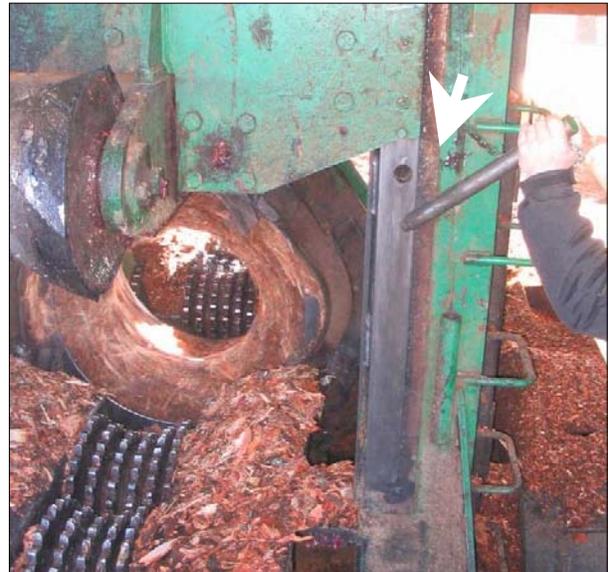
Intake of log debarking machine, showing one of two pins affixed to the frame of the machine by a chain. The pins can be inserted into designated slots to prevent the press roll from lowering. (see arrow)

The millwright did not block the press roll into place with the safety pins available for this purpose, located on each side of the holddown frame in storage jackets.

The coworker replacing the old pneumatic oil-injector system shut off the air compressor and released the air pressure using controls located in an area distant from the debarker. With the compressed air shut off, the holddown press roll above the in-feed roll of the debarker dropped down onto the millwright as the air pressure was released, crushing him. Insertion of the safety pins in the frame of the debarker would have prevented the press from lowering when the air system was turned off.

Recommendation #1: Prior to performing maintenance operations, de-energize, isolate, and block all forms of hazardous energy. This includes blocking machine parts against motion.

In this incident, no lockout/tagout procedure was followed. The gravitational energy in the press roll was not mechanically blocked by using pins attached to the frame of the machine, designed for that purpose. Machine parts controlled by pneumatic, hydraulic, or other fluid-operated systems are subject to motion if system pressure is lost, and should always be mechanically blocked before maintenance is started. Blocking machine parts against motion is part of a comprehensive hazardous energy control program.

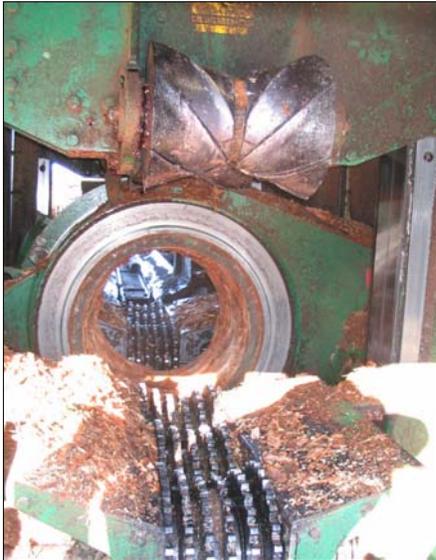
On the day of the incident, the millwright began routine maintenance, replacing the worn grip pins, which are welded onto the lower in-feed rolls on the debarker machine. He used a portable handheld right-angle grinder while kneeling down on the lower roller drum, under the holddown press roll. The millwright had shut down the electrical switch gear, located within 5 feet of the debarker. There were no lockout or tagout devices in place at any of the electrical control panels.
