## Fatality Investigation Report

OR 2004-37-1

### Janitor using propane buffer killed by carbon monoxide

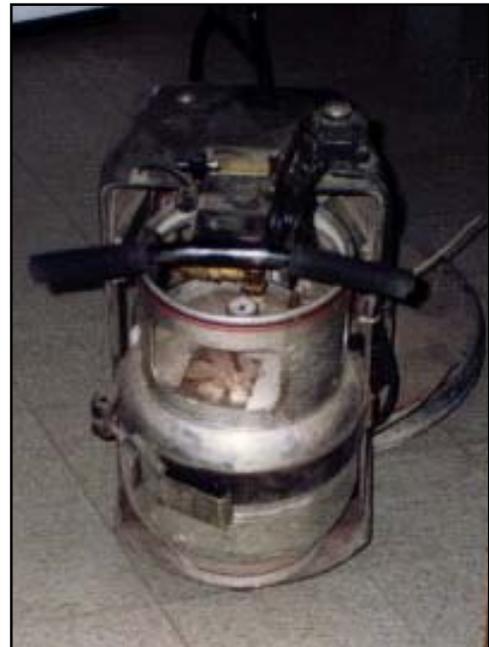
The propane-powered buffer used in this incident produced high levels of carbon monoxide.

The buffer, a Pioneer Eclipse propane buffer, Model CV11ST, had been owned by the employer for about 3 years, and was serviced within the past year. The buffer is started by plugging it into an electrical outlet, and is then powered by propane gas.

Proper equipment maintenance includes frequent and regular replacement or cleaning of engine air filters to ensure that equipment is operating efficiently, with a minimum of toxic exhaust. Inspection of the buffer in this incident discovered the air filter was clogged, which contributes to poor combustion and increased emission of carbon monoxide. The manufacturer's standard allowed a carbon-monoxide emission of 700 ppm at full throttle. When tested the buffer

produced carbon monoxide at a concentration over 85,000 ppm at full throttle. The buildup of carbon monoxide in the enclosed building was estimated to have reached a dangerous level of 1,461 ppm within 5 minutes, and 12,342 ppm within 60 minutes.

### **Recommendation #1. Propane-powered equipment used indoors should be replaced with electric-powered equipment.**

### **Recommendation #3. Equipment should be properly maintained in safe working condition.**
